**CAPITAL NEEDS ASSESSMENT (CNA)
ROCKLAND TOWERS (2-50)
5300 WASHINGTON STREET
WEST ROXBURY, MASSACHUSETTS 02132**

**D3G PROJECT NUMBER:
2021-0378**

**FINAL REPORT ISSUE DATE:
OCTOBER 14, 2021**

**INSPECTION DATES:
APRIL 19 & 22, 2021**

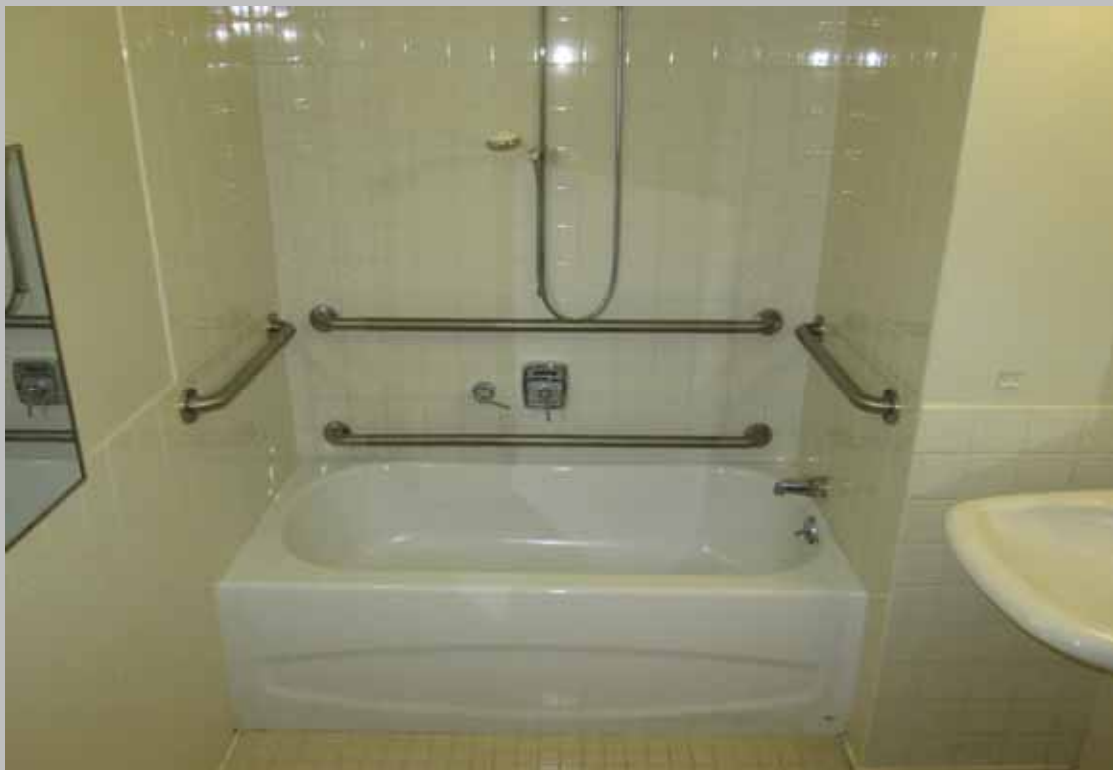
PHOTO #54

View of the shower within designated handicapped Unit 17 featuring compliant grab bars and a 60-inch shower hose

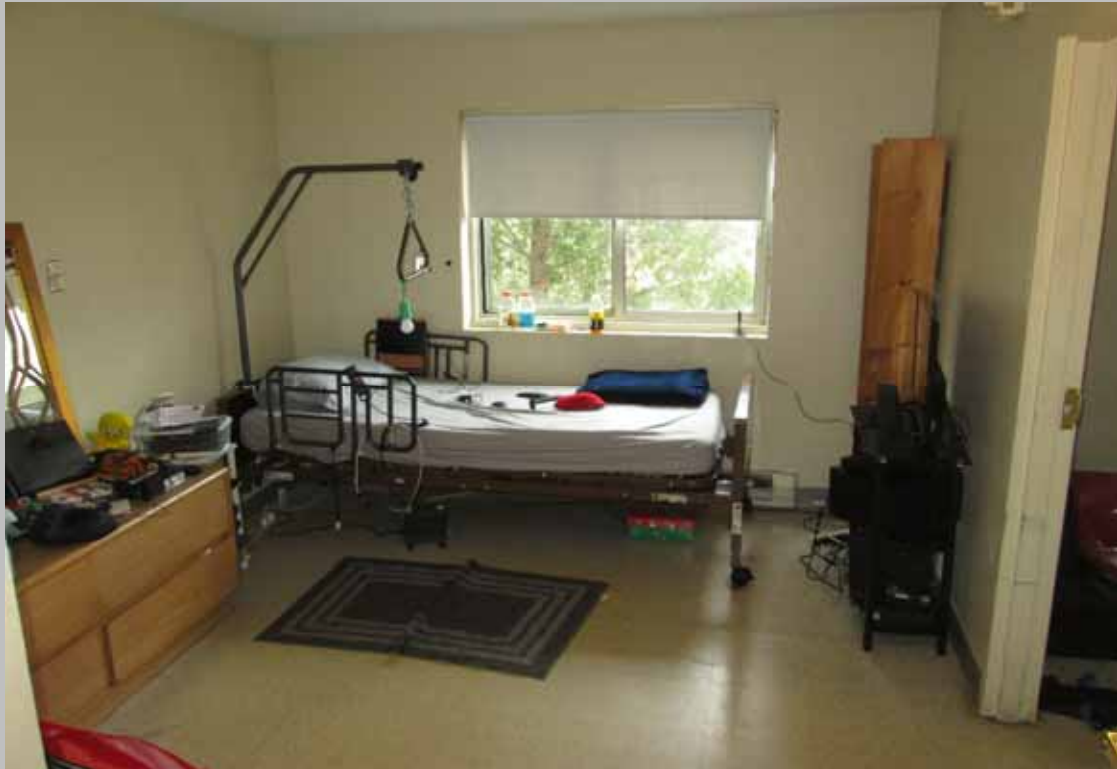
PHOTO #55

View of the bedroom within designated handicapped Unit 35
