HUD CAPITAL NEEDS ASSESSMENT

Franklin Field
180-20 Stratton Street
Dorchester, Massachusetts 02124

AEI Project No. 463341
Site Inspection Date: July 12, 14, 25, and 27, 2022

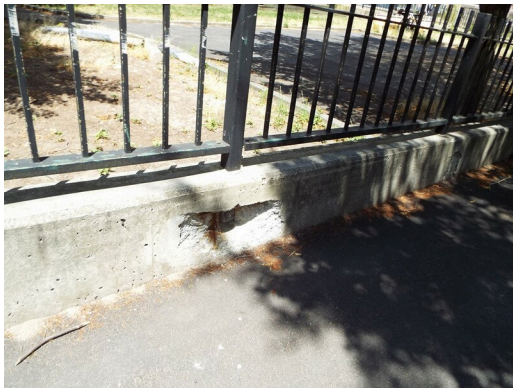
Spalling and deterioration was observed at concrete retaining walls located at buildings 9, 12 and 19. Repair is recommended. (Non-Critical Repair)

Concrete retaining wall spalling - rear building
9 (Non-Critical Repair)

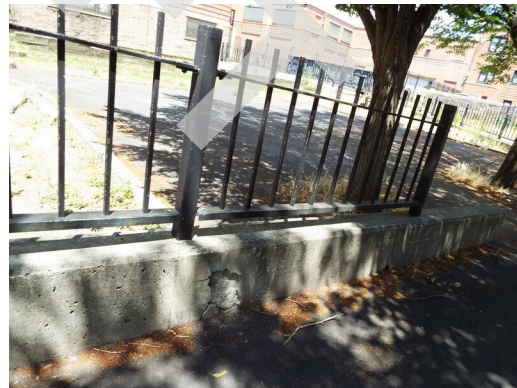
Concrete retaining wall spalling - rear building
9 (Non-Critical Repair)

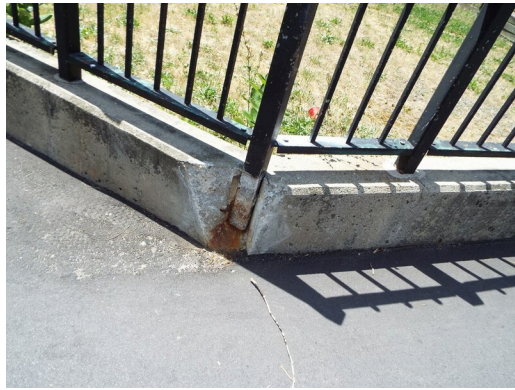
Concrete retaining wall spalling - rear building 9 (Non-Critical Repair)

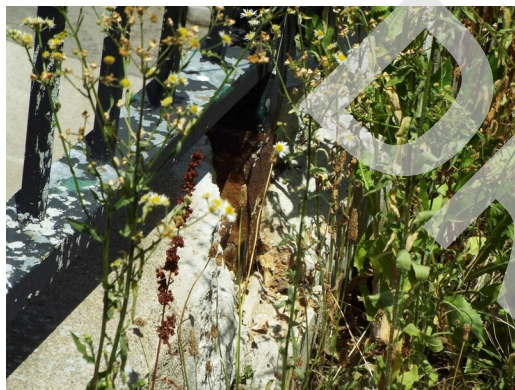
Concrete retaining wall spalling - rear building 12 (Non-Critical Repair)

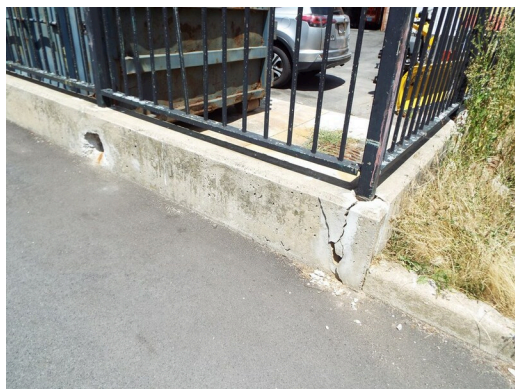
Concrete retaining wall spalling - rear building 12 (Non-Critical Repair)

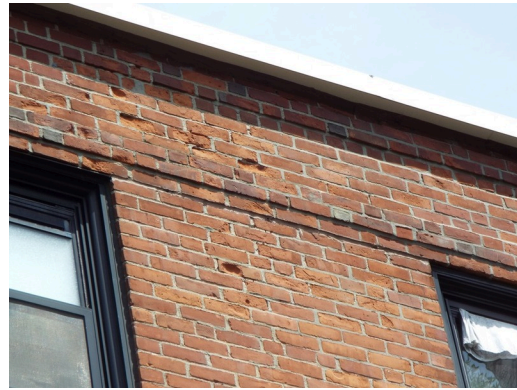
Brick spalling and masonry grout deterioration was observed at exterior brick masonry throughout the property. Inspection and repair recommendations by a licensed structural engineer is recommended. (Non-Critical Repair)

Brick masonry condition - building 4
(Non-Critical Repair)

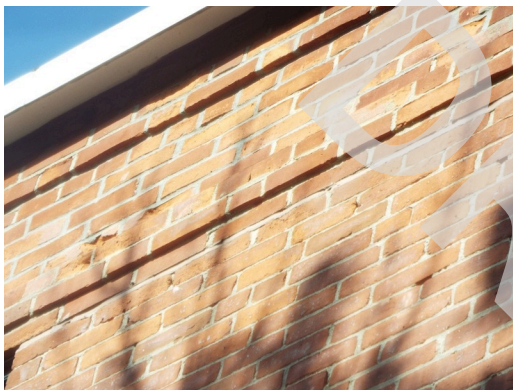
Brick masonry condition - building 6
(Non-Critical Repair)

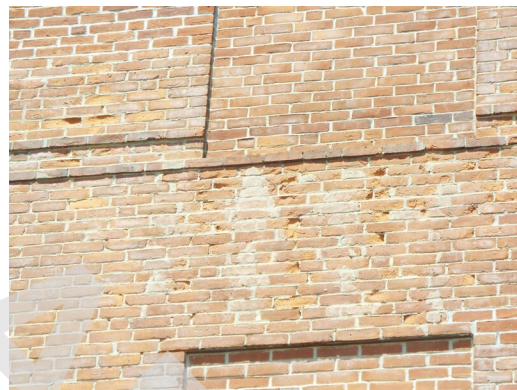
Brick masonry condition - building 7
(Non-Critical Repair)

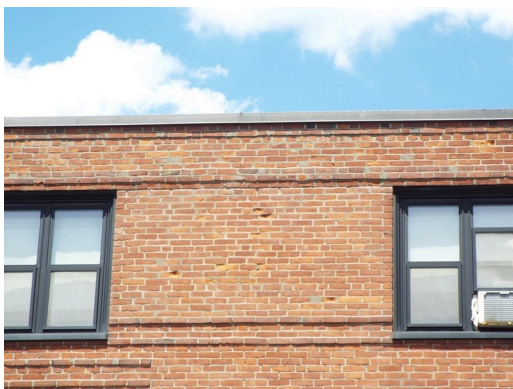
Brick masonry condition - building 8
(Non-Critical Repair)

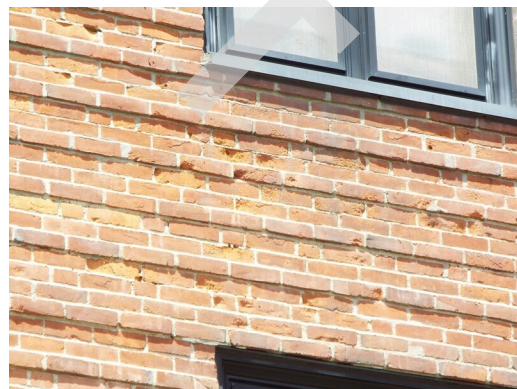
Brick masonry condition - building 9
(Non-Critical Repair)

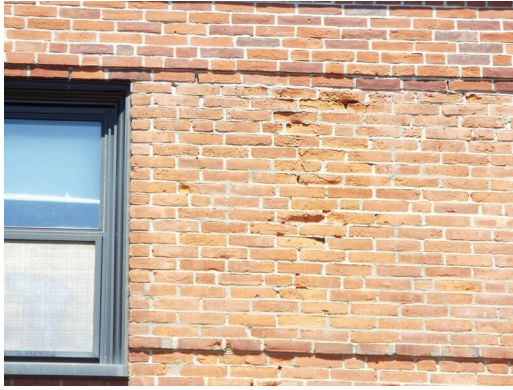
Brick masonry condition - building 10
(Non-Critical Repair)

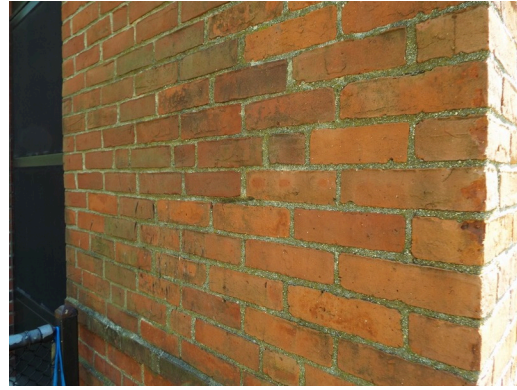
Brick masonry condition - building 11
(Non-Critical Repair)

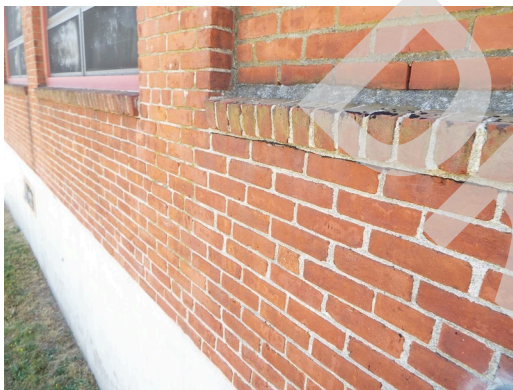
Brick masonry condition - building 12
(Non-Critical Repair)

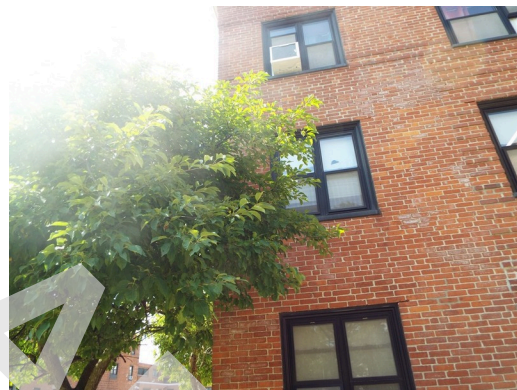
Brick masonry condition - building 13
(Non-Critical Repair)

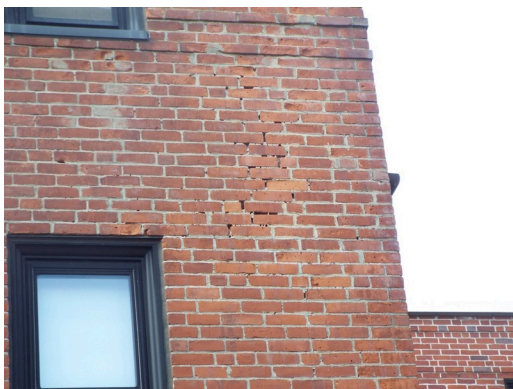
Brick masonry condition - building 14
(Non-Critical Repair)

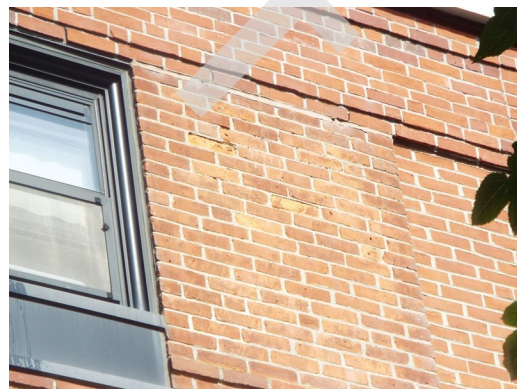
Brick masonry condition - building 16
(Non-Critical Repair)

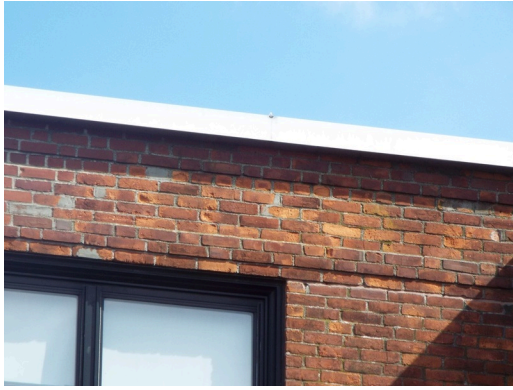
Brick masonry condition - building 17
(Non-Critical Repair)

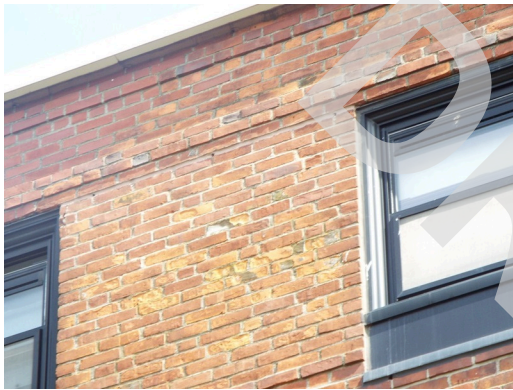
Brick masonry condition - building 19
(Non-Critical Repair)

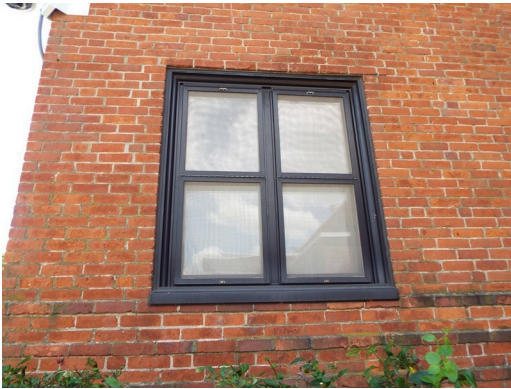
Typical window

The windows were reported to be installed in the 1980's and 1990's and are in good to fair condition. According to management, full window replacement is in the planning stages. Based on condition, and Estimated Useful Life (EUL). AEI recommends that the windows be replaced during the reserve period.

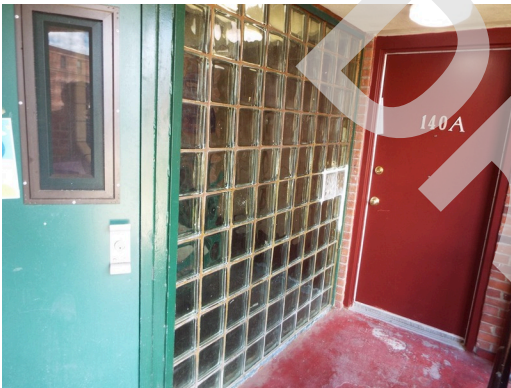
Glass block

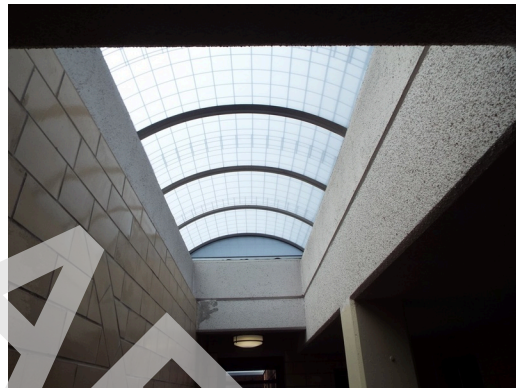
Skylight - building 2

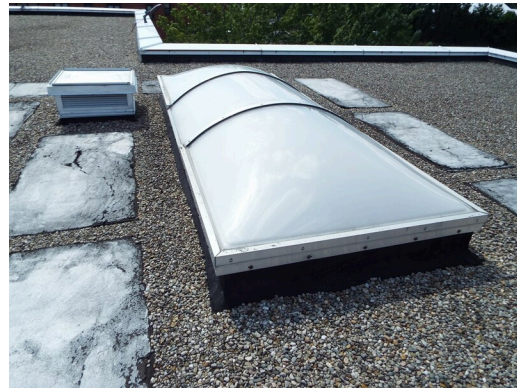
Skylight - building 14

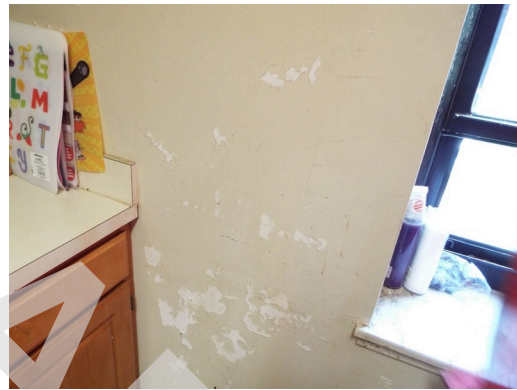
2-bed-1-bath - unit 50E - building 18 - wall paint condition (Non-Critical repair)

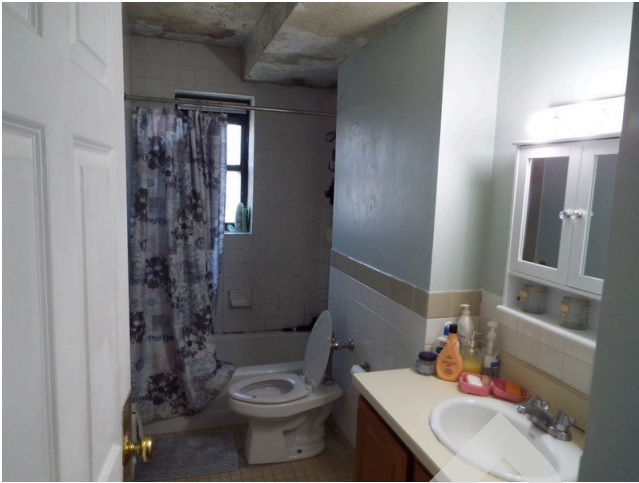
120. 3-bed-1.5-bath-TH - unit 22 - building 17 - bathroom ceiling condition (Critical Repair)

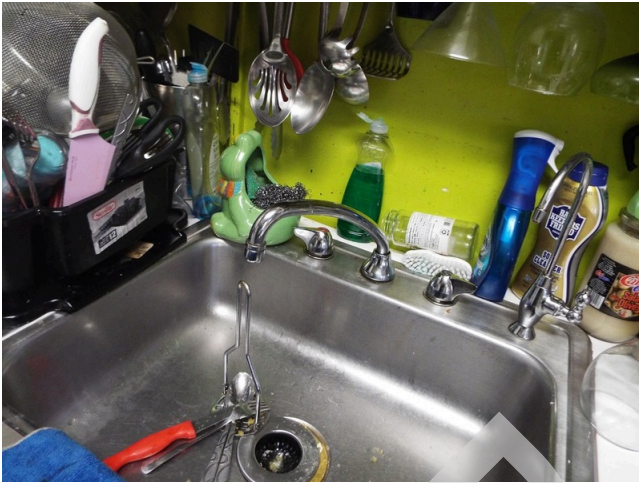
180. 4-bed-2-bath-UFAS - unit 53 - building 8, too
high (Critical Repair)

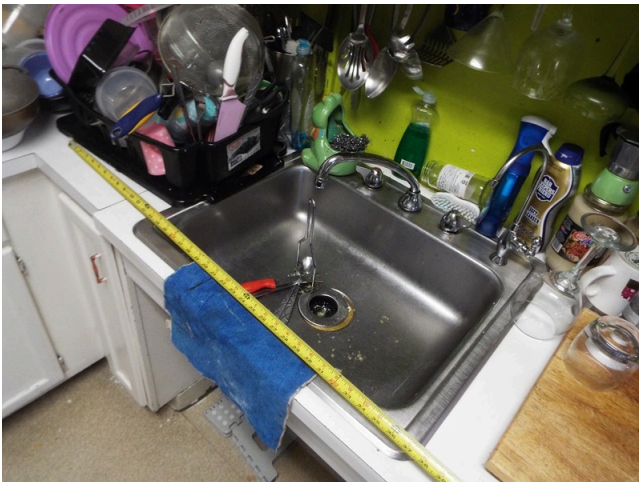
182. UFAS kitchen sink lacks pipe protection - unit 53 - building 8 (Critical Repair)

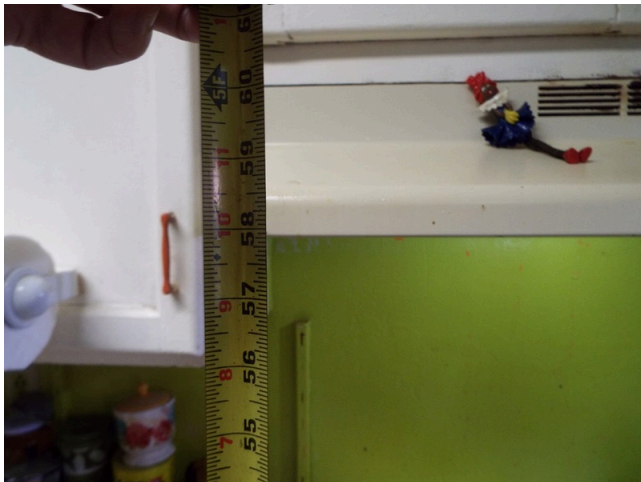
186. UFAS kitchen cabinet shelf exceeds 48 Inch height - unit 53 - building 8

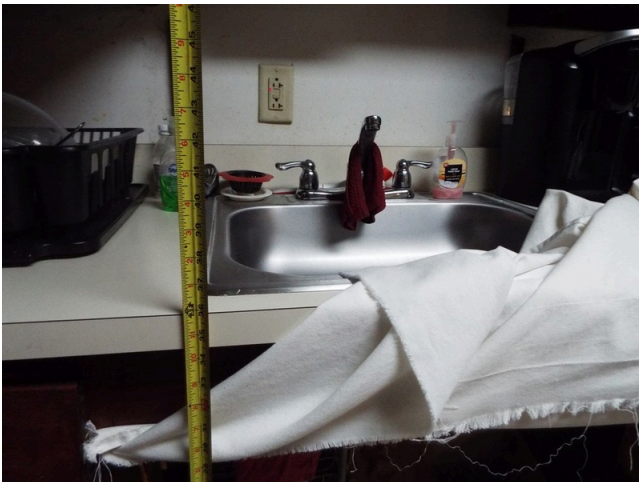
234. UFAS kitchen cabinets - 3-bed-1-bath-UFAS - unit 13 - building 4

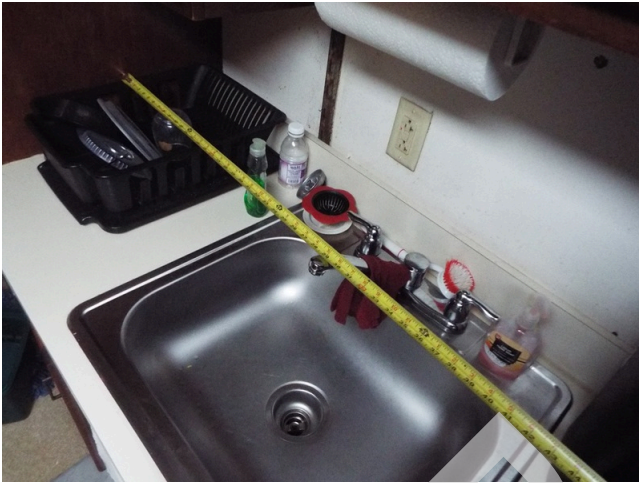
236. UFAS kitchen sink lacks pipe protection - unit 13 - building 4

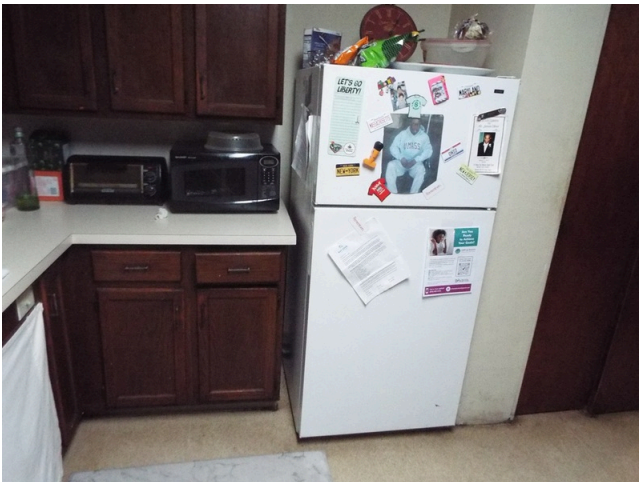
238. UFAS cooktop - unit 13 - building 4

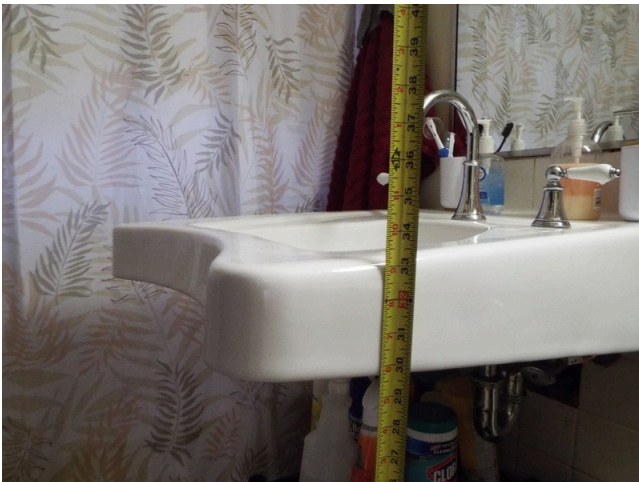
246. UFAS bathroom fixtures- unit 13 - building 4

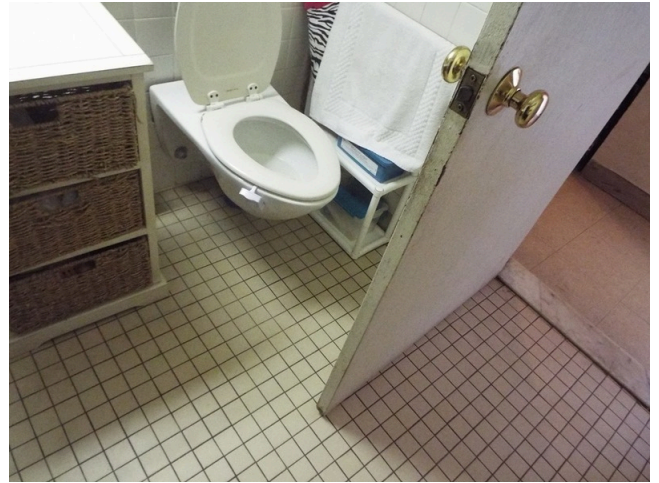
249. UFAS toilet lacks rear grab bar- unit 13 - building 4 (Critical Repair)

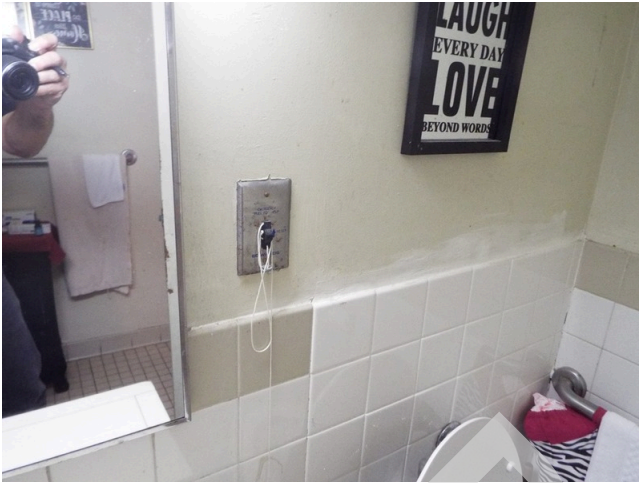
256. UFAS tub shower - unit 13 - building 4

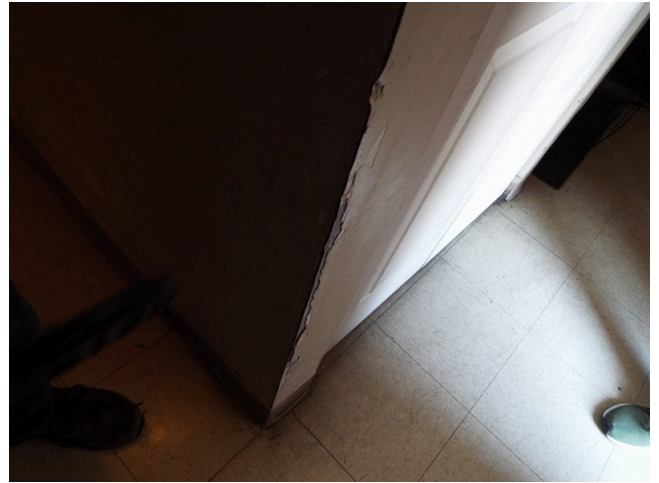
273. 3-bed-1-bath-UFAS - unit 13 - building 4 - wall condition (Non-Critical Repair)

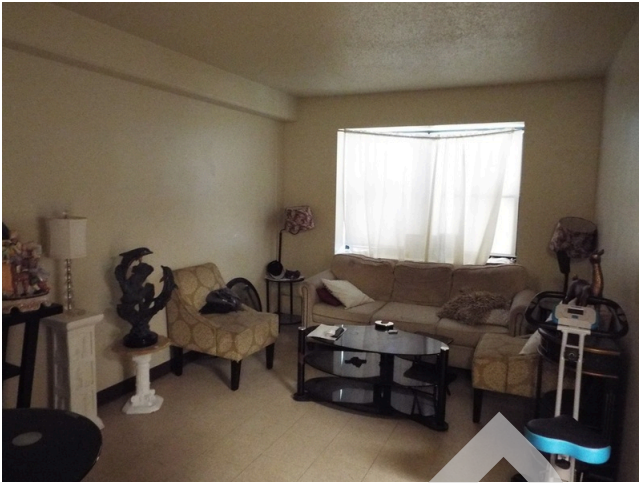
325. 5-bed-2-bath-TH - unit 190A - building 14 - living room

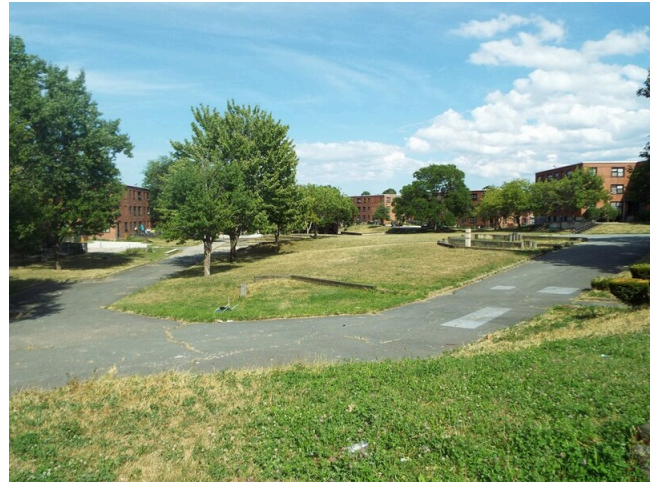
2. Topography

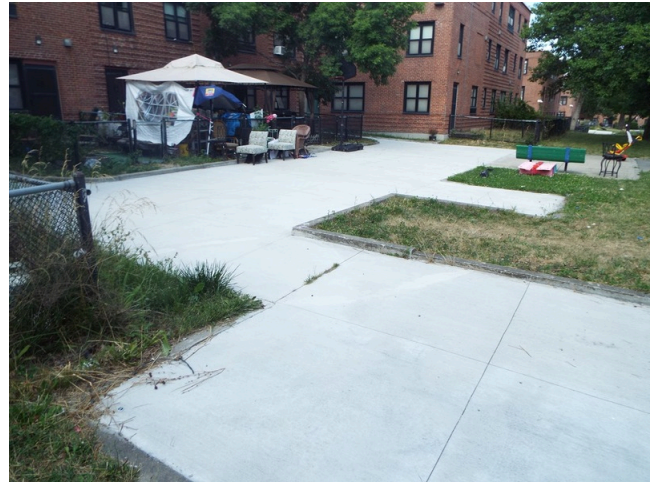
86. Terrace - building 17

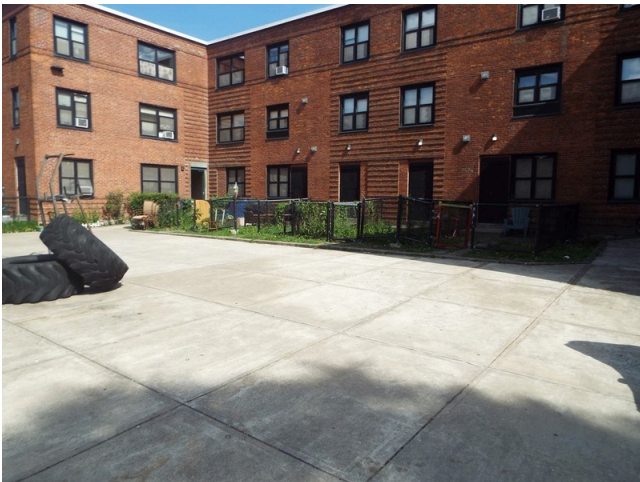
87. Terrace - building 19 rear

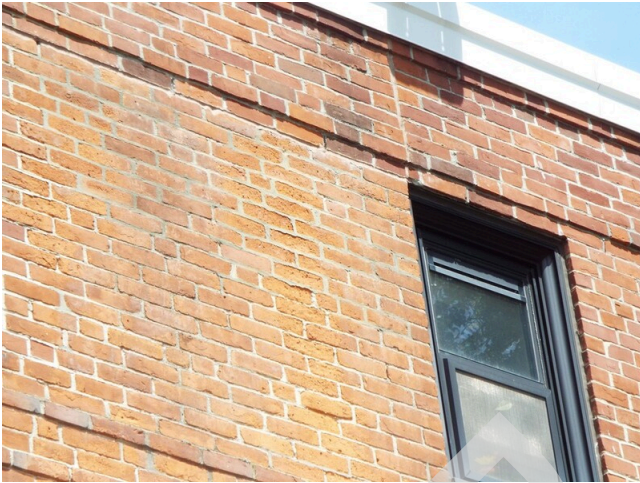
105. Brick masonry condition - building 2 (Non-Critical Repair)

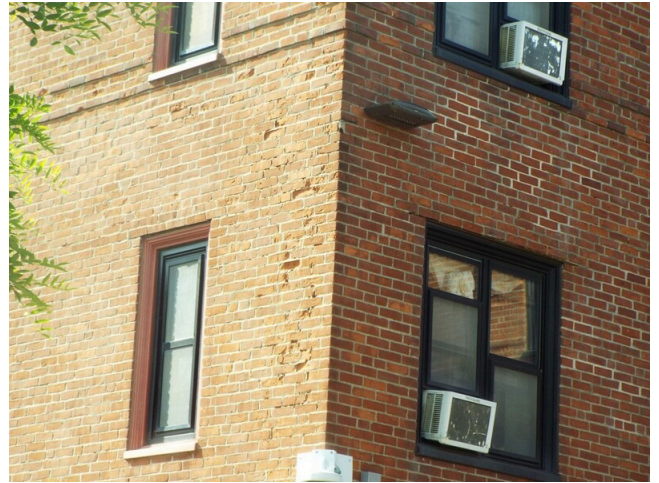
106. Brick masonry condition - building 3 (Non-Critical Repair)

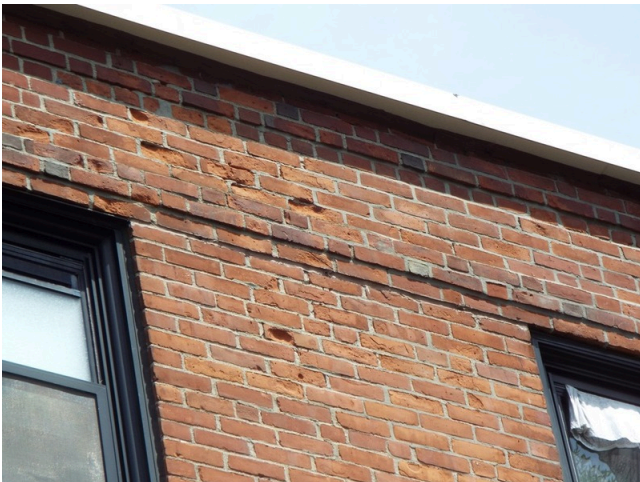
107. Brick masonry condition - building 4 (Non-Critical Repair)

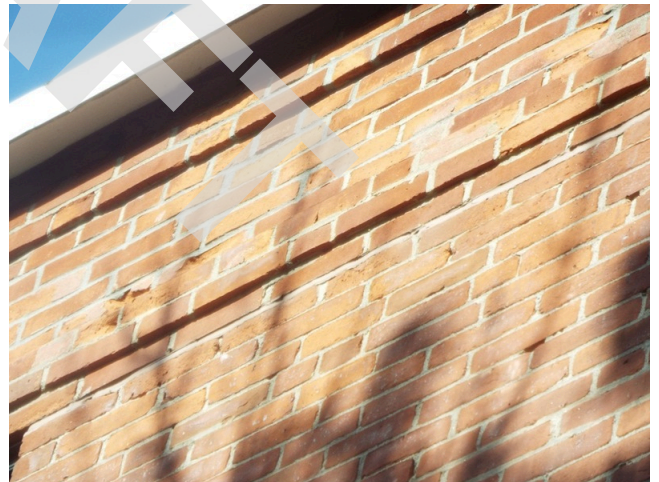
108. Brick masonry condition - building 6 (Non-Critical Repair)

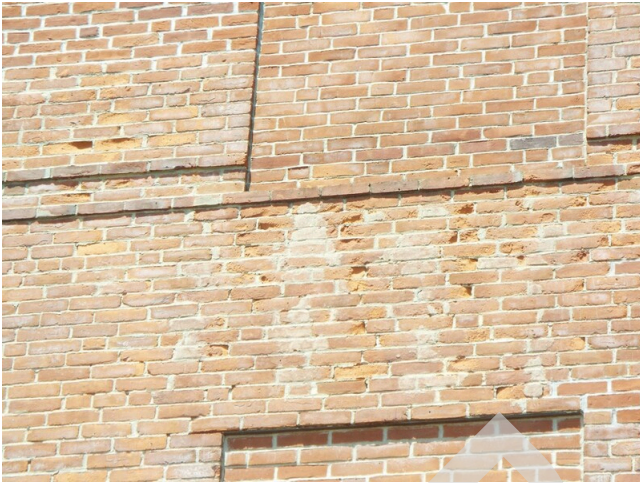
109. Brick masonry condition - building 7 (Non-Critical Repair)

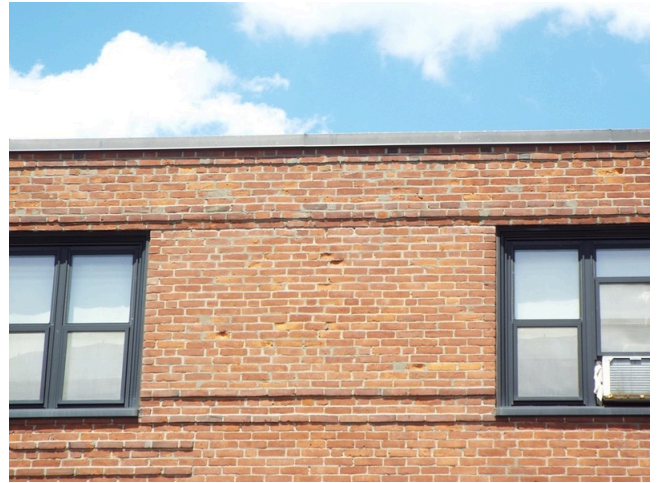
110. Brick masonry condition - building 8 (Non-Critical Repair)

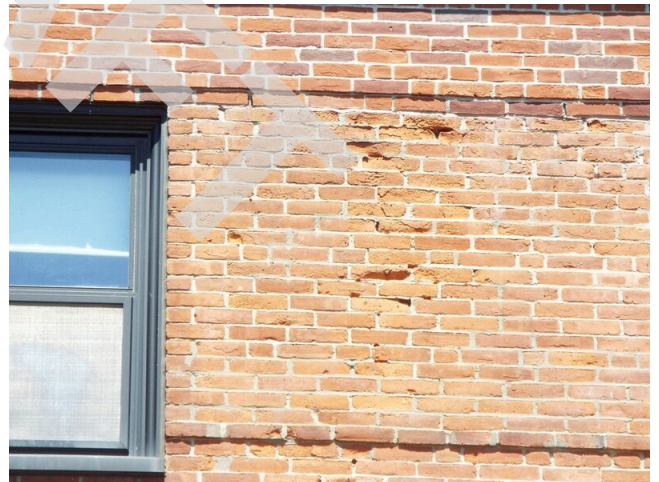
112. Brick masonry condition - building 10 (Non-Critical Repair)

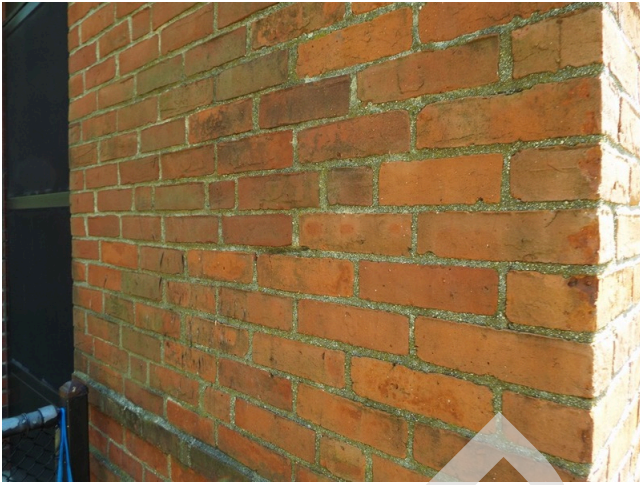
113. Brick masonry condition - building 11 (Non-Critical Repair)

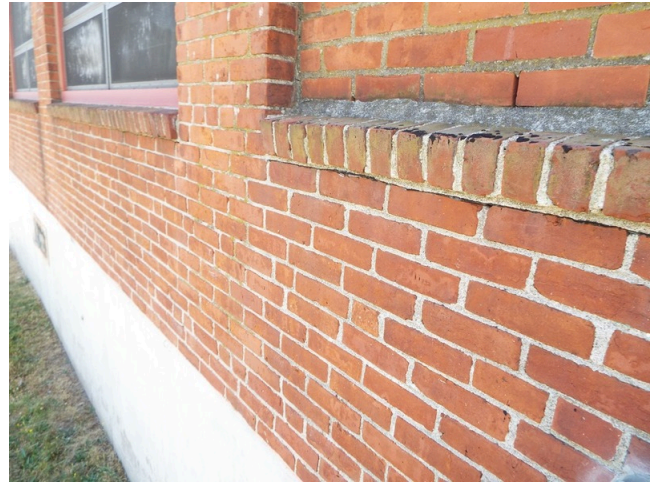
114. Brick masonry condition - building 12 (Non-Critical Repair)

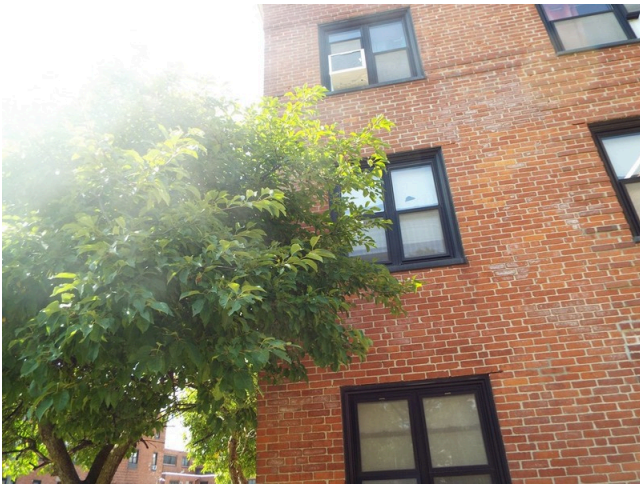
115. Brick masonry condition - building 13 (Non-Critical Repair)

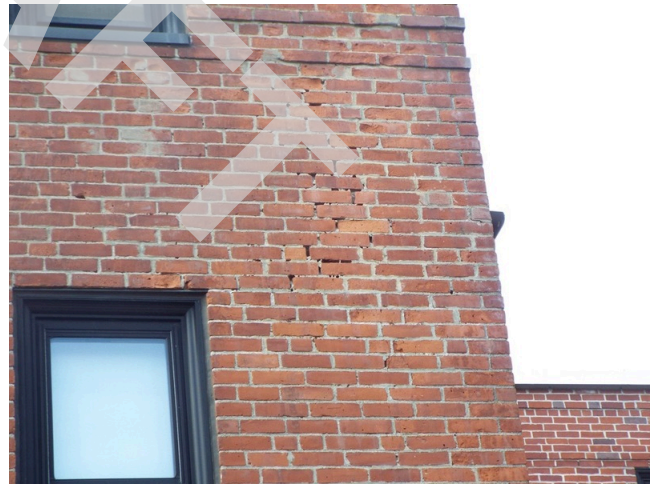
116. Brick masonry condition - building 14 (Non-Critical Repair)

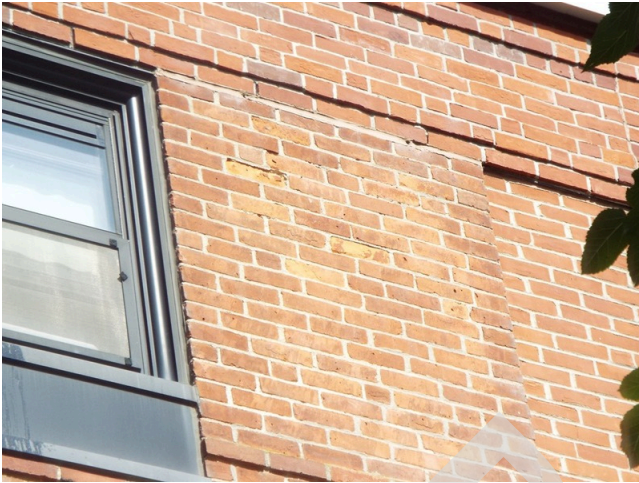
117. Brick masonry condition - building 16 (Non-Critical Repair)

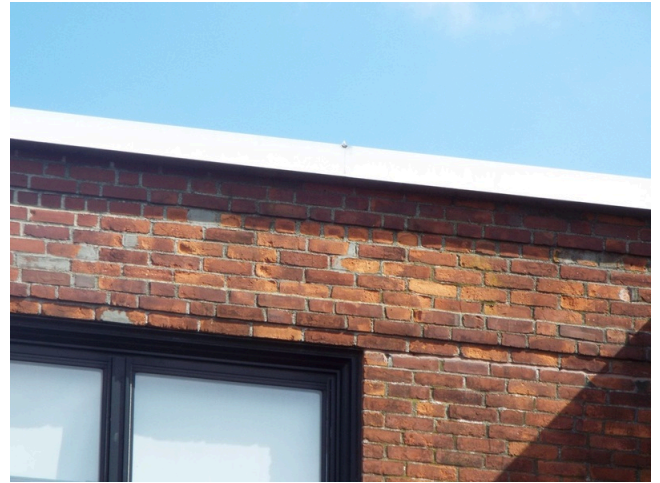
118. Brick masonry condition - building 17 (Non-Critical Repair)

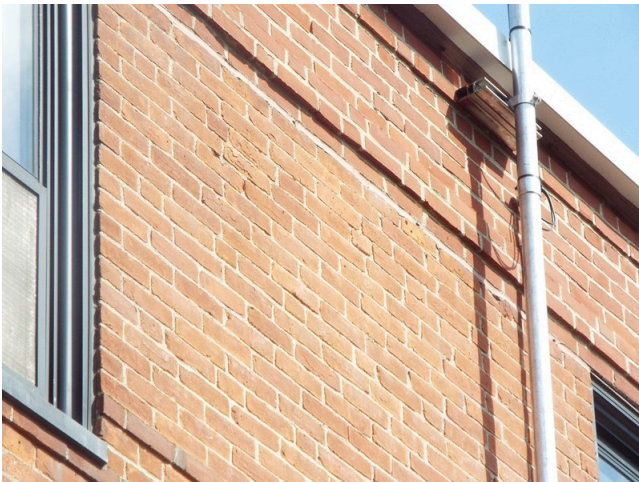
119. Brick masonry condition - building 18 (Non-Critical Repair)

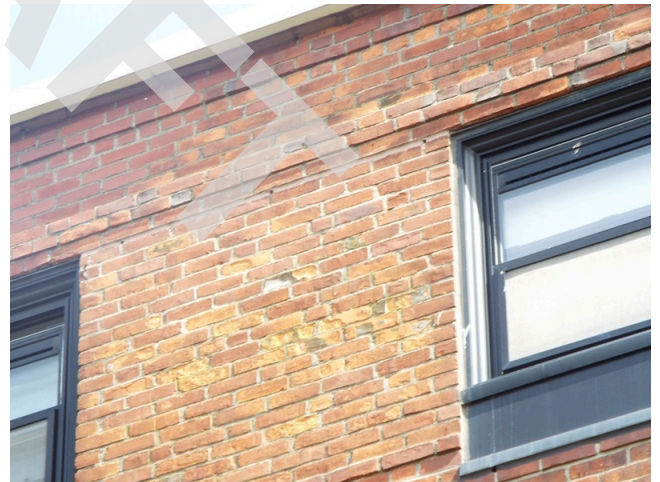
120. Brick masonry condition - building 19 (Non-Critical Repair)

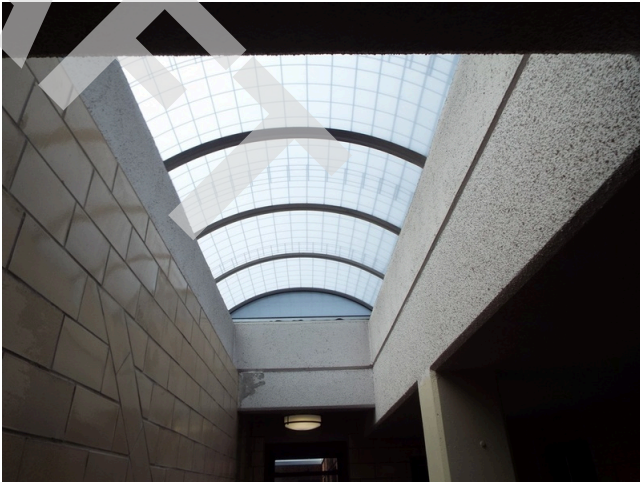
127. Roof penetrations- building 2

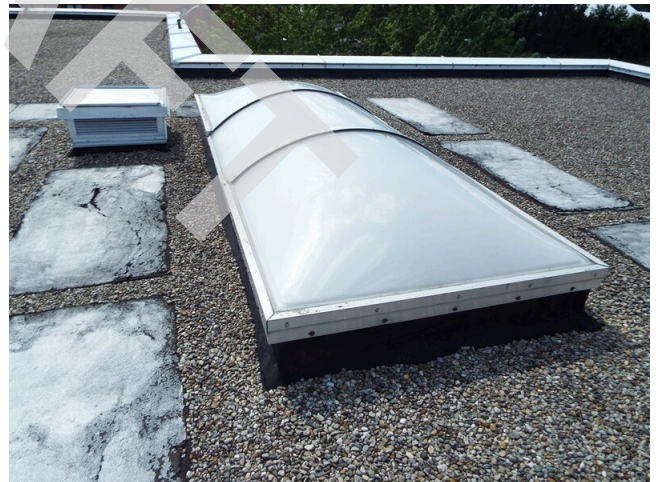
131. Roof penetrations - building 14

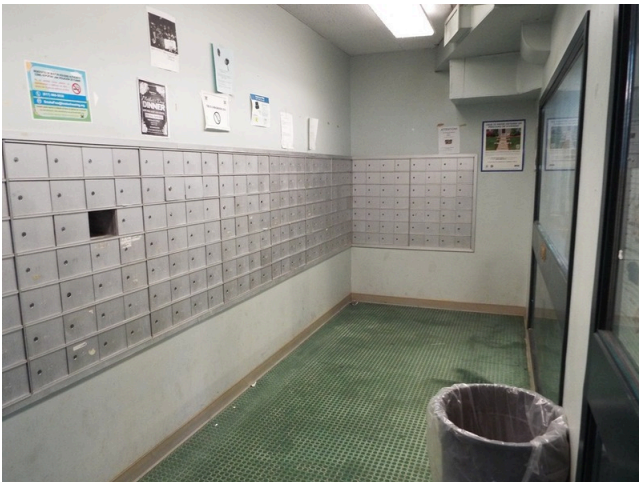
166. Common area - building 12 - office

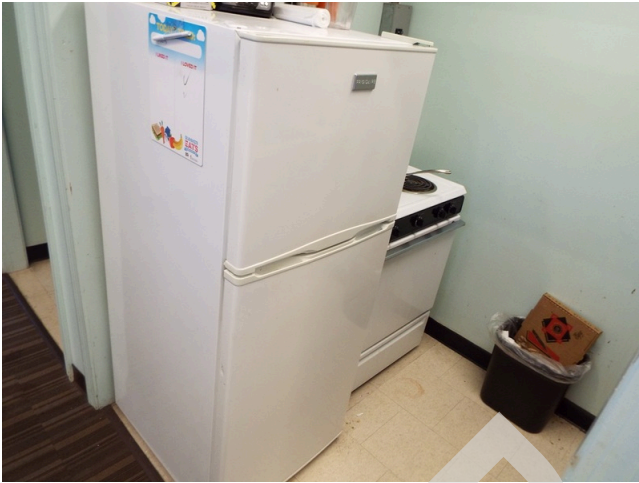
168. Common area - building 12 - employee kitchen

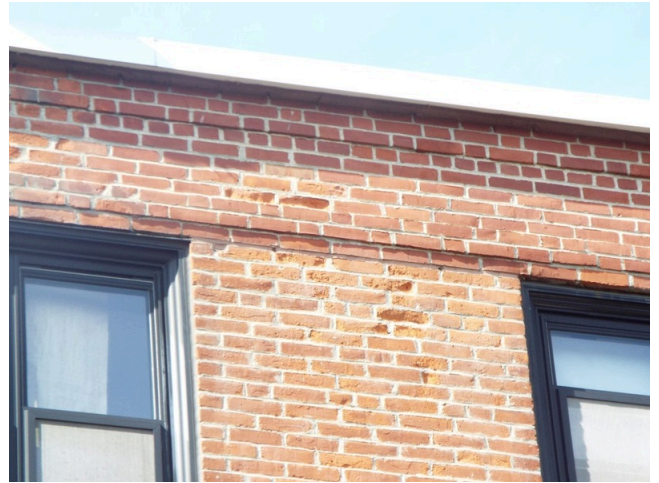
201. Brick masonry condition - building 17 (Non-Critical Repair)

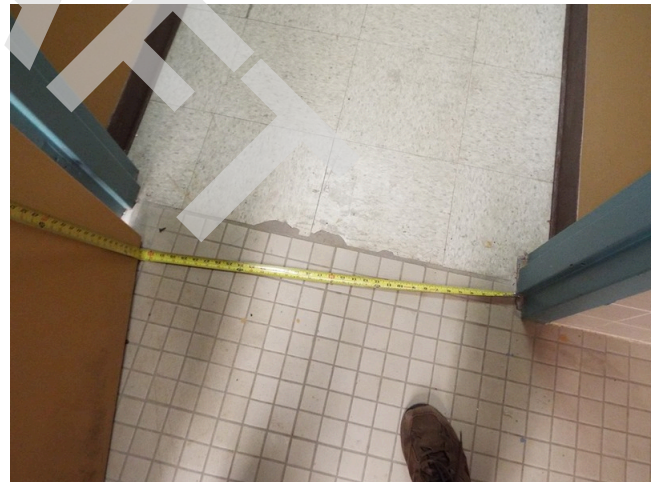
259. Common area - building 18 - teen center - men's restroom

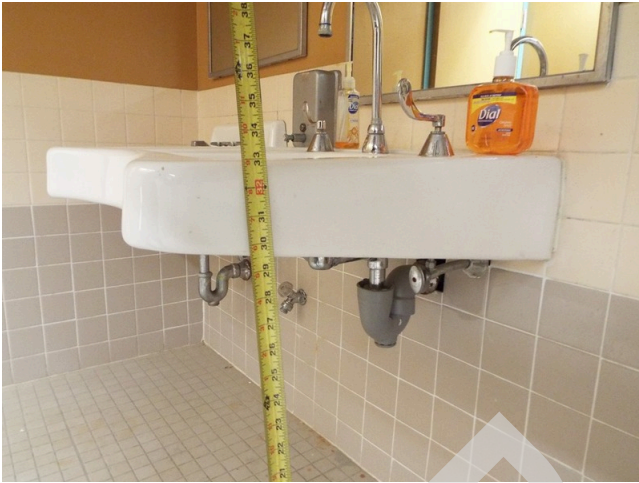
260. Common area - building 18 - teen center - men's restroom

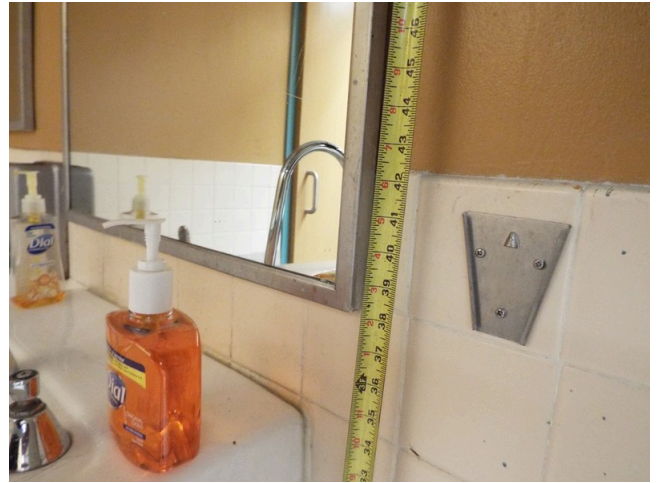
261. Common area - building 18 - teen center - men's restroom

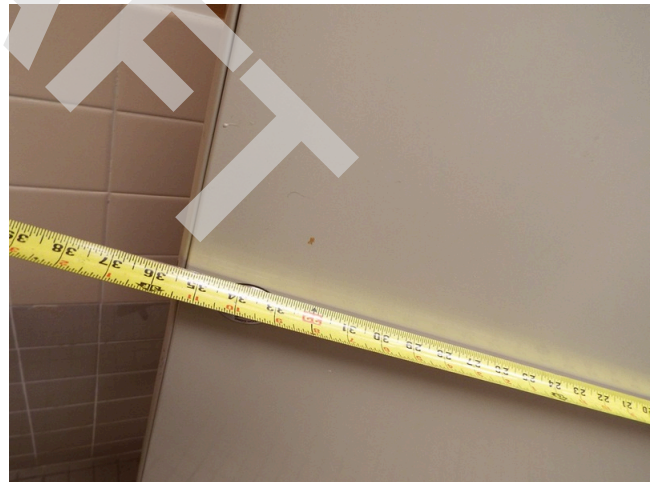
263. Common area - building 18 - teen center - men's restroom

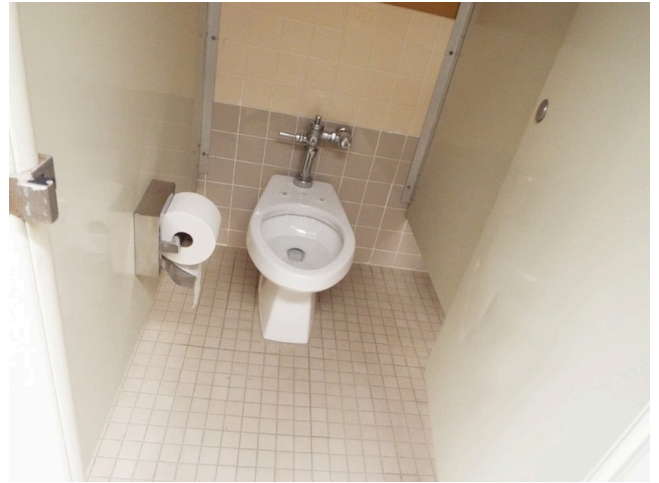
265. Common area - building 18 - teen center - men's restroom
