HUD CAPITAL NEEDS ASSESSMENT

Highland park
50 Highland Street
Boston, Massachusetts 02119

AEI Project No. 463344
Site Inspection Date: July 5, 2022

Boston Housing Authority
52 Chauncy Street
Boston, Massachusetts 02111

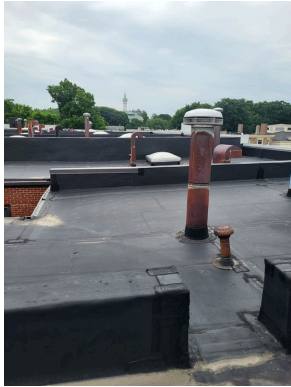
EPDM roofing

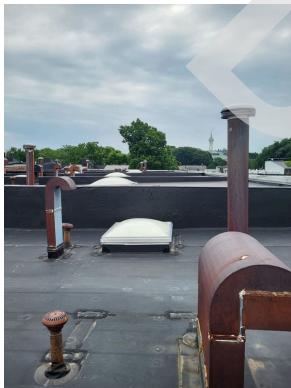
Roof skylight

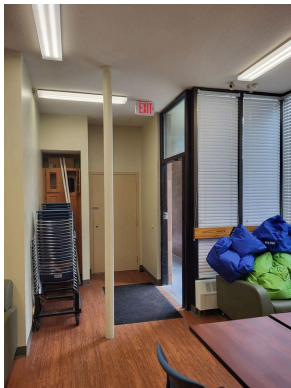
Community room and kitchen area emergency exit sign and emergency lighting

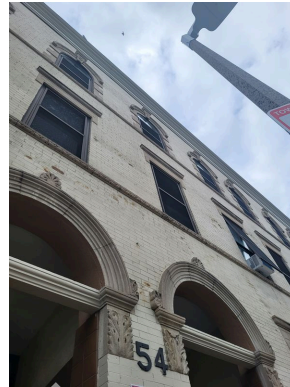
West elevation painted brick

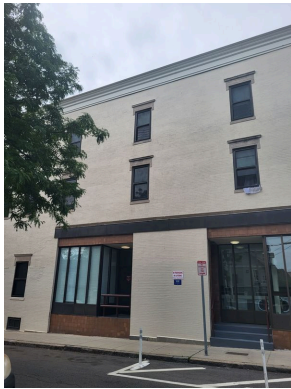
West elevation windows

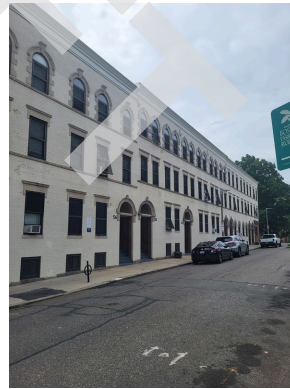
West elevation windows

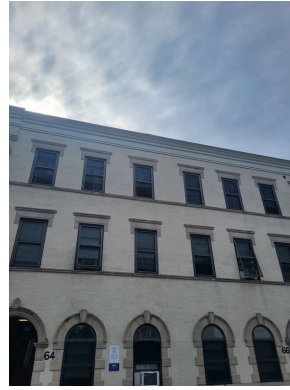
West elevation fascia

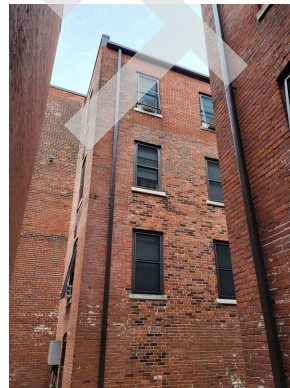
Roof gutters

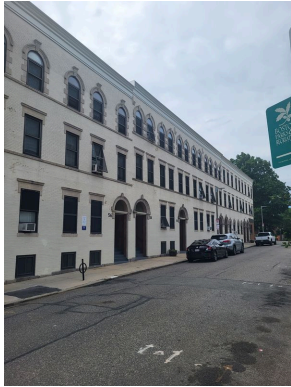
Window-mounted air conditioning, window screens and basement windows

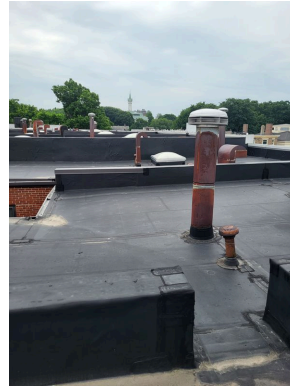
EPDM roofing

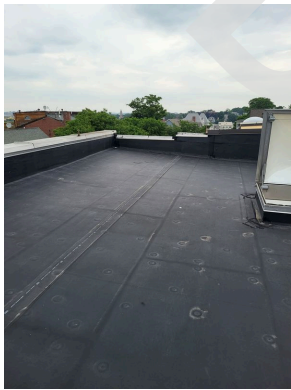
Roof skylight

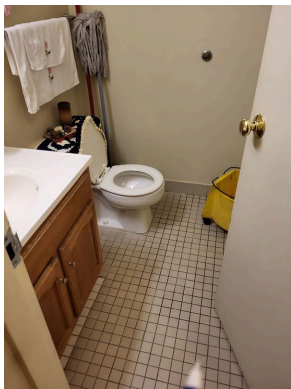
Apartment 52-3 bathroom toilet, vanity, sink and ceramic tile flooring

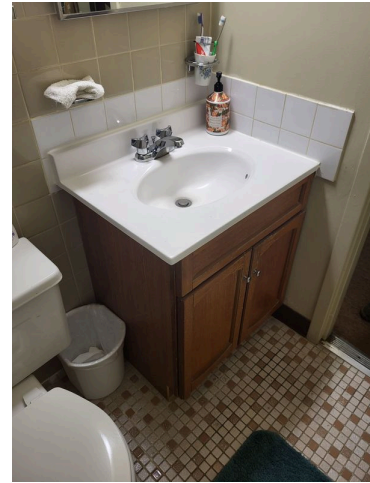
17. Apartment 54-2 bathroom sink

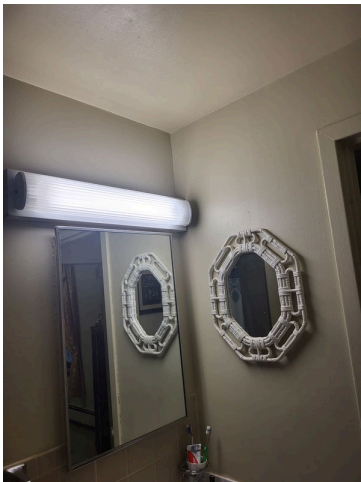
18. Apartment 54-2 bathroom vanity

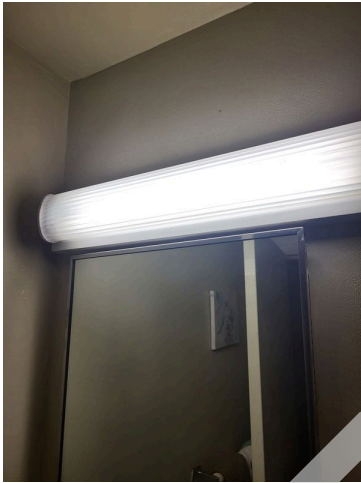
40. Apartment 56-3 bathroom GFCI

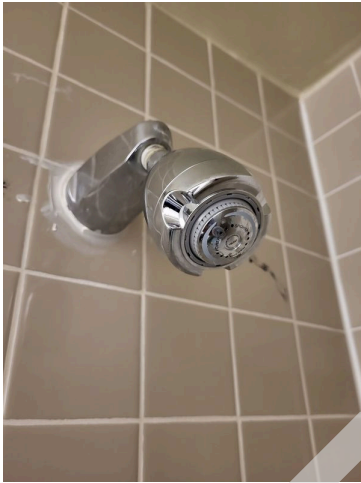
44. Apartment 56-3 bathroom bathtub hardware

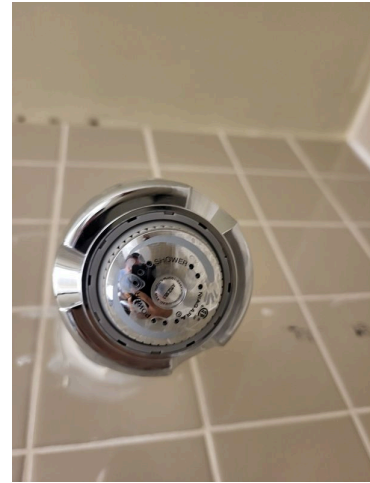
45. Apartment 56-3 bathroom bathtub shower head

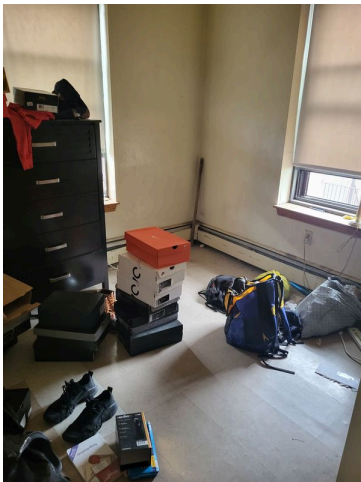
50. Apartment 56-3 bedroom

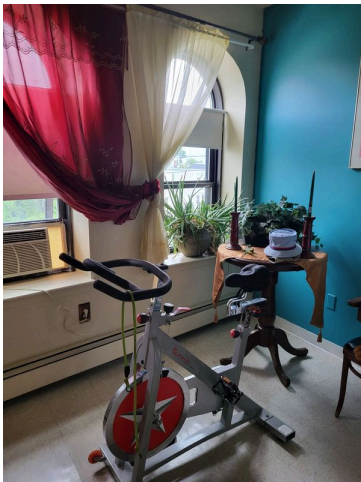
58. Apartment 58-3 window mounted air conditioner unit

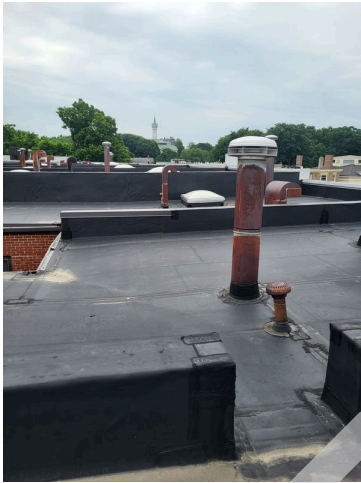
5. EPDM roofing

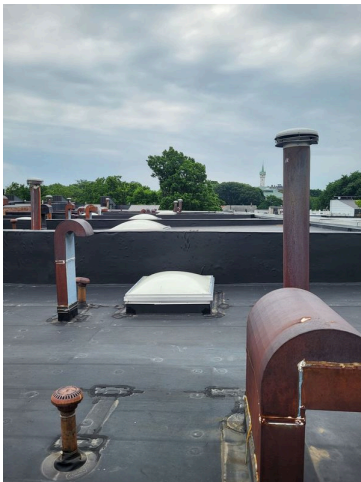
7. Roof skylight

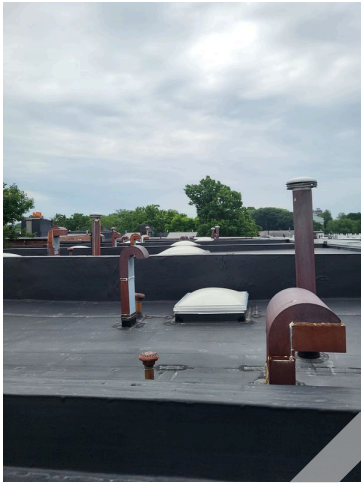
9. Roof skylights

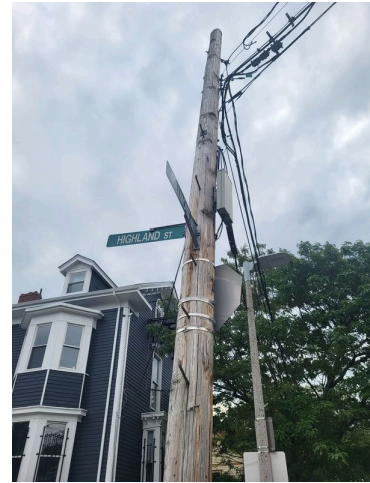
10. North elevation

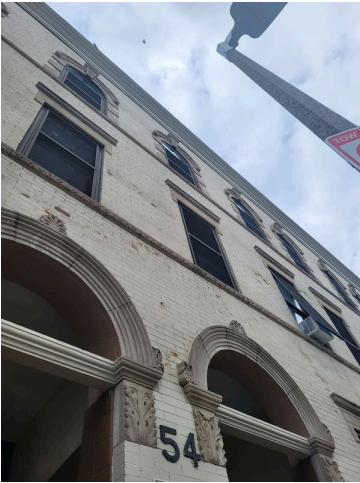
18. West elevation painted brick

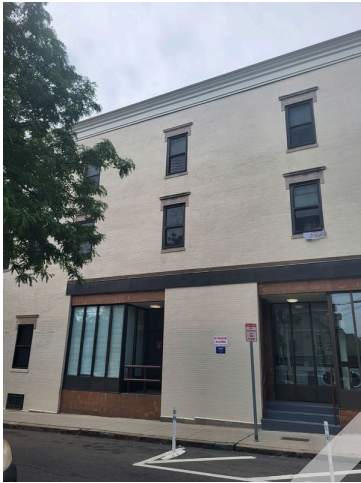
33. West elevation windows

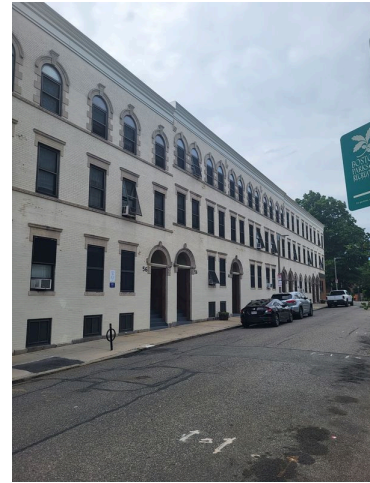
34. West elevation windows

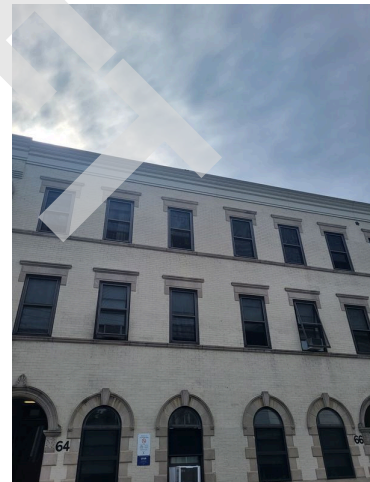
36. West elevation fascia

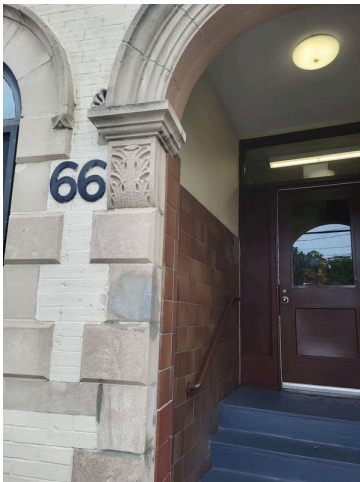
43. Building 66 signage

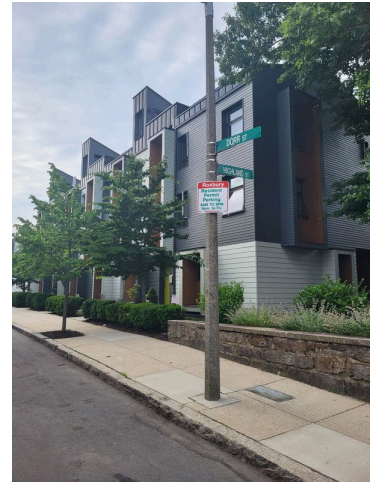
46. South elevation

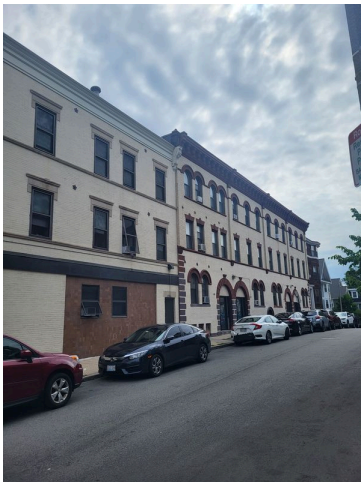
47. South elevation façade

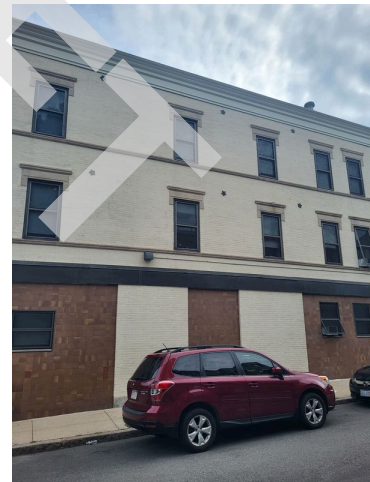
48. South elevation façade

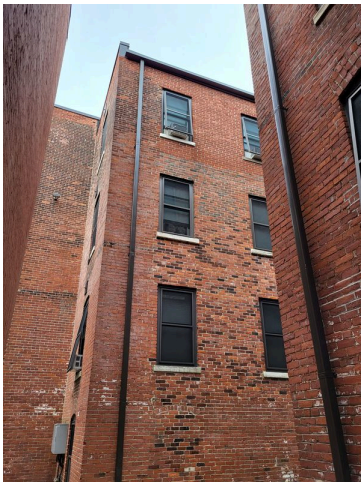
59. Roof gutters

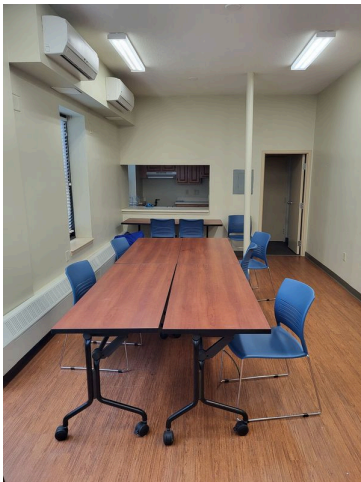
75. Community room and kitchen area

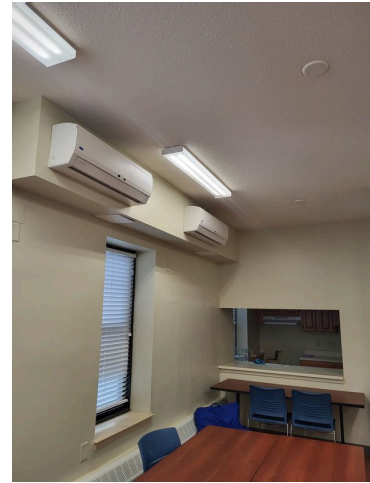
78. Community room and kitchen area

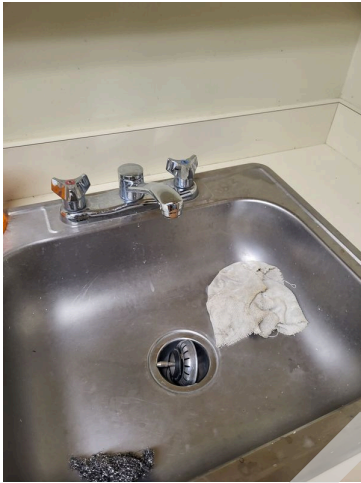
84. Community room kitchen area flooring, cabinets, countertops, range hood and hydronic baseboard
