HUD CAPITAL NEEDS ASSESSMENT

Bellflower
24 Bellflower Street
Dorchester, Massachusetts 02125

AEI Project No. 463347
Site Inspection Date: July 8, 2022

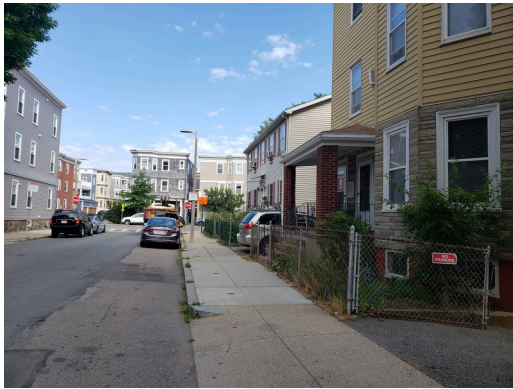
Adjacent Buildings

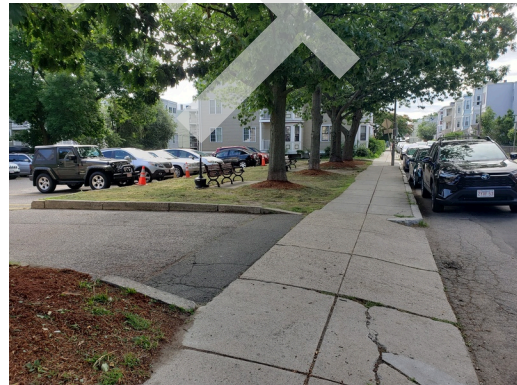
Parking Lot Secondary Entry

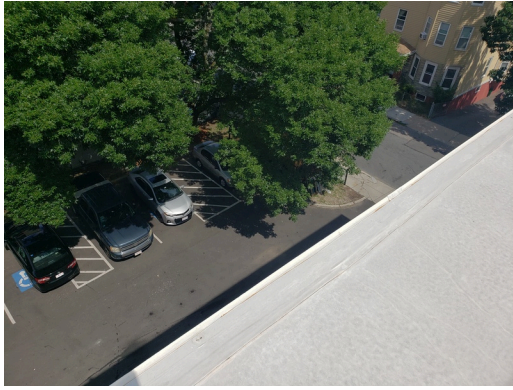
ADA Parking Lot- Entry

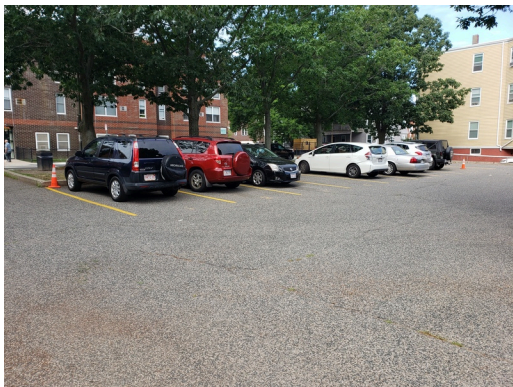
Parking Lot

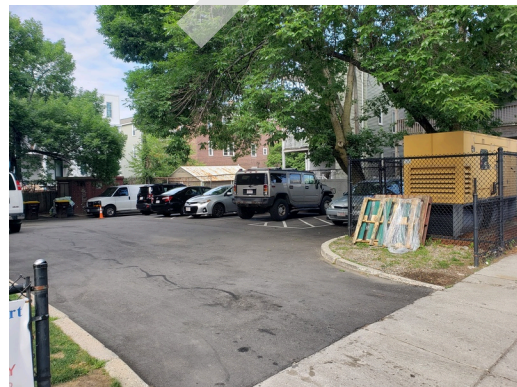
ADA Parking Lot

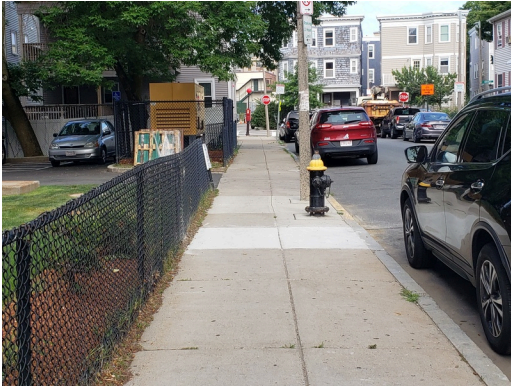
Public Sidewalk

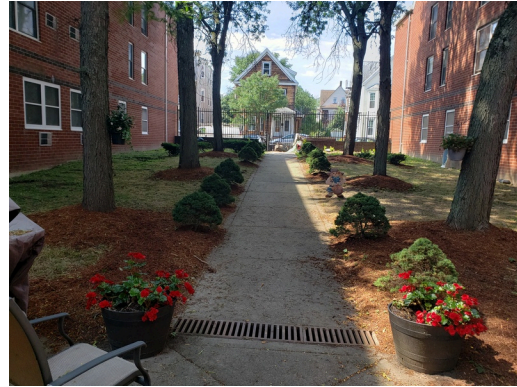
Landscaping

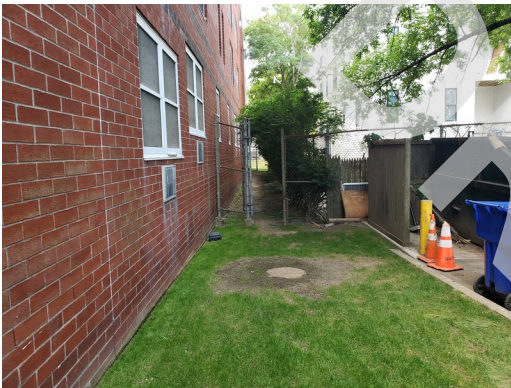
Landscaping

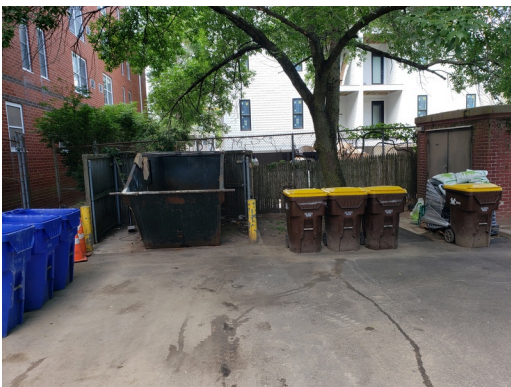
Dumpster

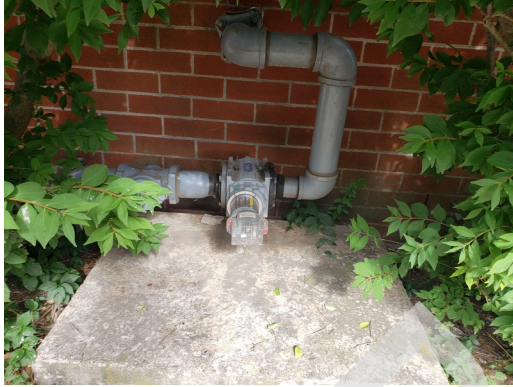
Water Meter

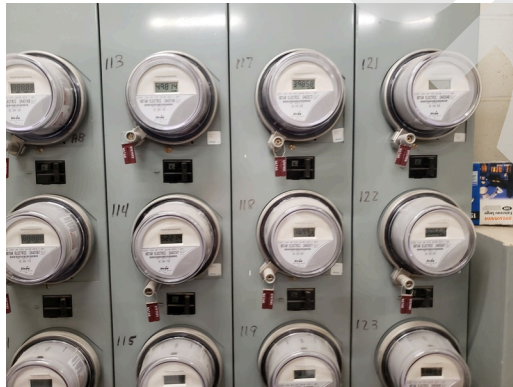
Electrical Meter

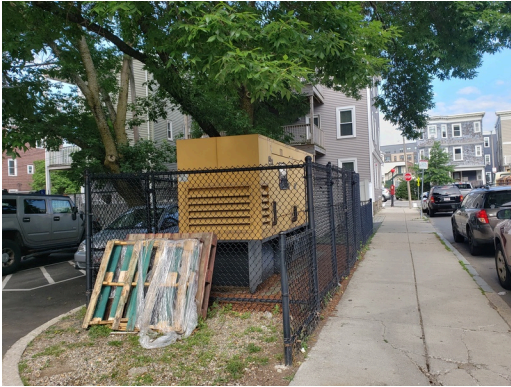
Generator

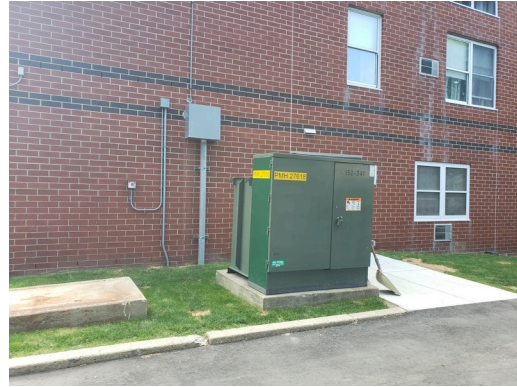
Transformer

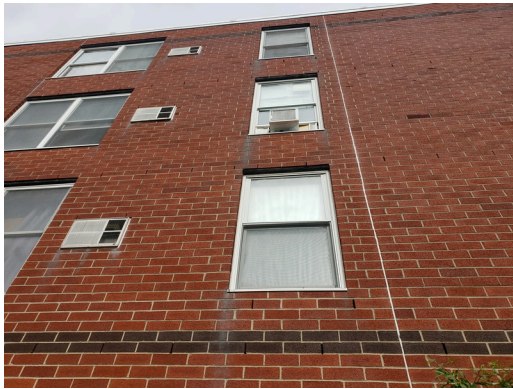
Window

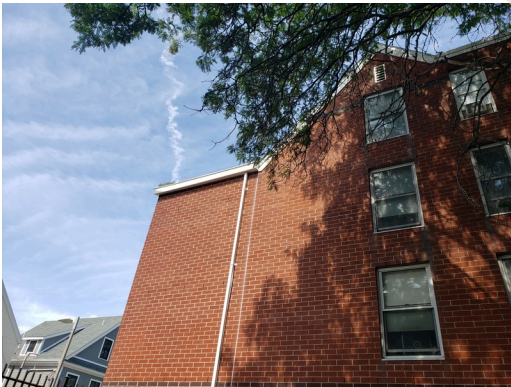
Roof flashing appeared to be in overall good condition.

Guttering

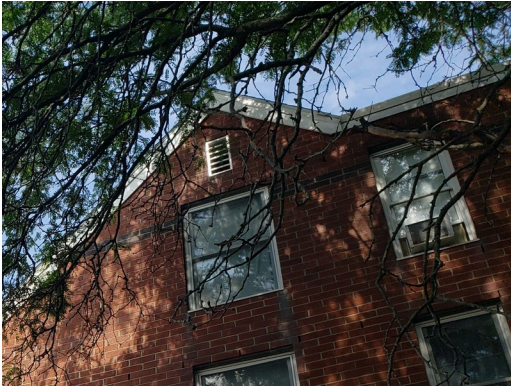
The attics are ventilated by gable-end wall vents. The vents are constructed with wood material with a painted finish.

Gable Vent

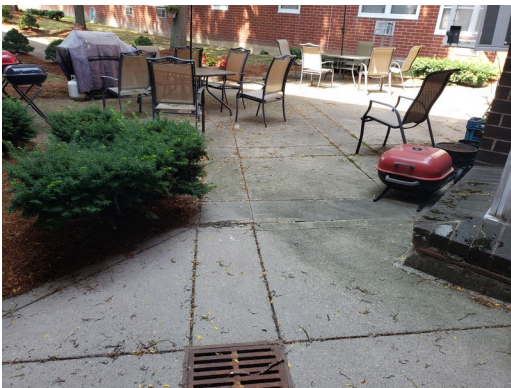
Common Area- Courtyard

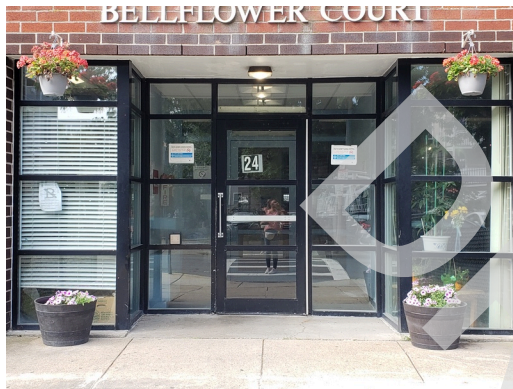
Entry

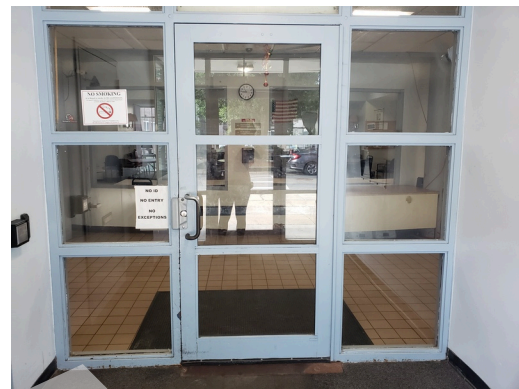
Front Door

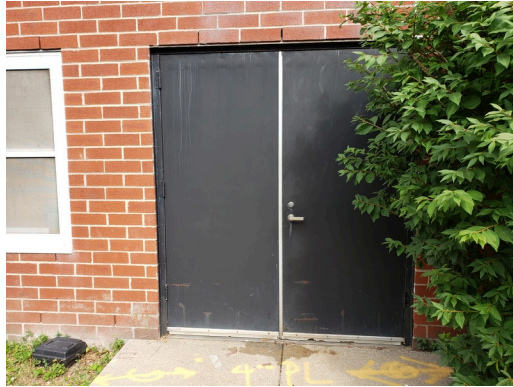
Service Door

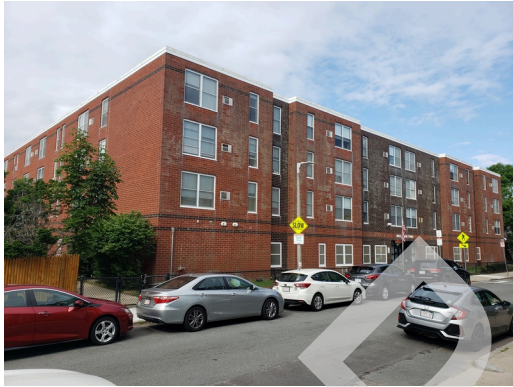
Building Exterior

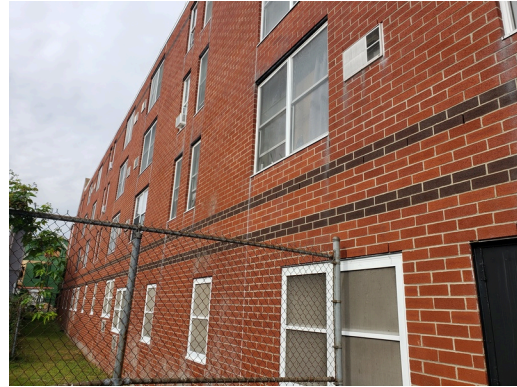
Eastern Building Exterior

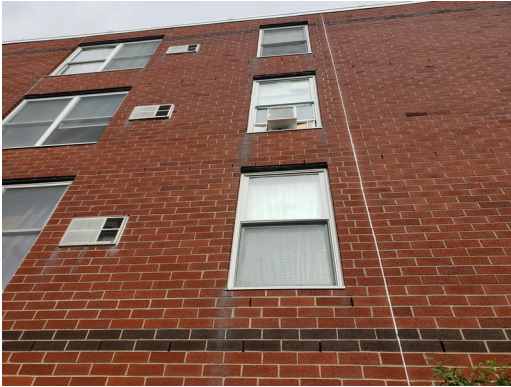
Window

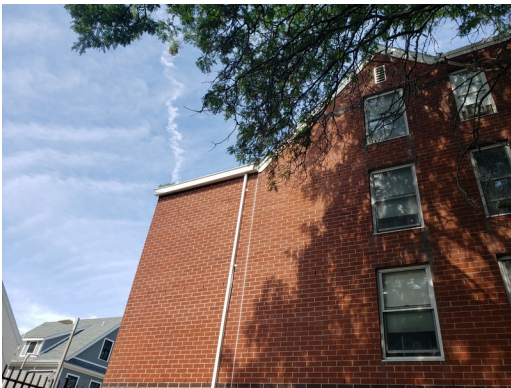
Guttering

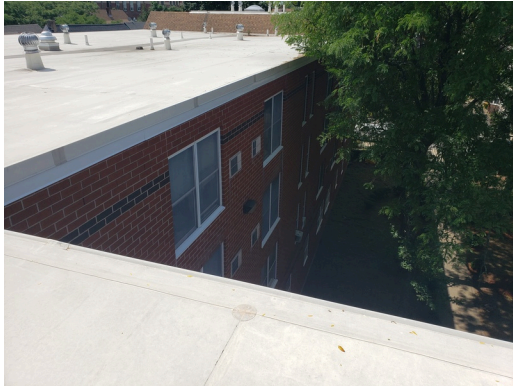
Roofing Coping

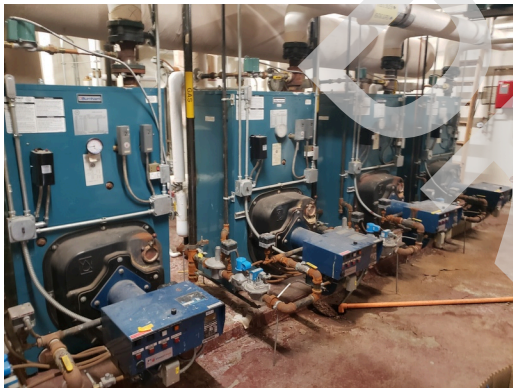
HVAC- Boiler

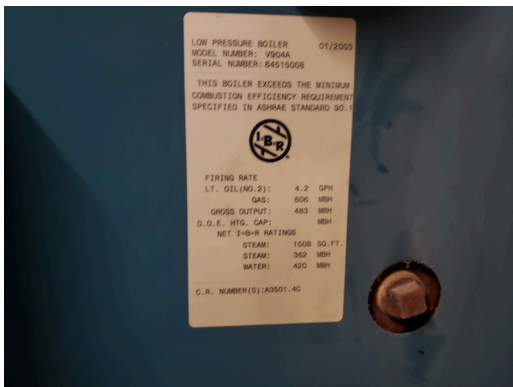
HVAC- Boiler

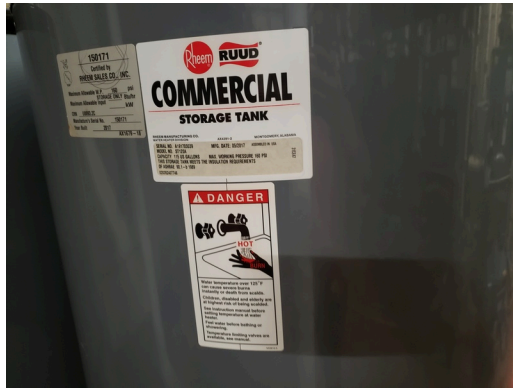
Water Storage Tank 115-Gallon

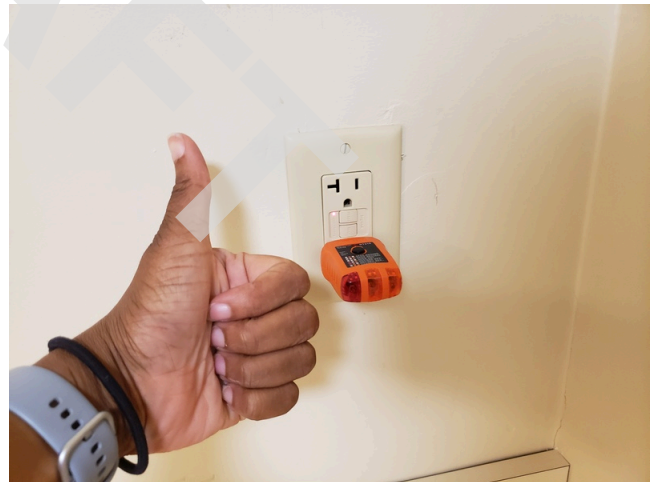
4. GFCI Outlet

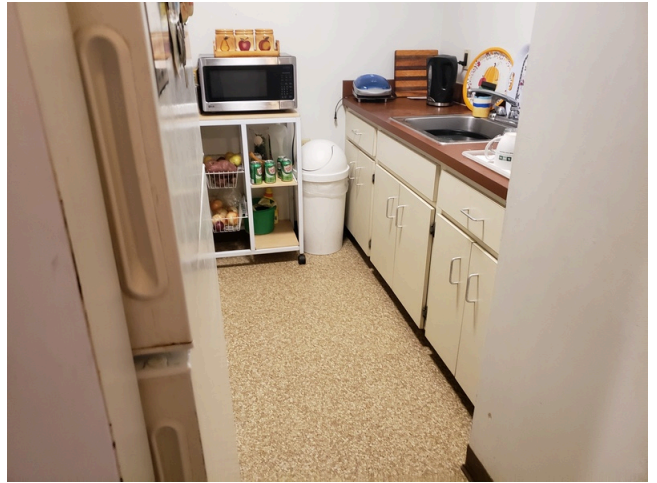
6. Unit 409- 1bed/1bath- Kitchen

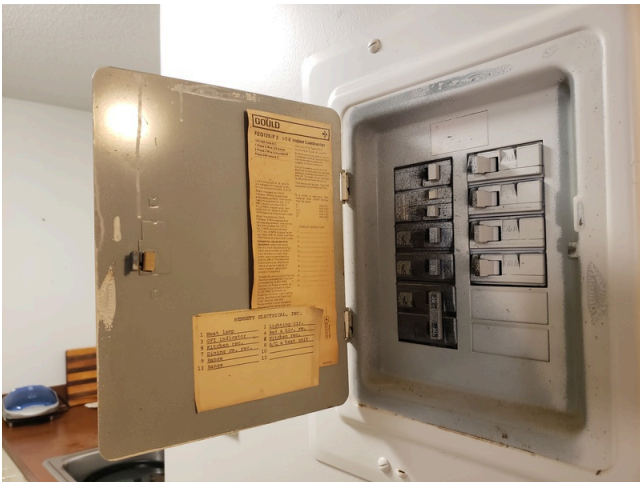
7. Electrical Panel

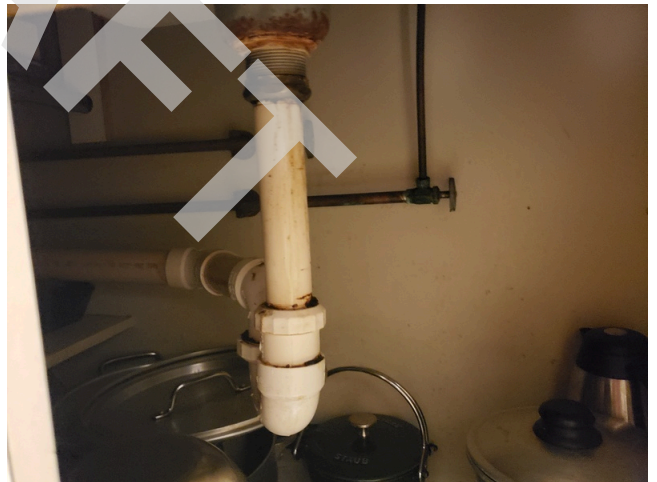
8. Plumbing

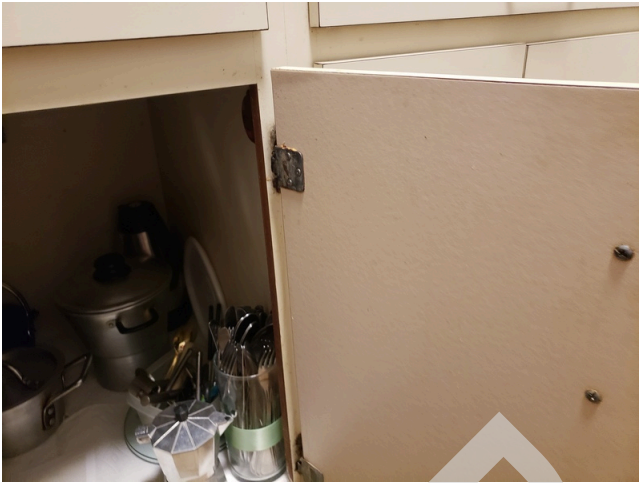
9. Typical Cabinet

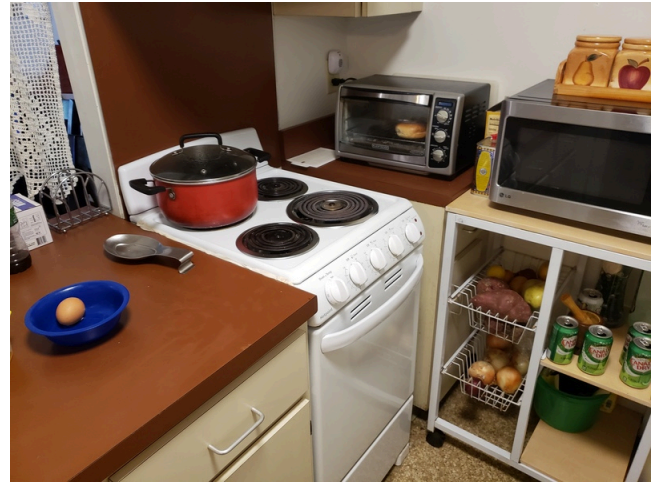
10. Typical Range

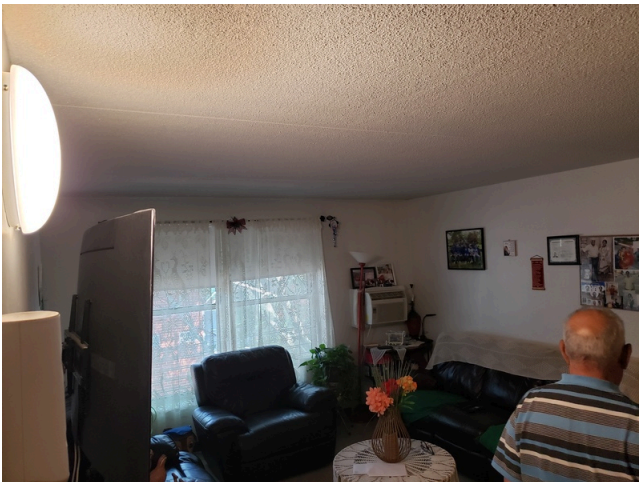
11. Unit 409- 1bed/1bath- Living Room

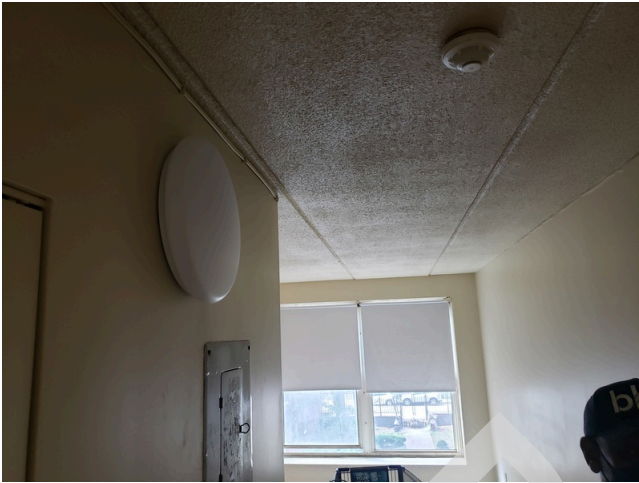
18. Unit 315- UFAS- 1bed/1bath- Kitchen

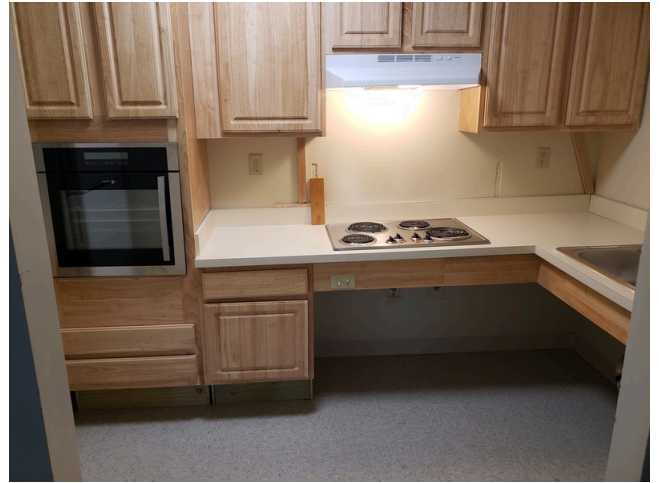
19. Unit 315- UFAS- 1bed/1bath- Kitchen- Clear Floor Space at Cooktop

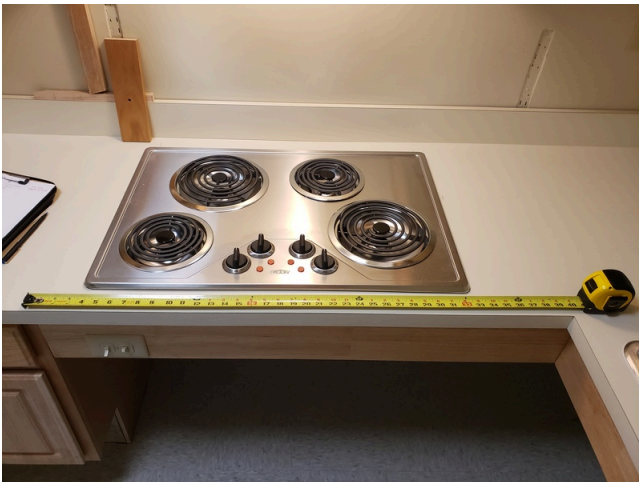
20. Unit 315- UFAS- 1bed/1bath- Kitchen- Cooktop Height

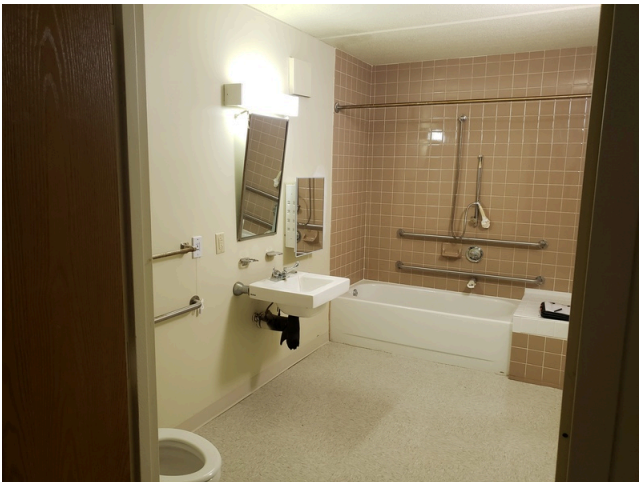
28. Unit 315- UFAS- 1bed/1bath- Bathroom- Door
Width

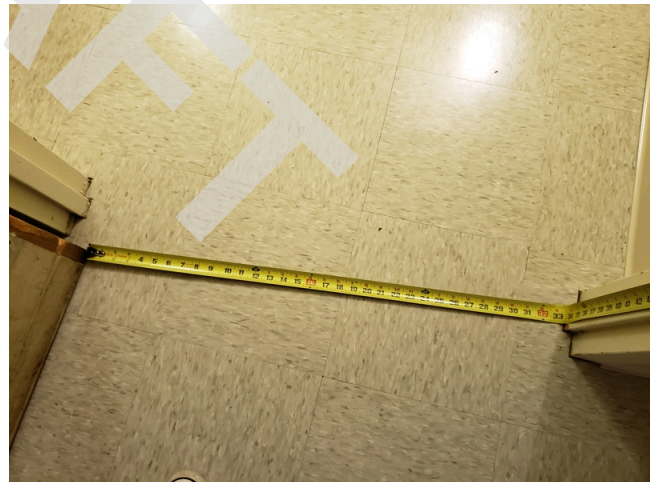
29. Unit 315- UFAS- 1bed/1bath- Bathroom- Clear Floor Space at WC

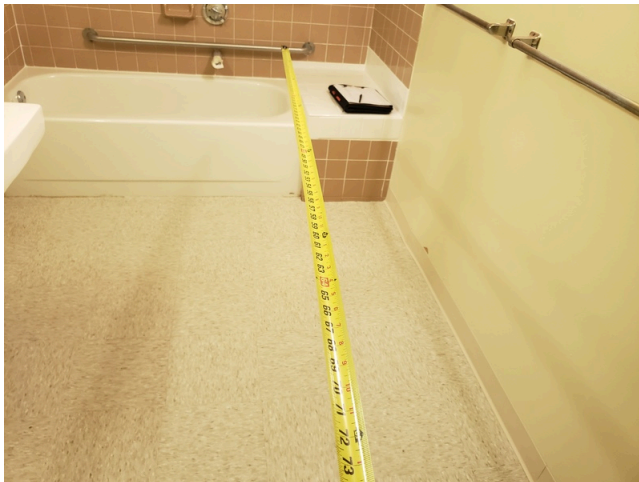
32. Unit 315- UFAS- 1bed/1bath- Bathroom- Clear Floor Space

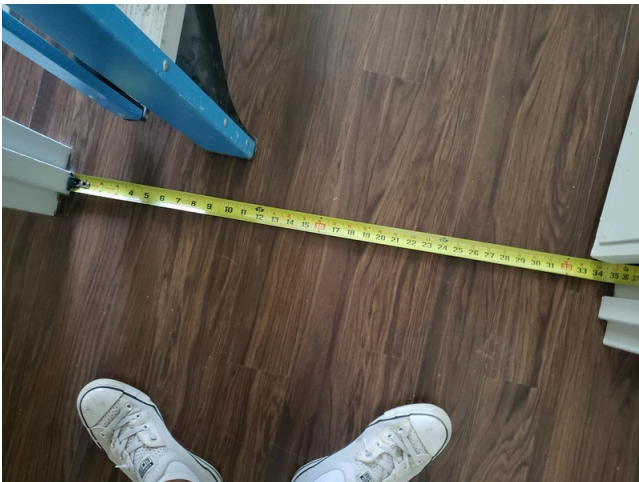
47. Unit 101-UFAS HDCP- 2bed/1bath- Bedroom-
Door Width

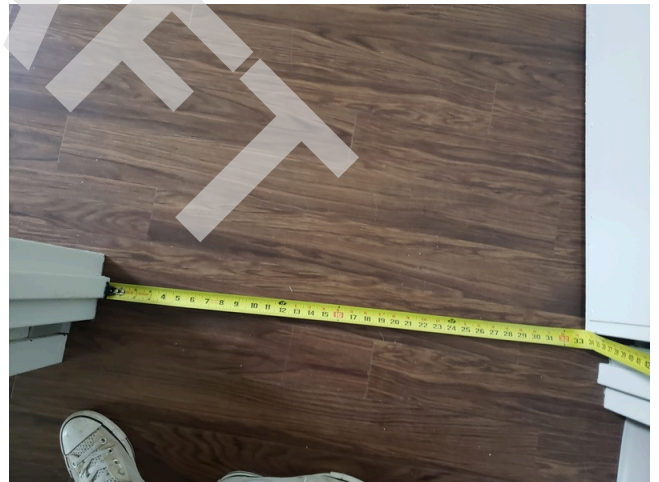
48. Unit 101-UFAS HDCP- 2bed/1bath- Bedroom-
Door Width

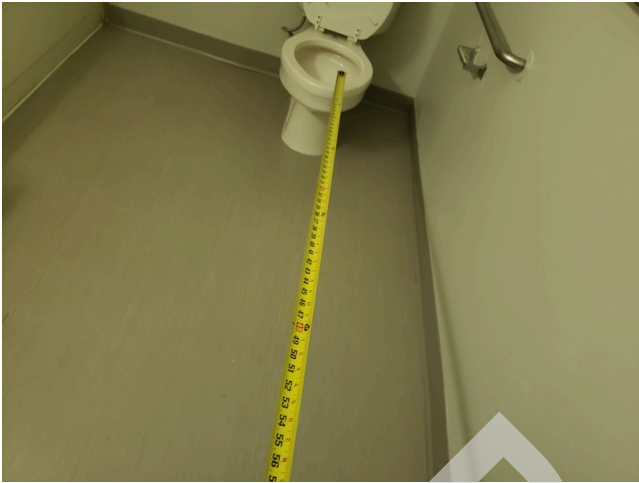
53. Unit 101-UFAS HDCP- 2bed/1bath- Bathroom-
Clear Floor Space at WC

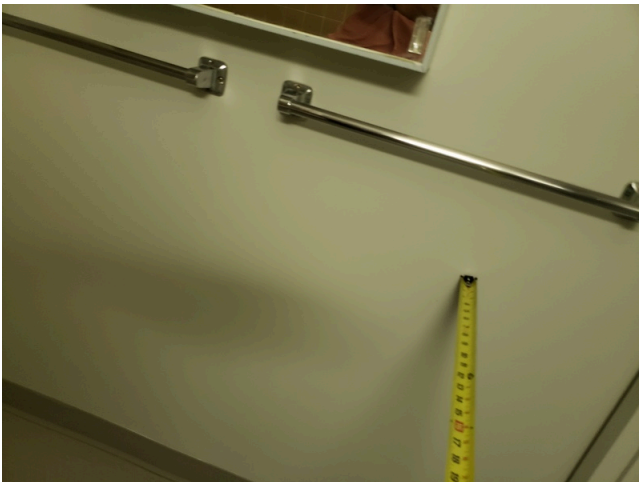
55. Unit 101-UFAS HDCP- 2bed/1bath- Bathroom-
Clear Floor Space at WC

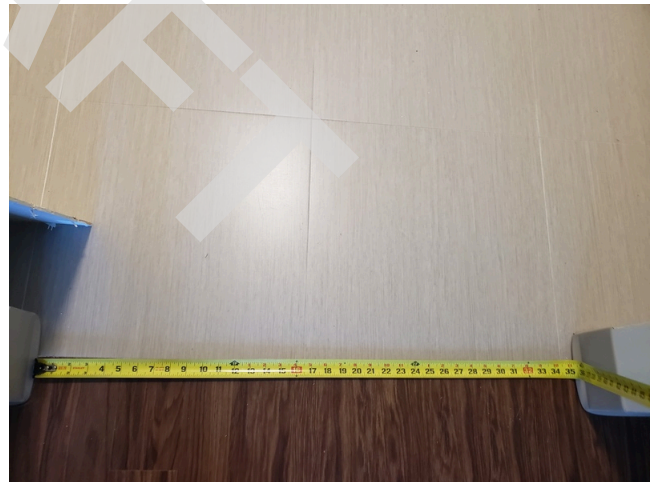
56. Unit 101-UFAS HDCP- 2bed/1bath- Kitchen-
Entry Opening

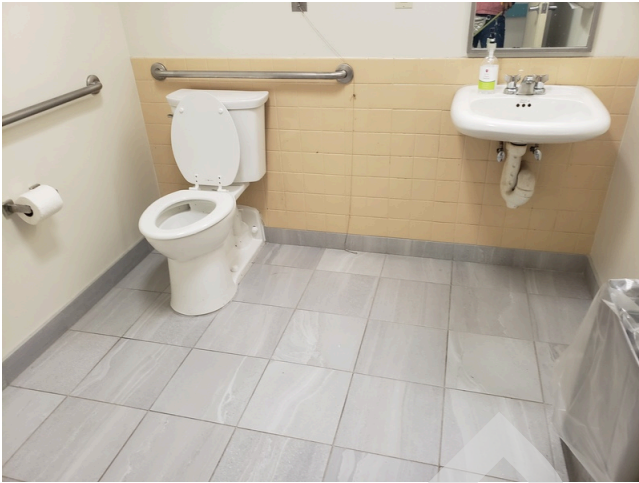
40. Common Area- Public Women's Restroom- Clear Floor Space at Door

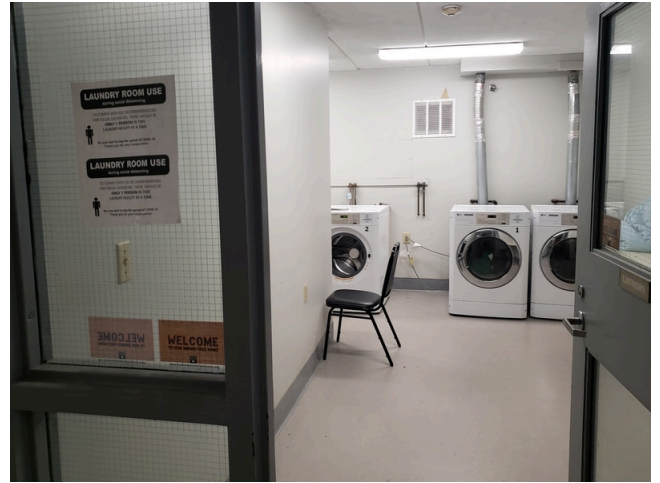
49. Leased Washer/ Dryer

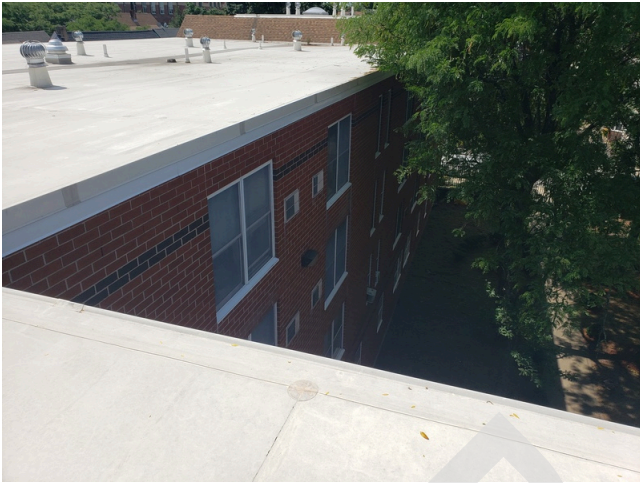
88. TPO Roofing (Low-Rise) and Asphalt Shingle Roofing
