## HUD CAPITAL NEEDS ASSESSMENT

Washington Street  
91 Washington Street  
Brighton, Massachusetts 02135

AEI Project No. 463351  
Site Inspection Date: July 20, 2022

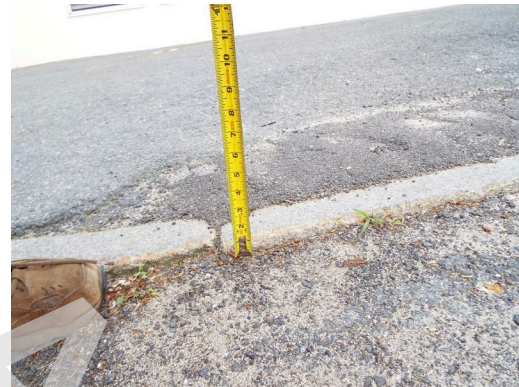
Differential settlement of asphalt pavement and a raised curb was observed at the accessible parking access aisle located at the rear of the building. The conditions represent a trip hazard. Repair is required. (Critical Repair)

Trip hazard - accessible parking access aisle  
(Critical Repair)

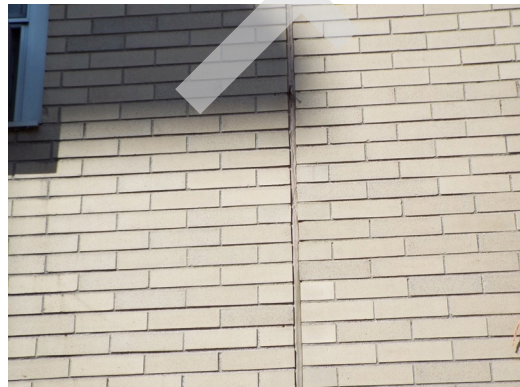
Sealant condition

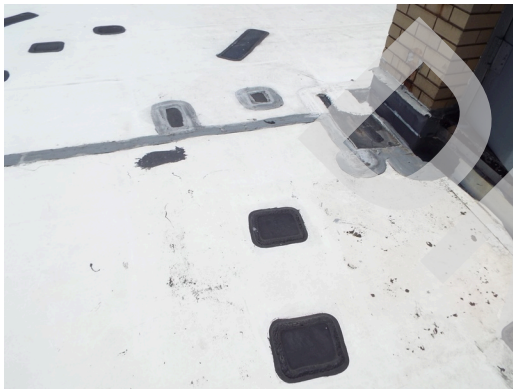
Roof patches

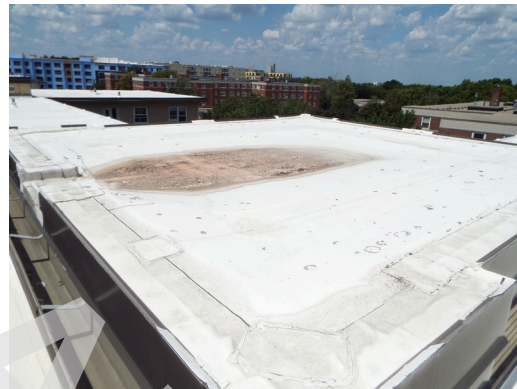
Roof ponding

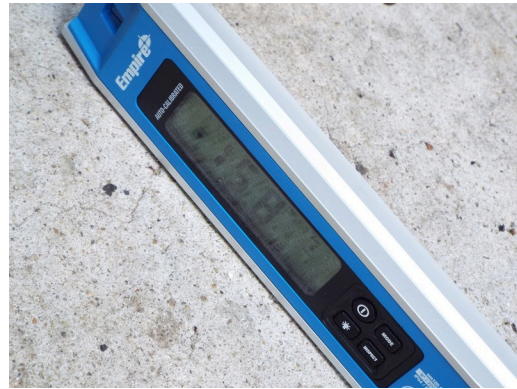
Accessible rear entry - slope exceeds allowable (Critical Repair)

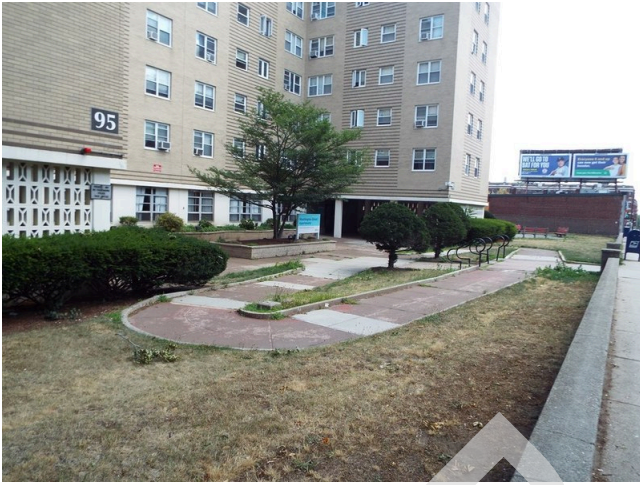
1. Topography

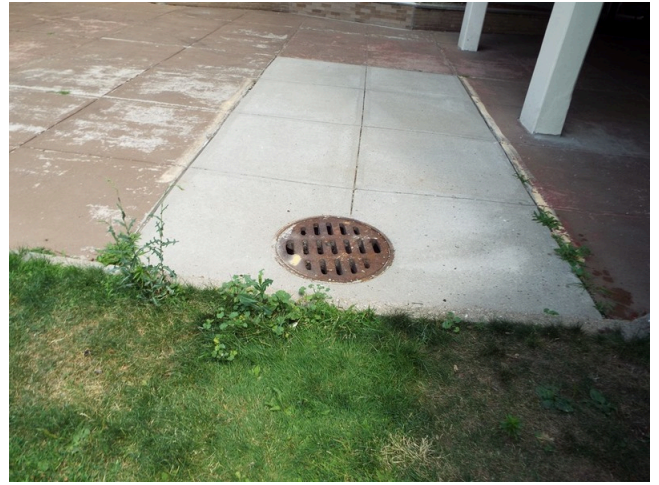
2. Area drain

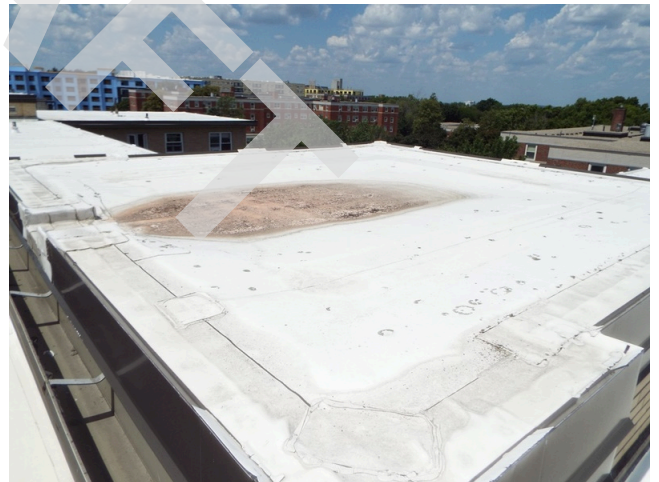
59. Roof patches

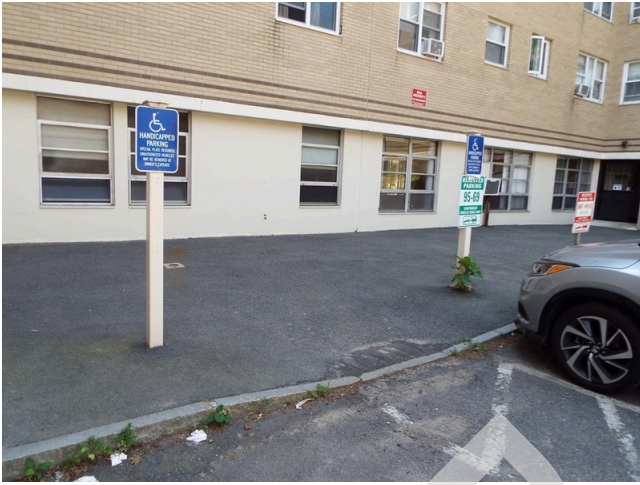
88. Accessible parking - running slope exceeds allowable (Critical Repair)

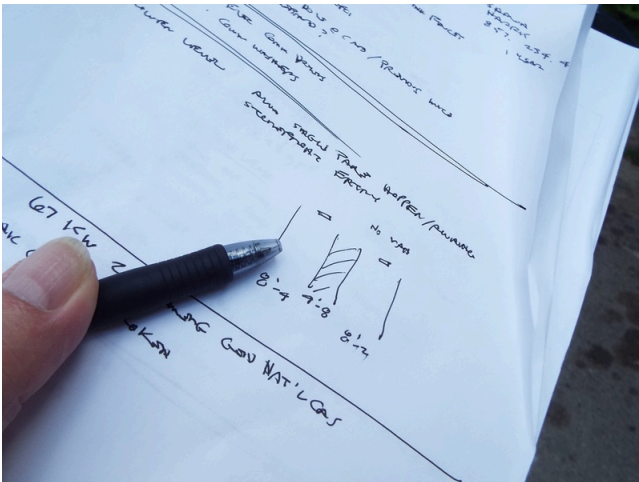
98. Accessible parking - running slope exceeds allowable (Critical Repair)

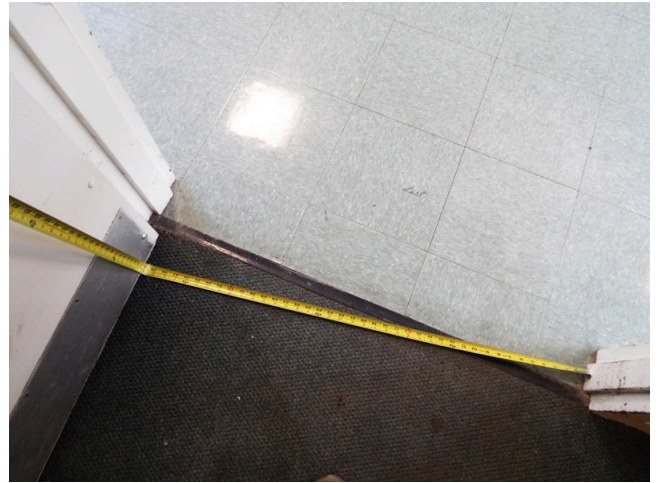
118. Common area - community room door clearance

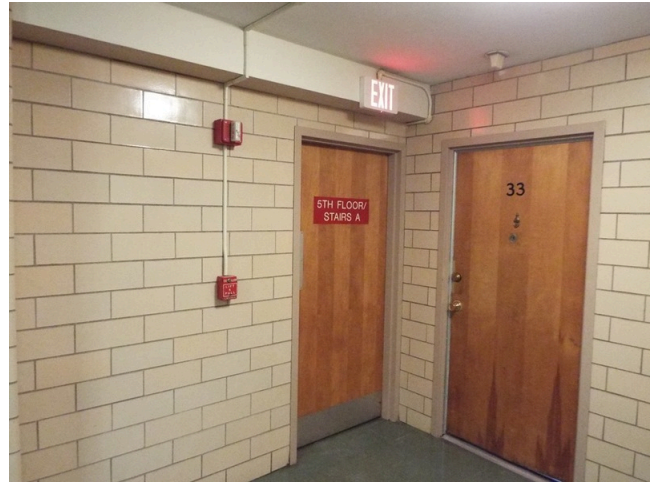
185. Trash chute door

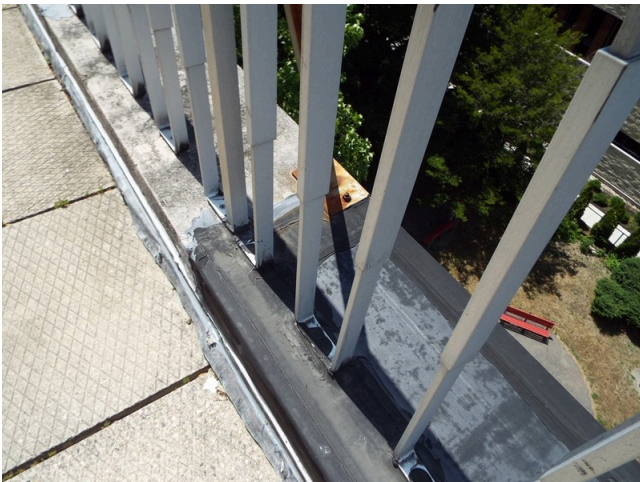
314. Rooftop terrace

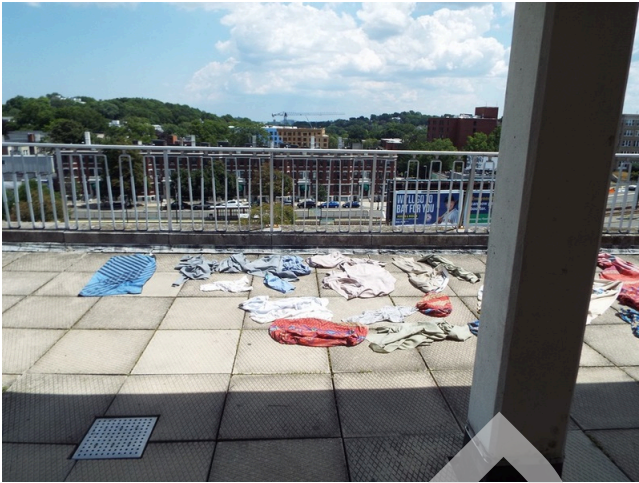
316. Seating area

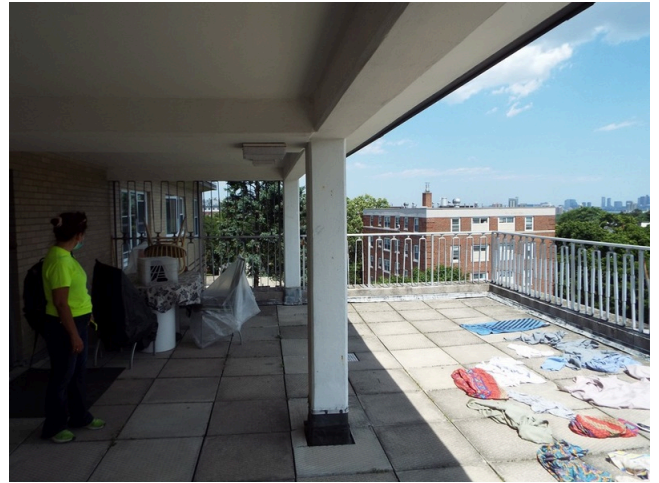
317. Rooftop terrace

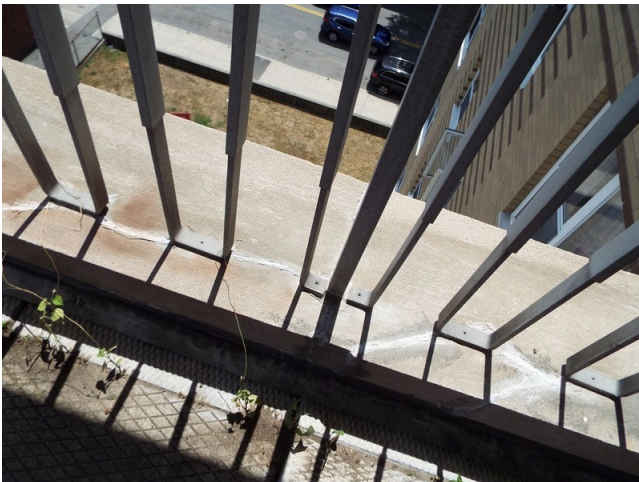
318. Rooftop terrace

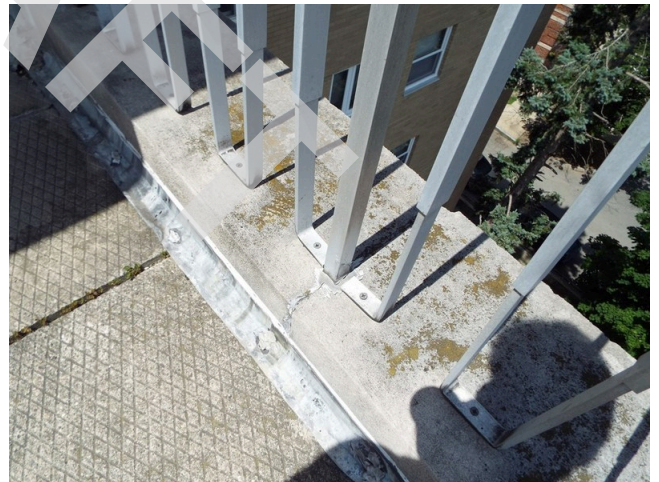
319. Rooftop terrace

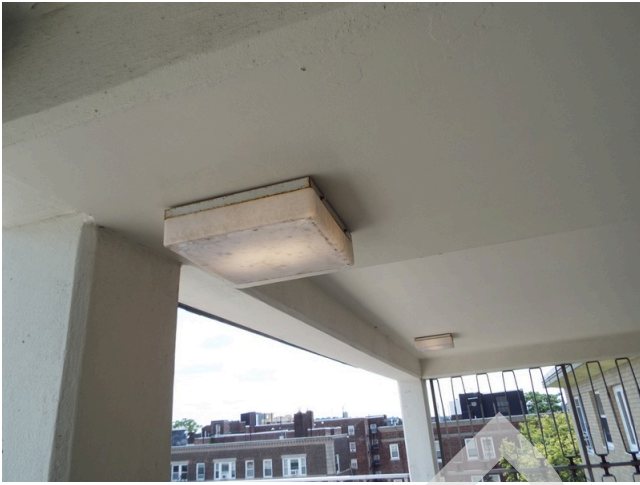
320. Rooftop terrace
