HUD MAP CAPITAL NEEDS ASSESSMENT

Davison
101 Davison Street
Hyde Park, Massachusetts 02136

AEI Project No. 463352
Site Inspection Date: July 13, 2022

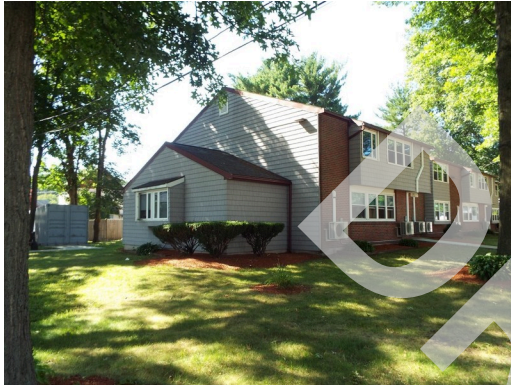
No notable deficiencies or indications of deferred maintenance of topography, drainage or retaining wall features were observed or reported.

Topography

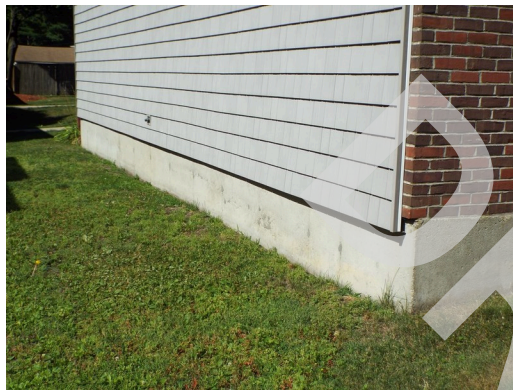
No notable deficiencies or indications of deferred maintenance of foundations were observed or reported.

Typical foundation

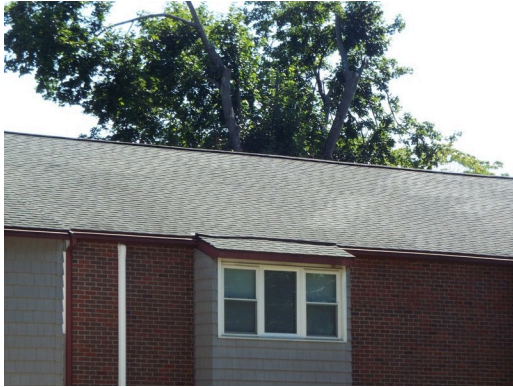
Roof ID	Construction Type	Approx. Area	Reported Age	RUL	Warranty	Action	Condition
All	Pitched with asphalt shingles	16,000 SF	16 years	4 years	No	RR	Good/Fair

Typical roofing

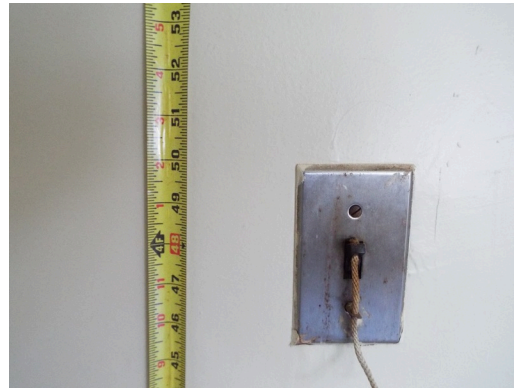
Emergency call device (older)

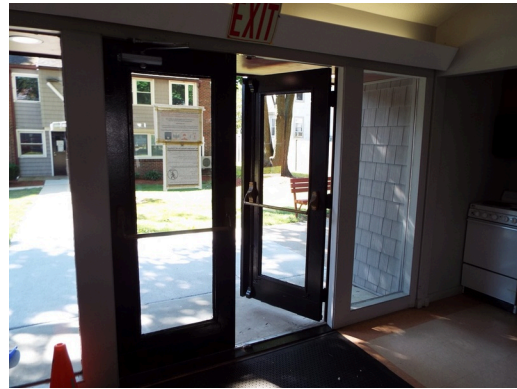
Community building - entry

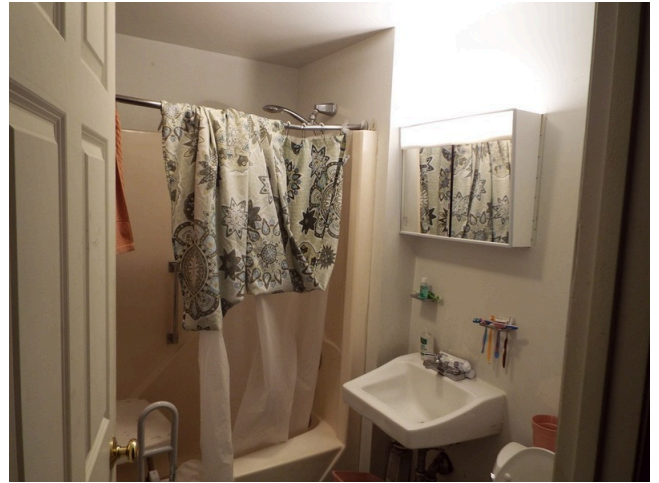
13. 0-bed-1-bath - unit 13 - building 93-95 -
bathroom fixtures

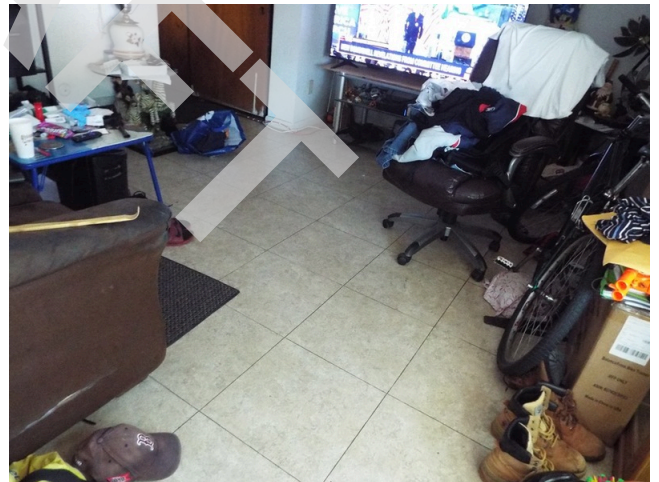
39. 2-bed-1-bath - unit 7 - building 93-95 - living room

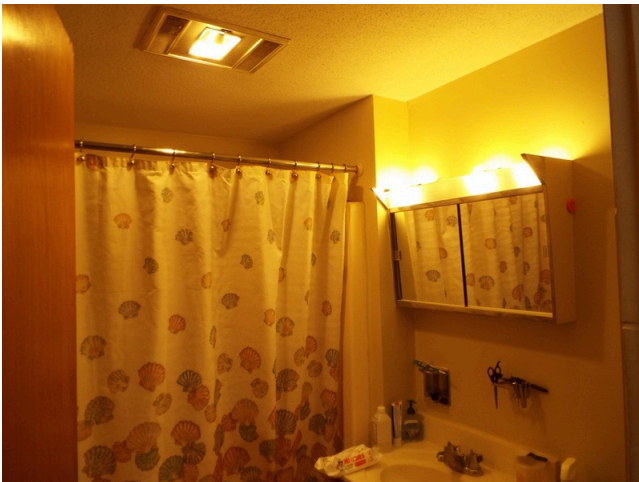
42. 2-bed-1-bath - unit 7 - building 93-95 - bathroom

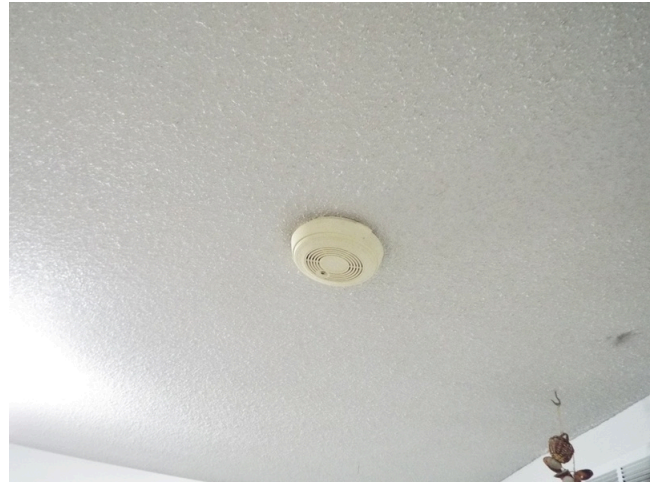
45. 2-bed-1-bath - unit 7 - building 93-95 - bedroom

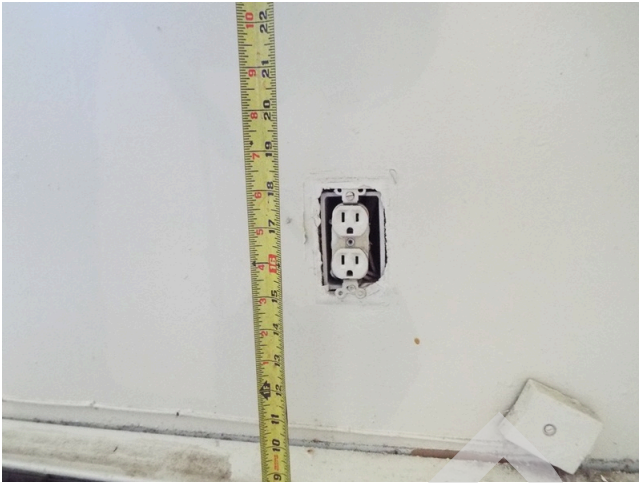
56. Emergency call device (older)

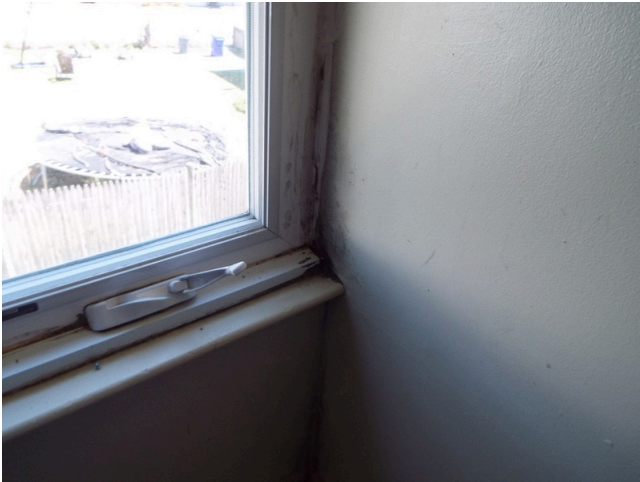
122. 1-bed-1-bath - unit 32 - building 105-109, mildew around frames

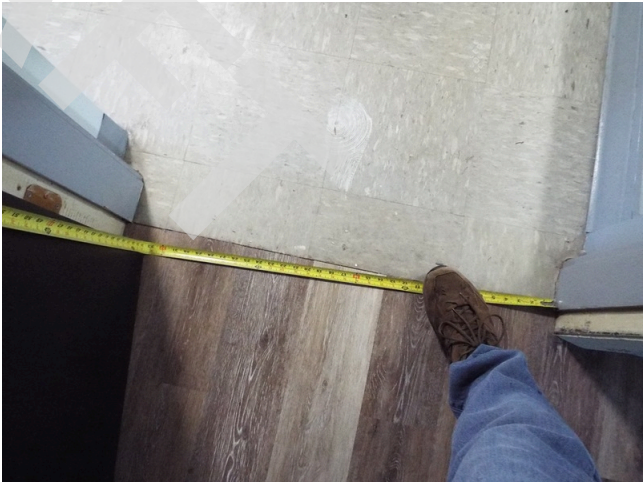
139. Typical unit interior entry door

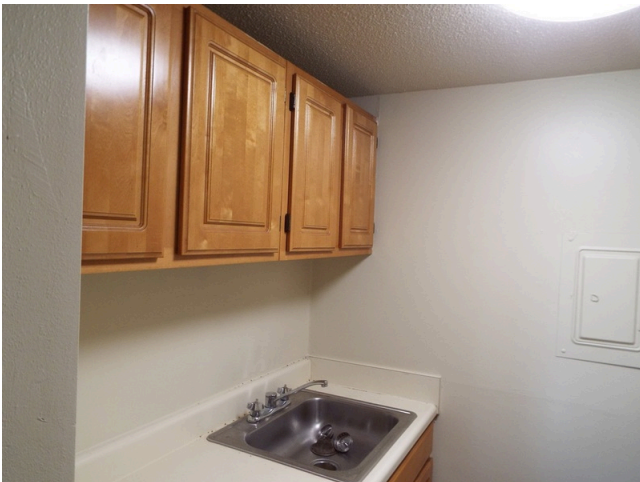
150. 0-bed-1-bath - unit 41 - building 110-112 -
kitchen cabinets

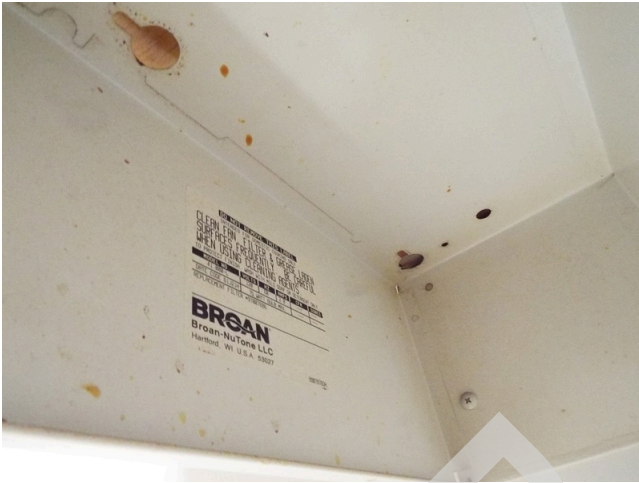
160. 0-bed-1-bath - unit 41 - building 110-112 -
range hood

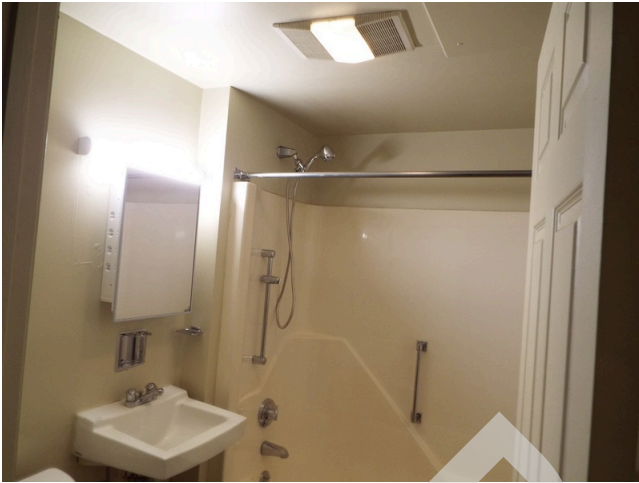
168. 0-bed-1-bath - unit 41 - building 110-112-
bathroom fixtures

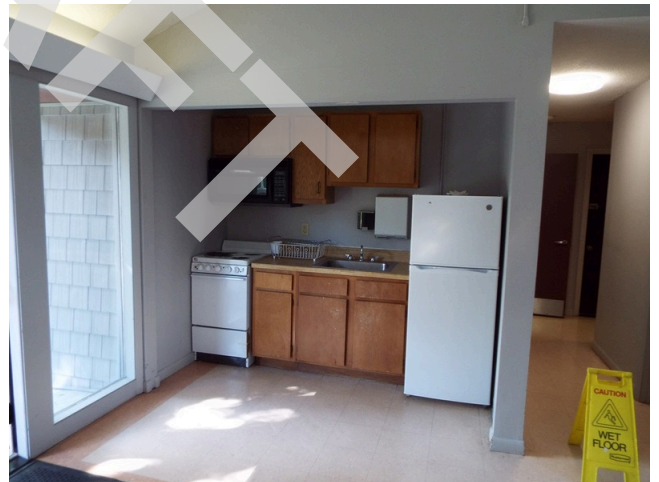
48. Community building - kitchen

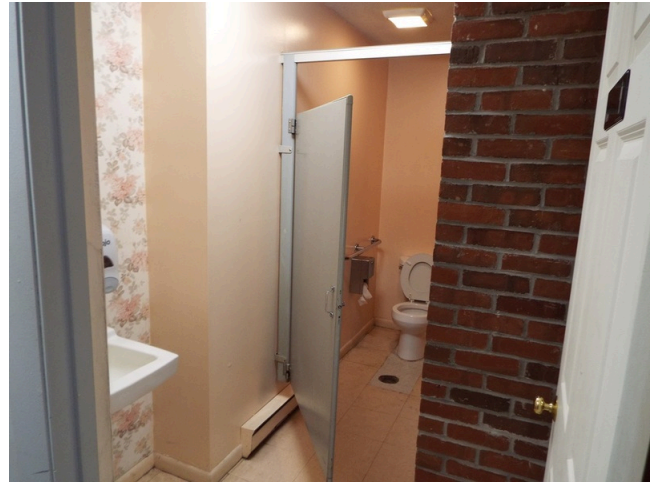
50. Community building - mens restroom

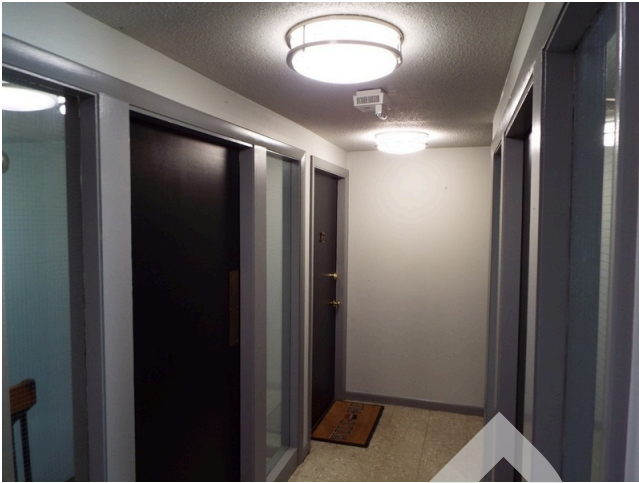
53. Typical upper hall - building 110-112

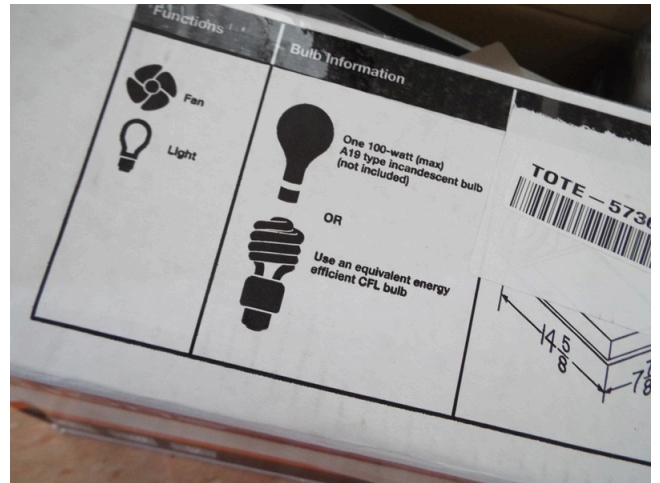
86. Light fixture bulbs

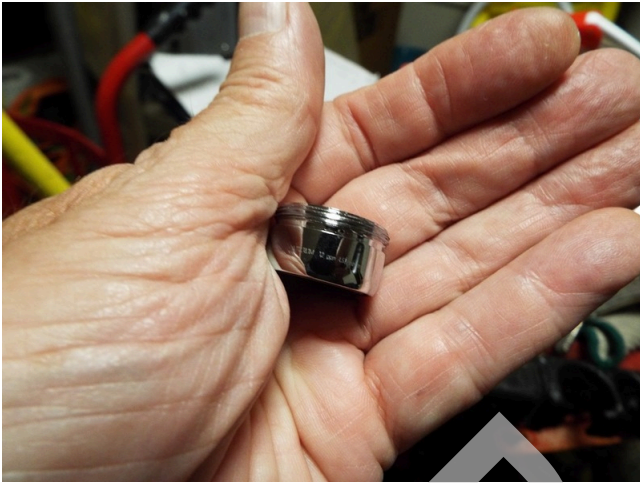
93. Typical aerators

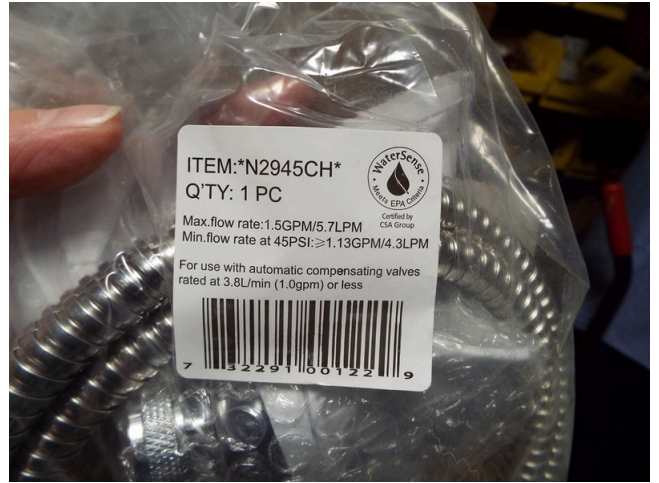
94. Shower head

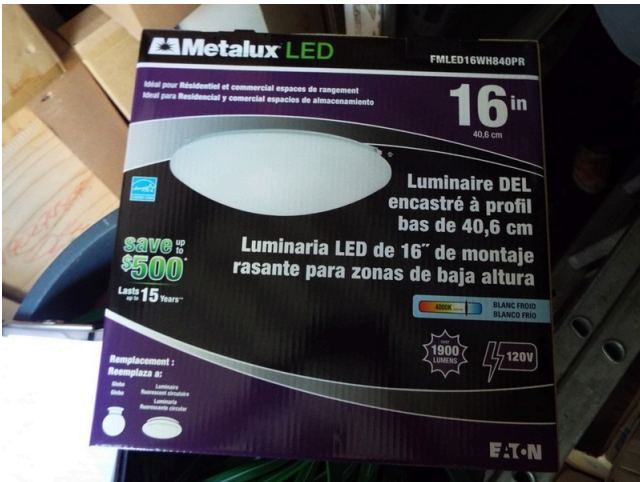
95. Light fixture bulbs

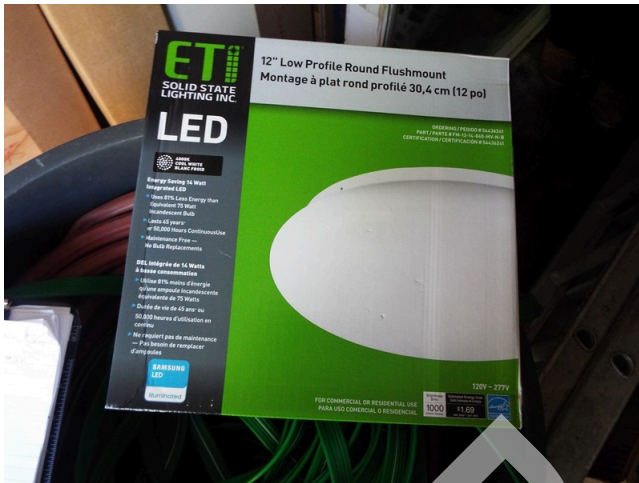
97. Light fixture bulbs

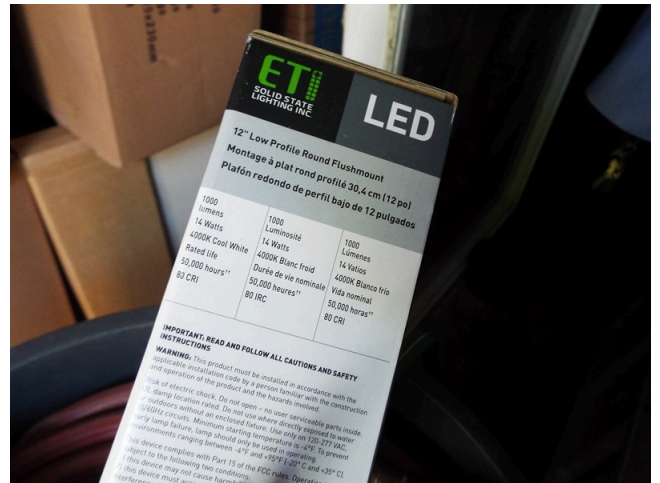
98. Light fixture bulbs

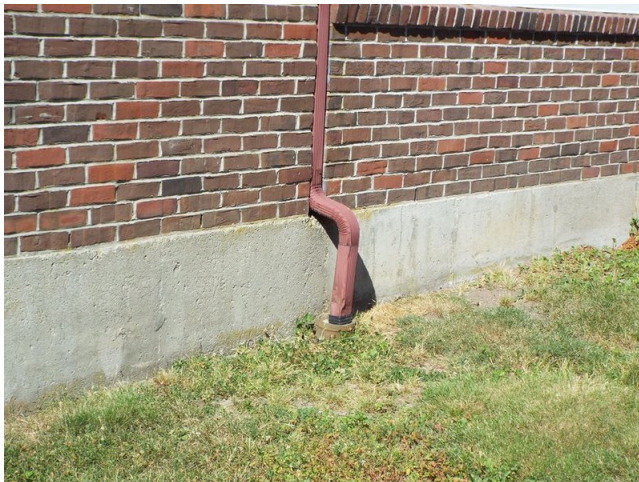
99. Downspout boot
