HUD MAP CAPITAL NEEDS ASSESSMENT

Ashmont
374 Ashmont Street
Dorchester, Massachusetts 02124

AEI Project No. 463355
Site Inspection Date: July 6, 2022

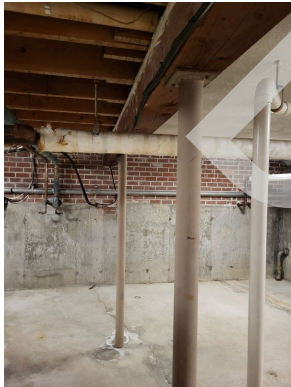
Basement ceiling damage (Non-Critical Repair)

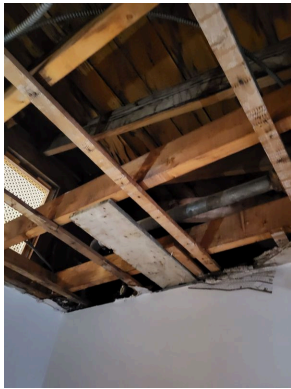
Common area restroom hole in ceiling
(Non-Critical Repair)

AEI observed damaged ceiling in the common area restroom located in the community room. Replacement of the community room roof is recommended. (Non-Critical Repair)

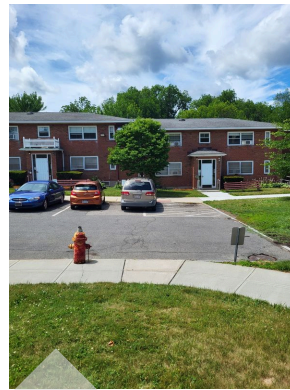
Property parking lot install handicap accessible parking (Critical Repair)

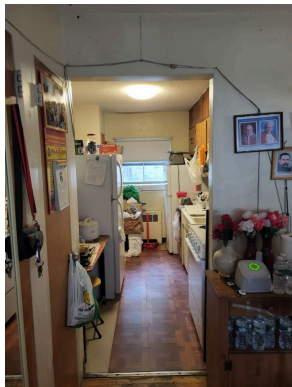
AEI observed several kitchen cabinets and countertops that were in poor physical condition and require replacement. An example unit is 346-10. Property management should perform a 100% inspection to understand how many sets of cabinets are in this condition. AEI believes 20% of the cabinets are in poor condition.

Apartment 346-10 kitchen

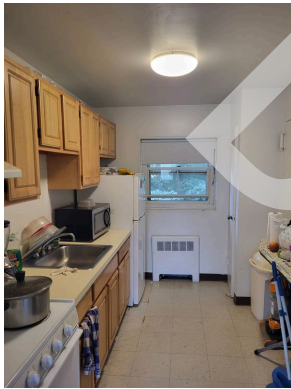
Apartment 352-19 kitchen

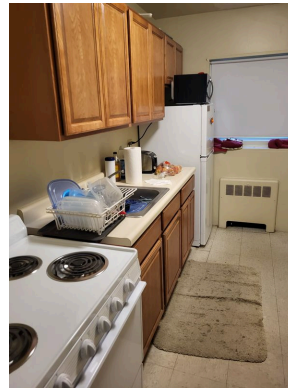
Apartment 354-21 kitchen

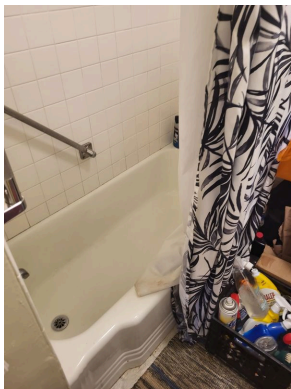
Apartment 364-36 bathroom bathtub and hardware

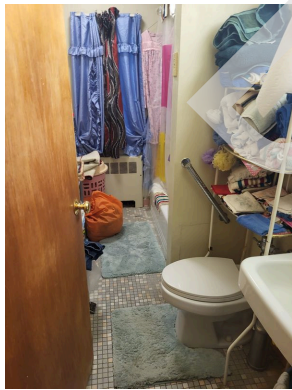
Apartment 342-1 bathroom

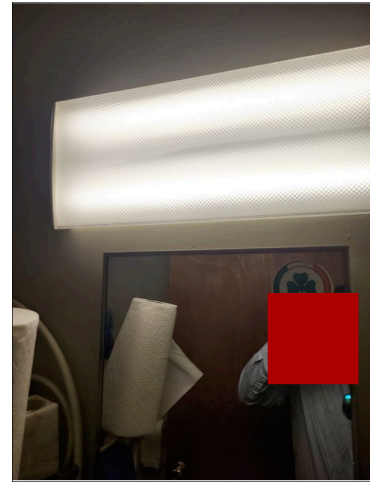
2. Apartment 346-10 bathroom light fixture

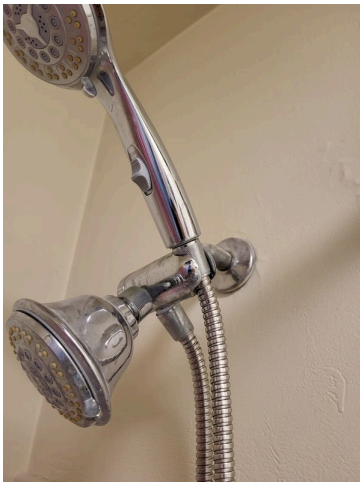
3. Apartment 346-10 bathroom bathtub shower head

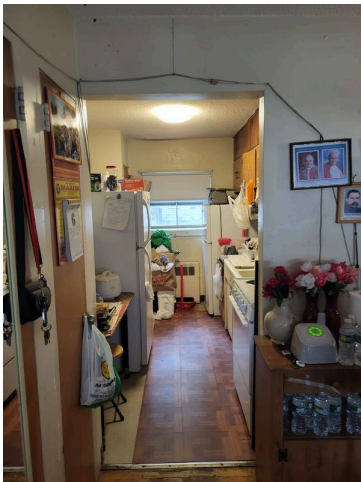
7. Apartment 346-10 kitchen

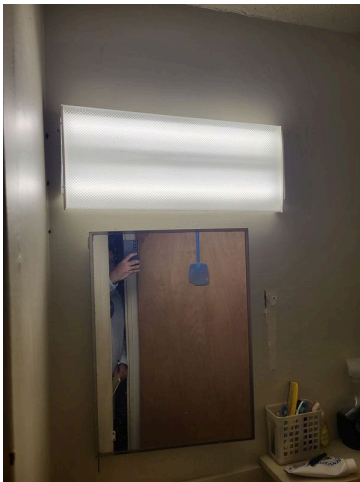
15. Apartment 346-10 bathroom light fixture and medicine cabinet

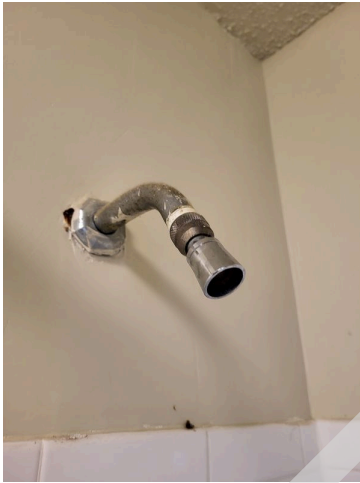
21. Apartment 346-10 bathroom bathtub shower head

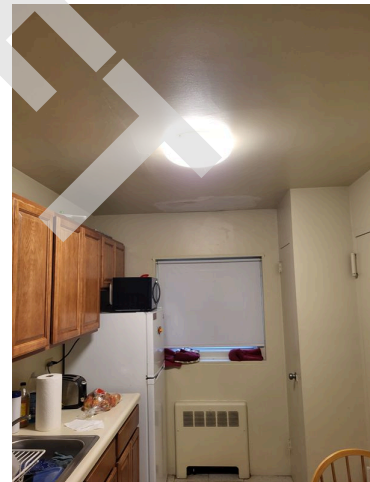
43. Apartment 354-21 kitchen ingress/egress door

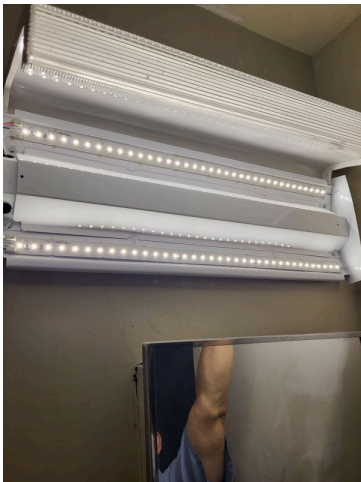
54. Apartment 356-25 bathroom

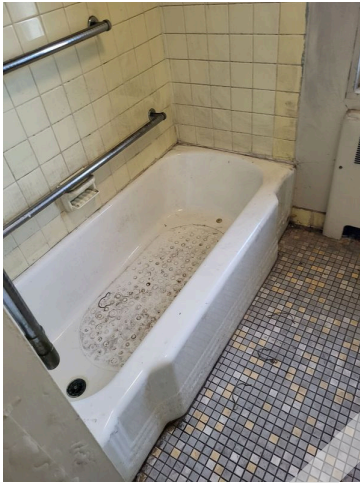
72. Apartment 370-46 bathroom toilet, grab bar, sink and floor (Non-Critical Repair)

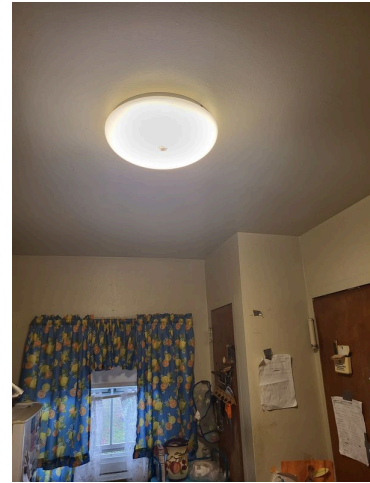
118. Apartment 342-1 kitchen light fixture

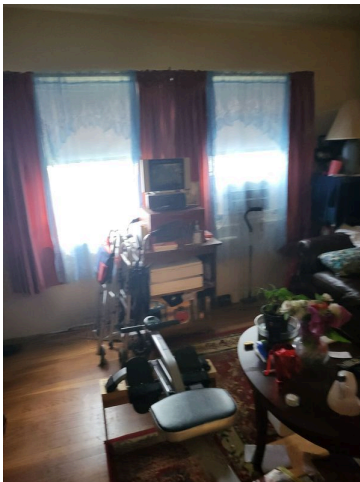
119. Apartment 342-1 living room area

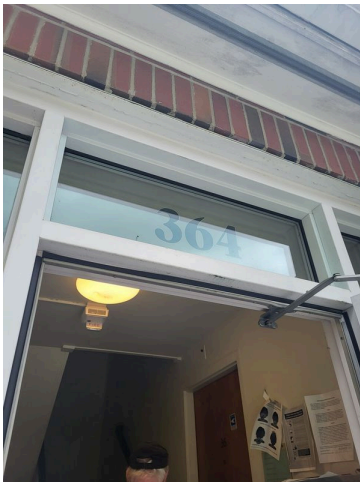
87. Apartment building 358-374 ingress/egress

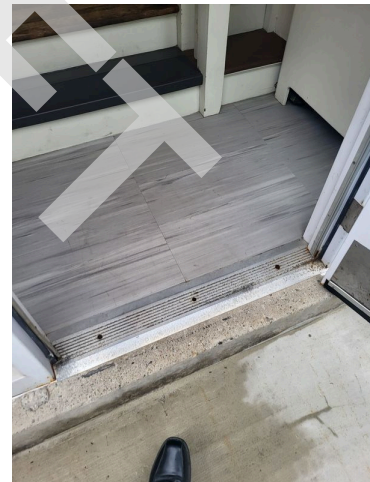
88. Apartment building 358-374 ingress/egress doorway

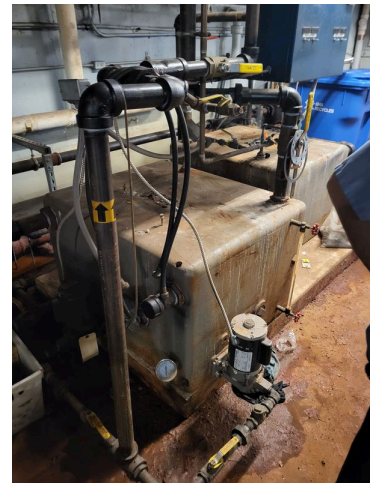
98. Steam exchangers
