## HUD CAPITAL NEEDS ASSESSMENT

Margaret Collins (Pond St)  
29 Pond Street  
Jamaica Plain, Massachusetts 02130

AEI Project No. 463357  
Site Inspection Date: June 30, 2022

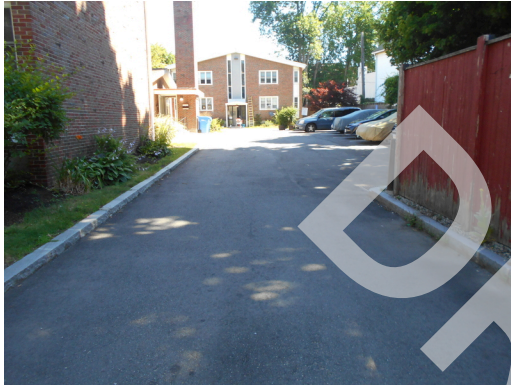
Site entrance from Pond Street

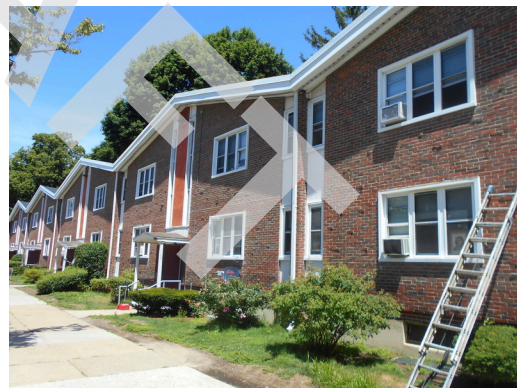
Building A front façade

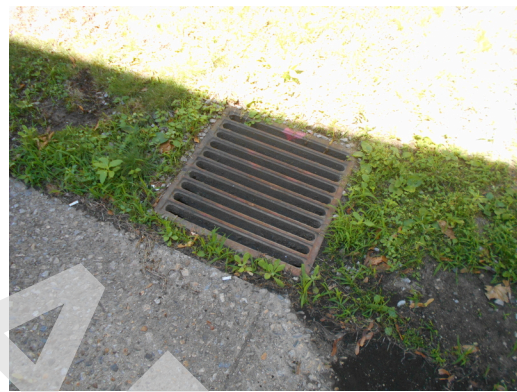
Site drainage

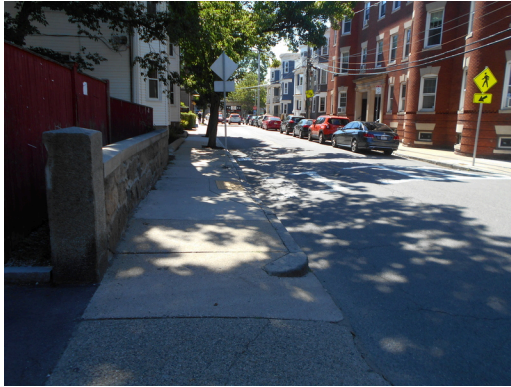
Pond Street

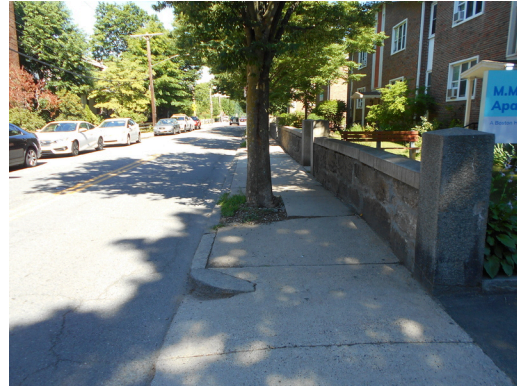
Pond Street

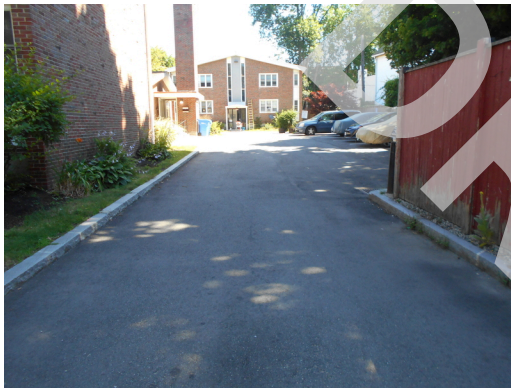
Site entrance from Pond Street

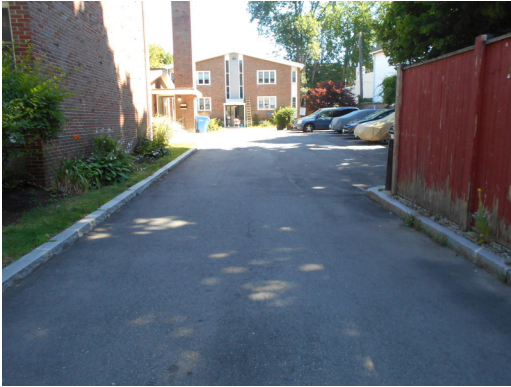
Site entrance from Pond Street

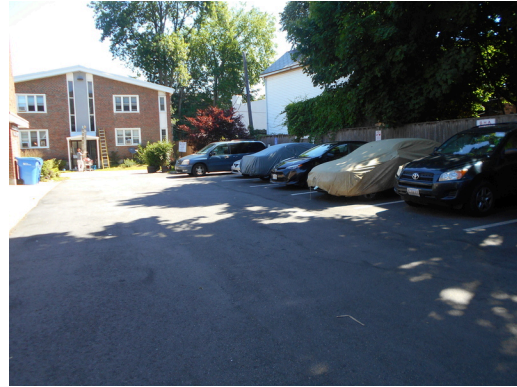
Asphalt parking lot

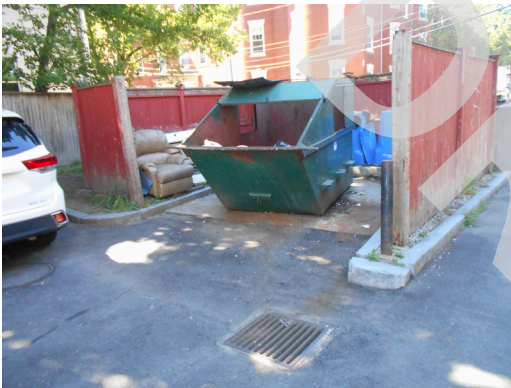
Refuse area

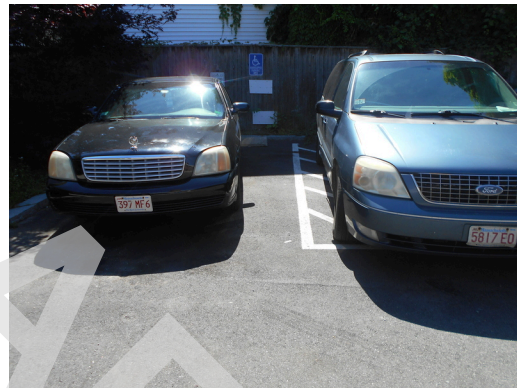
| Items | Description | Action | Condition |
|---|--|---|---|
| Number of ADA Spaces | 1 | IM | Poor |

Handicap parking space

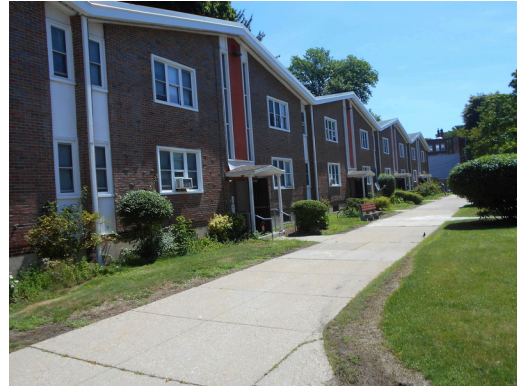
Building A front façade

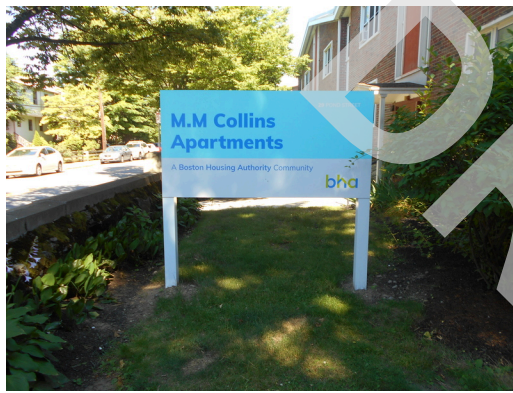
Property Signage

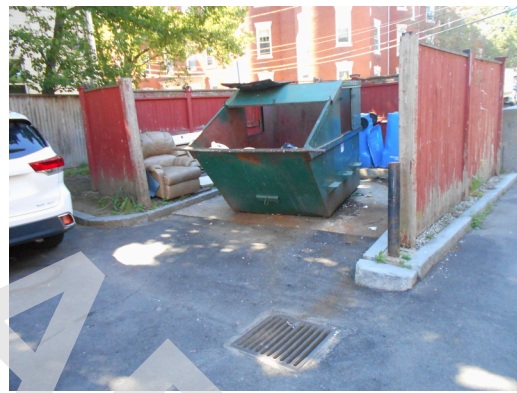
Refuse area

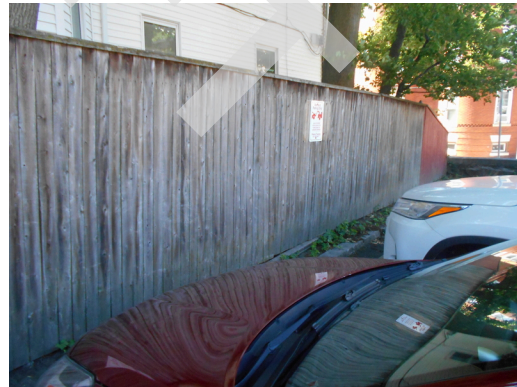
Parking lot wood fencing

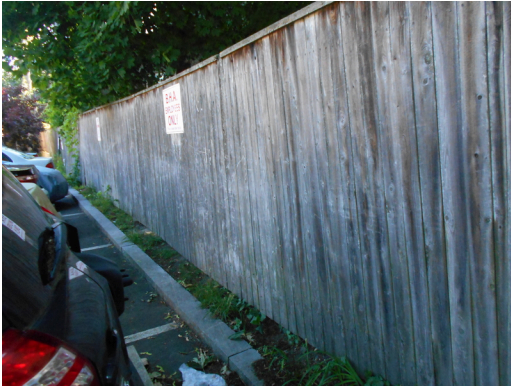
Parking lot wood fencing

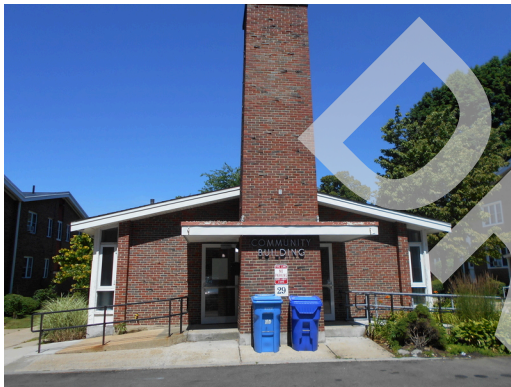
Community building

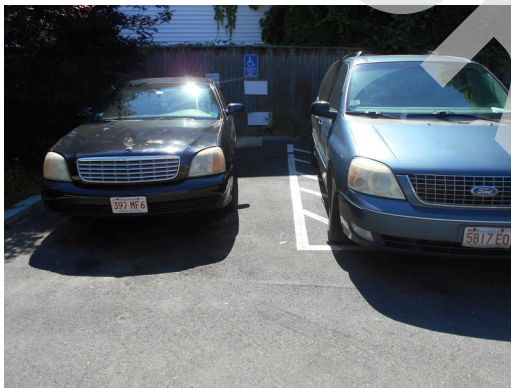
Handicap parking space

| | <b>Building History</b> | Yes | No | N/A | Comments |
|---|---|---|---|---|--|
| 2. | Are there sufficient van-accessible parking spaces available (96" wide aisle for van)? | | ✓ | | 0 designated van accessible spaces provided<br><br>1 designated accessible spaces required (Critical Repair) |

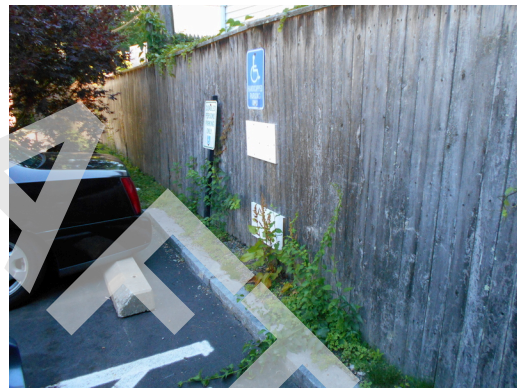
Handicap parking space

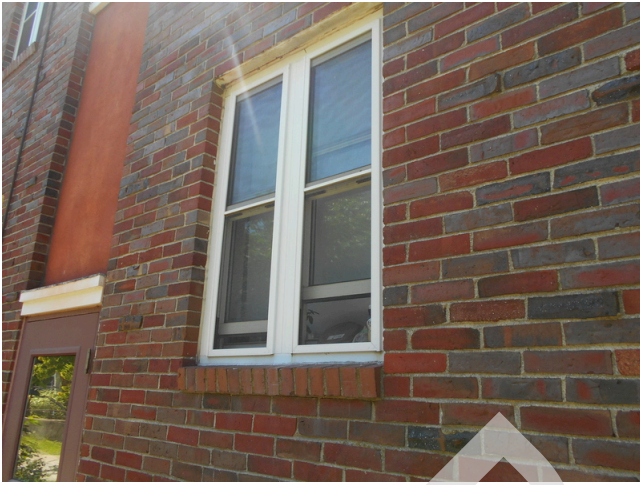
89. Typical tenant windows
