HUD CAPITAL NEEDS ASSESSMENT

ME McCormack
10 Kemp Street
South Boston, Massachusetts 02127

AEI Project No. 463360
Site Inspection Date: July 7th & July 8th

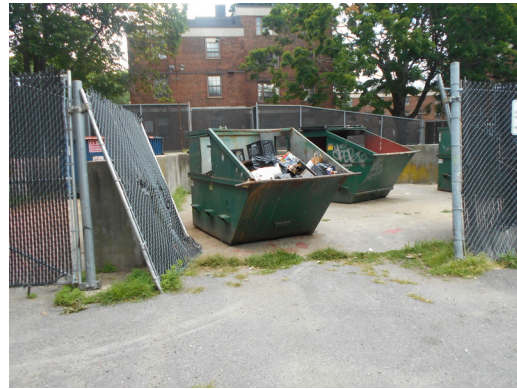
Refuse area by building 30, damaged fencing
(Non-Critical Repair)

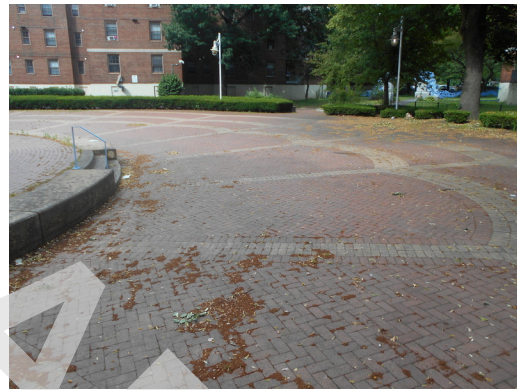
Sterling square, plaza, brick pavers

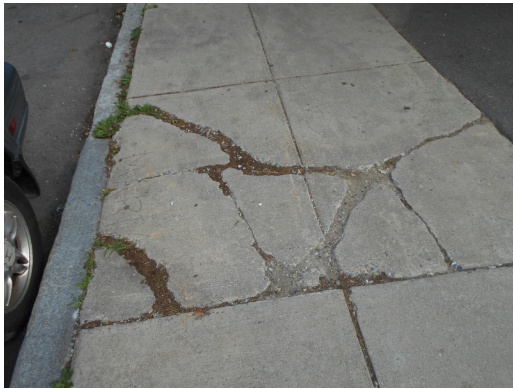
Concrete trip hazard between building 3 and building 4 (Critical Repair)

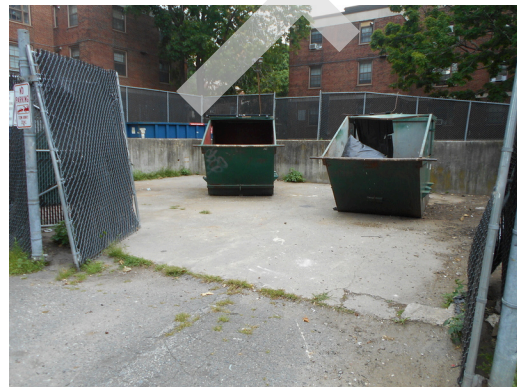
Refuse area by building 30, damaged fencing (Non-Critical Repair)

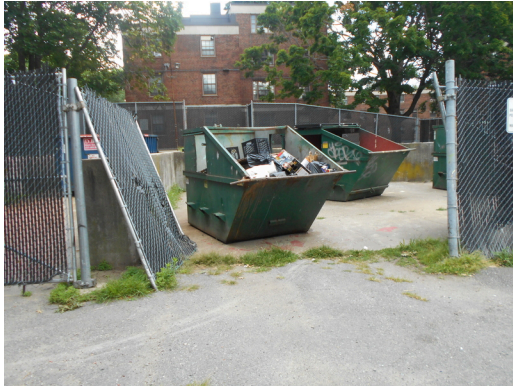
Refuse area by building 30, damaged fencing
(Non-Critical Repair)

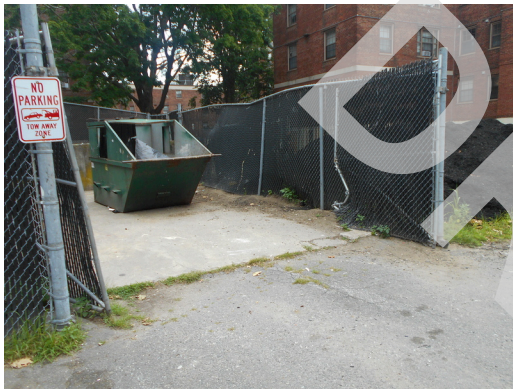
Refuse area by building 30, damaged fencing
(Non-Critical Repair)

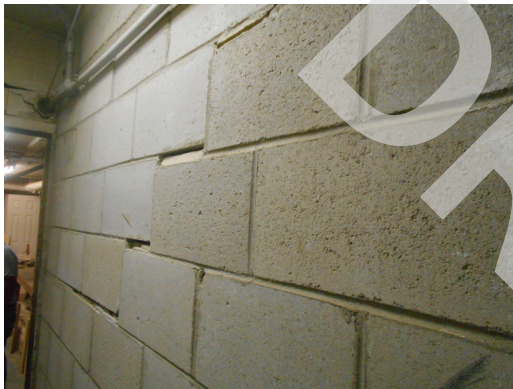
Building 30 basement, 15 Logan way, cracking CMU-wall (Non-Critical Repair)

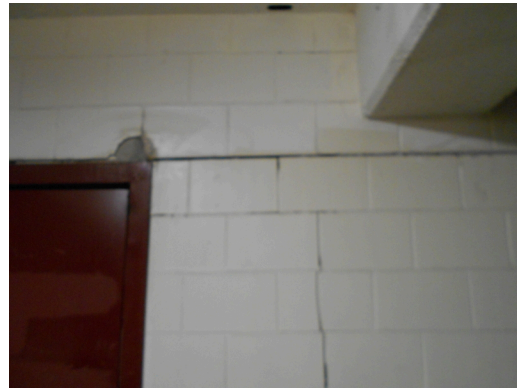
The basements of building 30, building 23 and building 17 was observed with cracking in the basement of the CMU-wall. As this is a sign of a potential structural issue, AEI recommends having a licensed structural engineer inspect the buildings. (Critical Repair)

Building 23, 2 Logan Way basement, cracking CMU-wall (Non-Critical Repair)

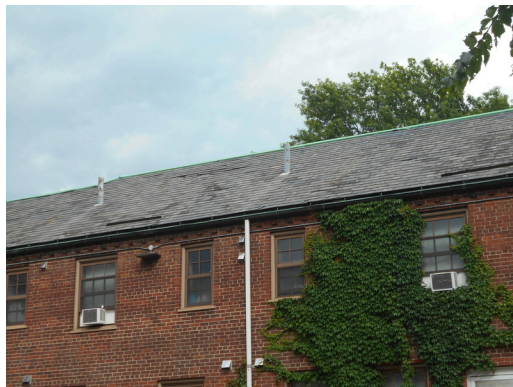
Building 6 slate tile roofing, shingles falling (Non-Critical Repair)

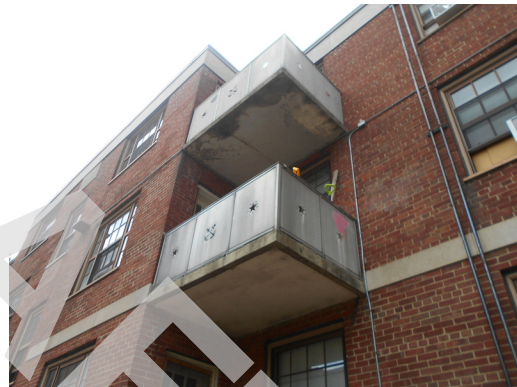
Building 32, concrete balcony, deterioration on underside (Critical Repair)

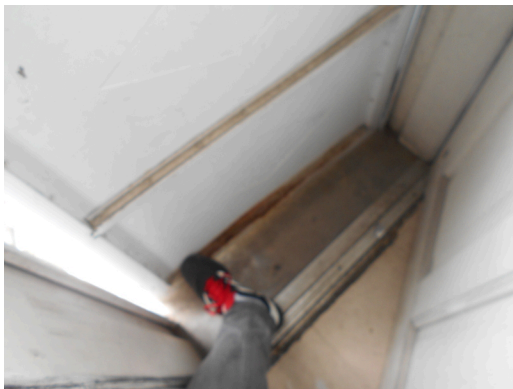
Building 5 unit 186, 64 O'Callaghan Way, 3br/1ba Townhouse - Rear door, damaged (Non-Critical Repair)

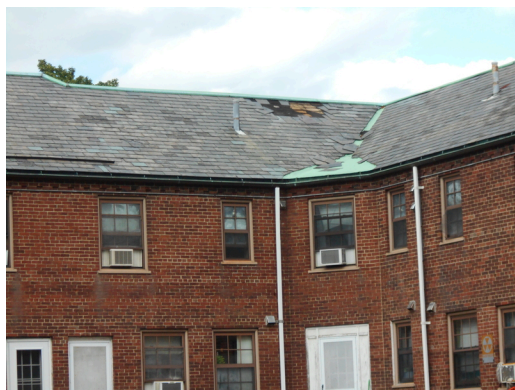
Building 3 rear façade, damaged slate tile roofing (Non-Critical Repair)

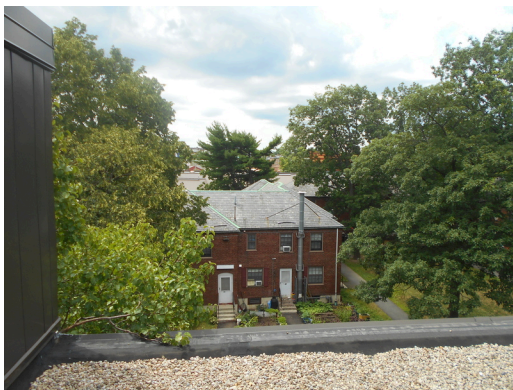
Typical slate tile roof

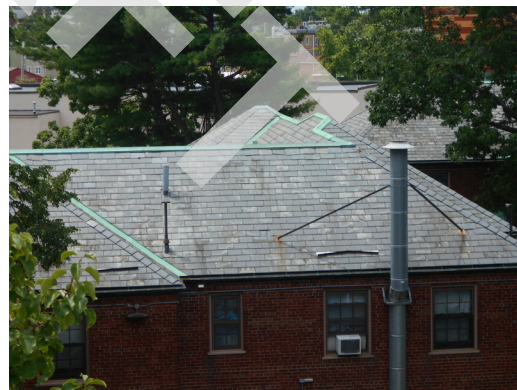
Typical slate tile roof

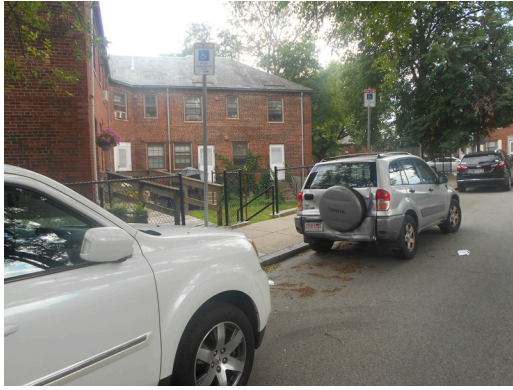
Handicap designated street parking by building 11, 16 Kemp Street, unit 116, no access aisle or curb cut (Critical Repair)

CRITICAL REPAIRS									
Need Category	Component	Repair or Replacement Location	Classification of Work	Quantity	Unit of Measure	Unit Cost	Total	Comments	
CRITICAL REPAIRS (ACCESSIBILITY)									
Striping and Marking	Reconfigure Handicapped Parking (Critical Repair)	Designated handicapped parking	Level 1 Alteration	1	Each	\$ 1,000.00	\$ 1,000.00	Based upon the twelve (12) standard uncovered parking spaces available at the site, one (1) handicapped accessible parking spaces, inclusive of one (1) van accessible handicapped parking space are required by the Americans with Disabilities Act Accessibility Guidelines (ADAAG). The site currently features three (3) designated handicapped spaces; however the existing spaces were observed without access aisles, curb cuts, and neither spaces is van accessible. In order for the existing designated handicapped parking space to comply with ADAAG, the installation of access aisles, curb cuts and conversion of one (1) space to van accessible is required. Standard handicapped spaces require a 60" wide access aisles and vertical and horizontal identification. Van accessible handicapped spaces require a 96" wide access aisle, vertical signage identifying the space as van accessible, and horizontal identification. The designated handicapped parking spaces should be located at the closest accessible route to the building entrances and two (2) spaces may share a single access aisle.

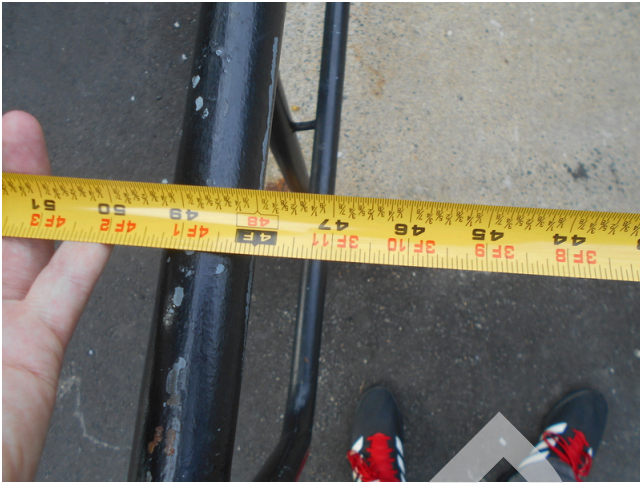
5. Leasing office handicap ramp rail width, 48"

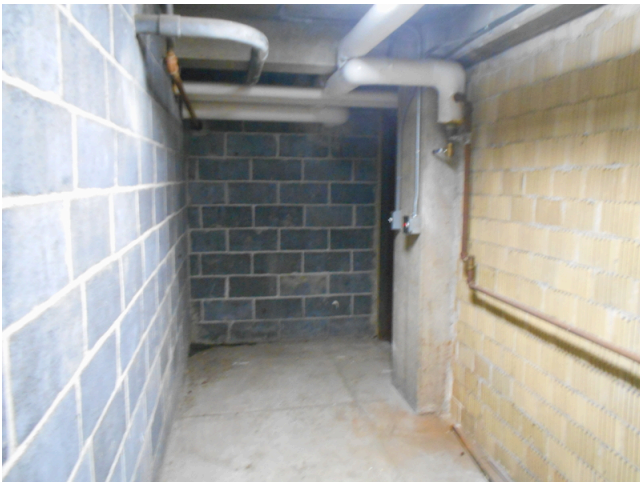
55. Building 1 basement

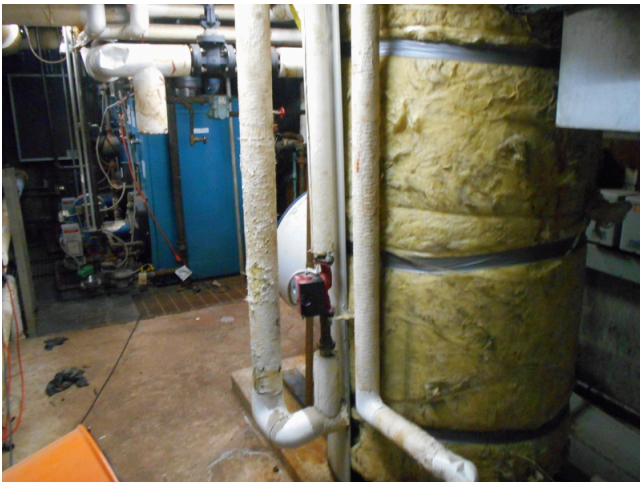
63. Building 4 mechanical room

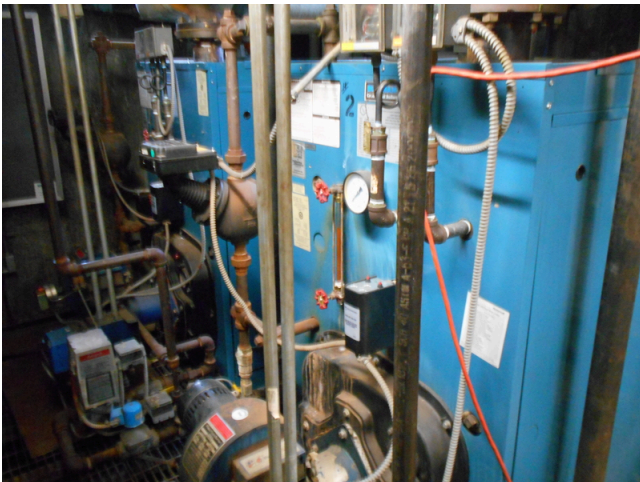
67. Typical boilers

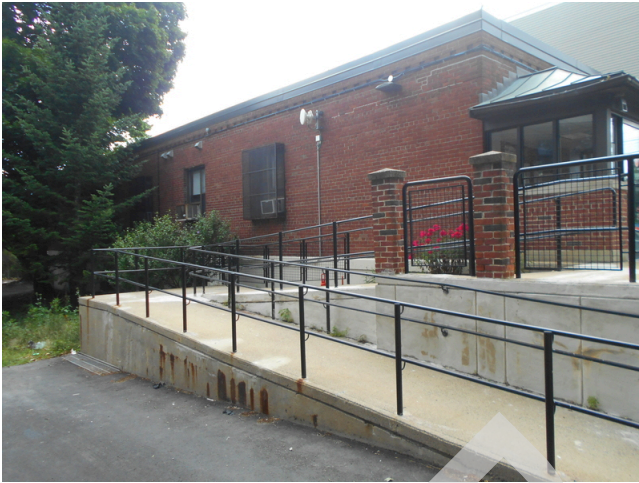
69. Leasing office side façade

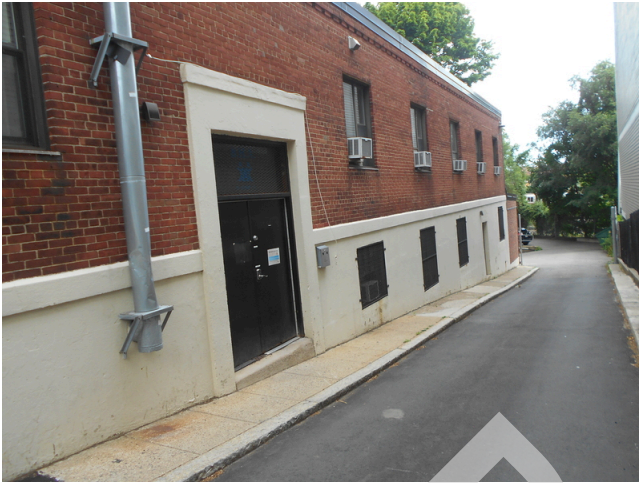
73. Leasing office side façade and driveway

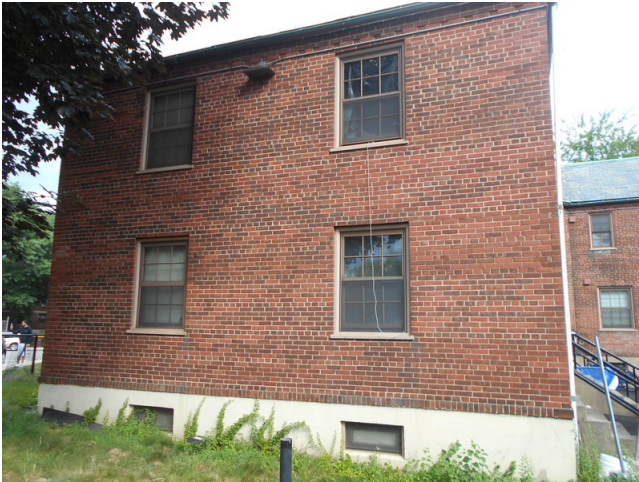
83. Building 11 side façade

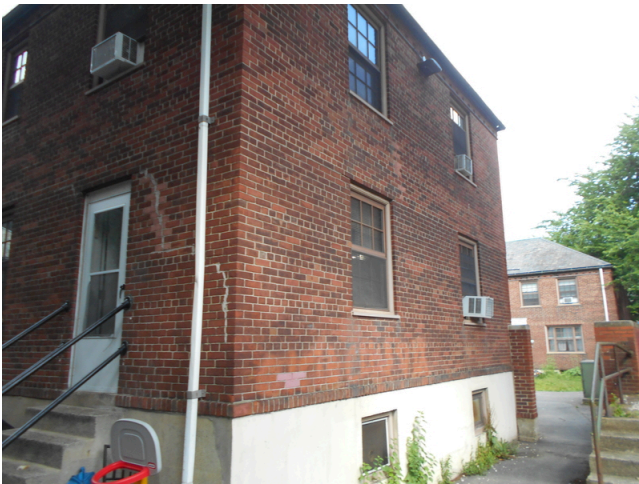
87. Building 11 side façade

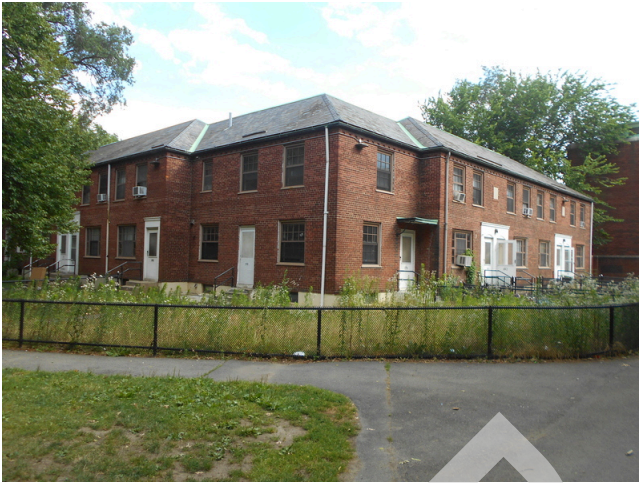
93. Building 6 front façade, need to improve landscaping

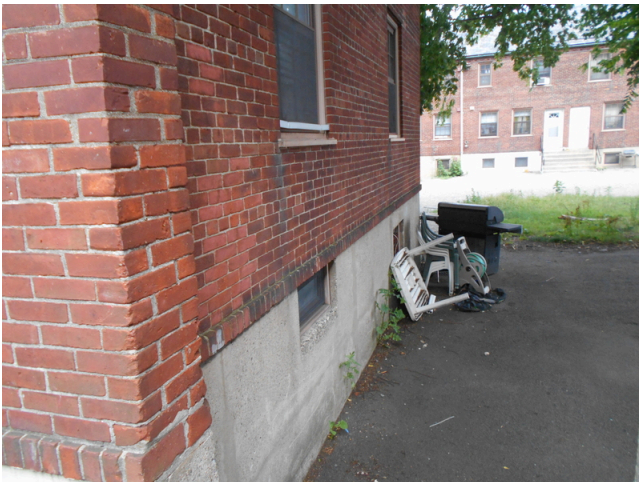
95. Building 6 side façade

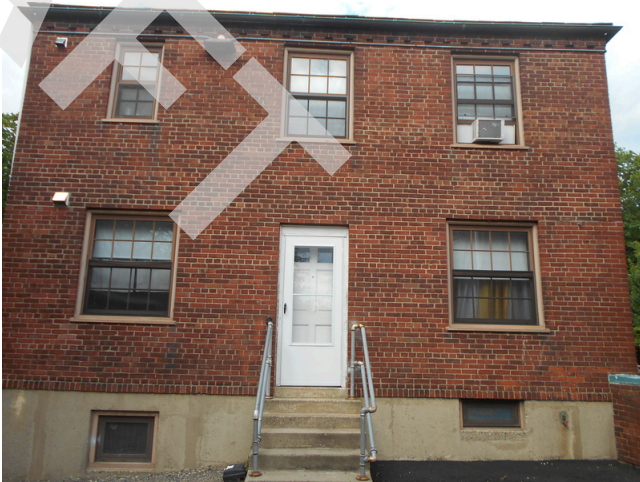
100. Building 6 side façade

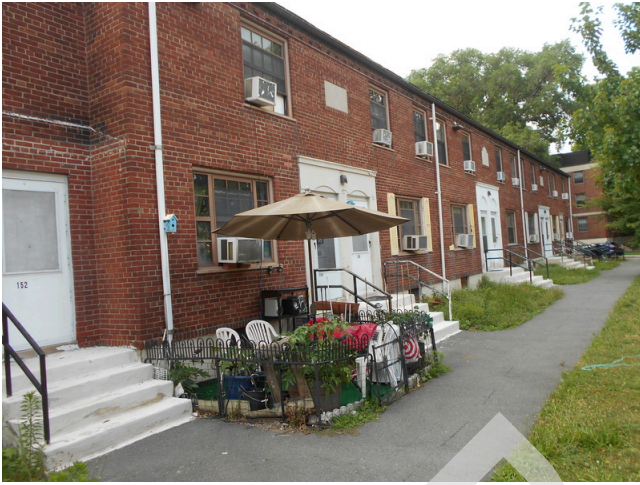
101. Building 6 side façade

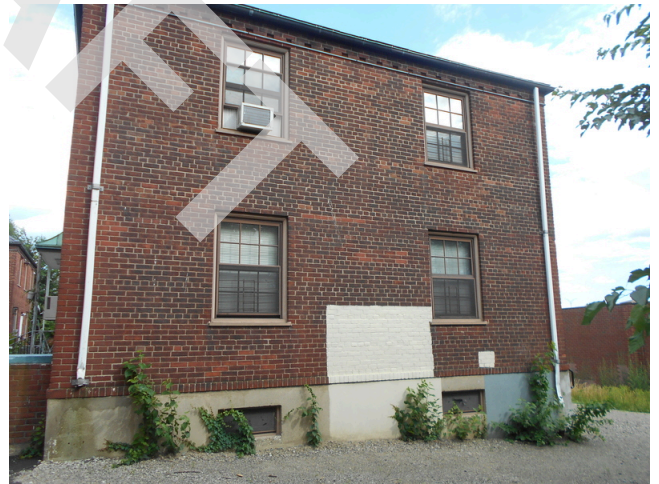
104. Building 5 side façade

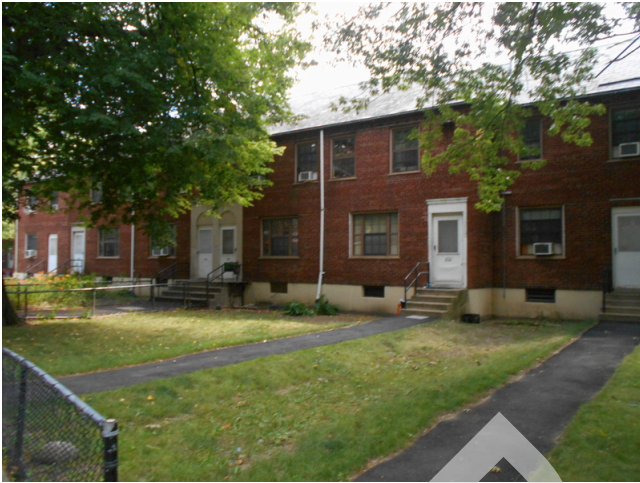
117. Building 3 side façade

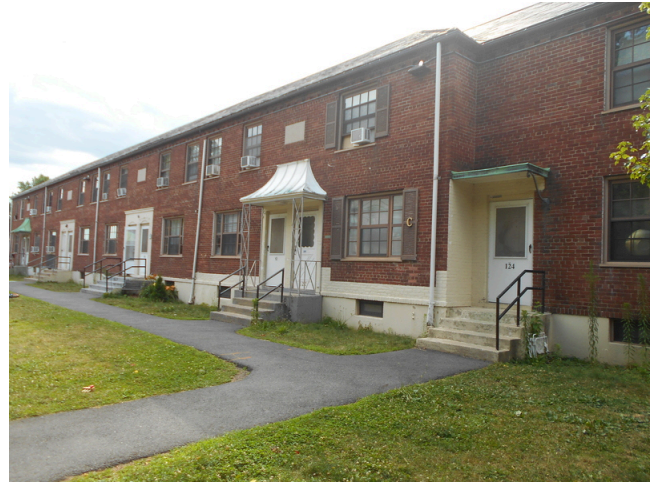
118. Building 3 side façade

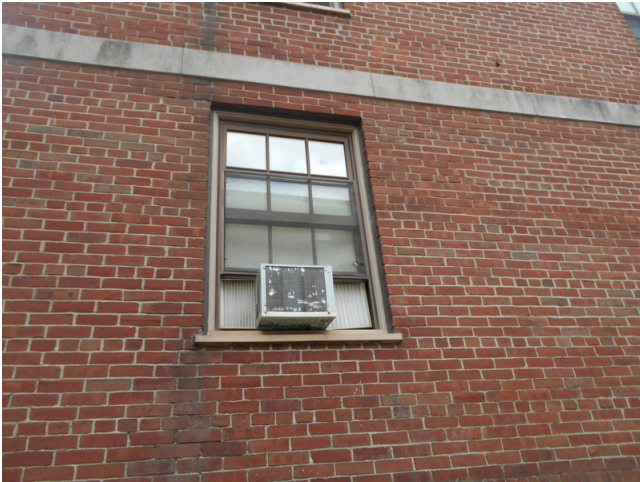
223. Typical aluminum window

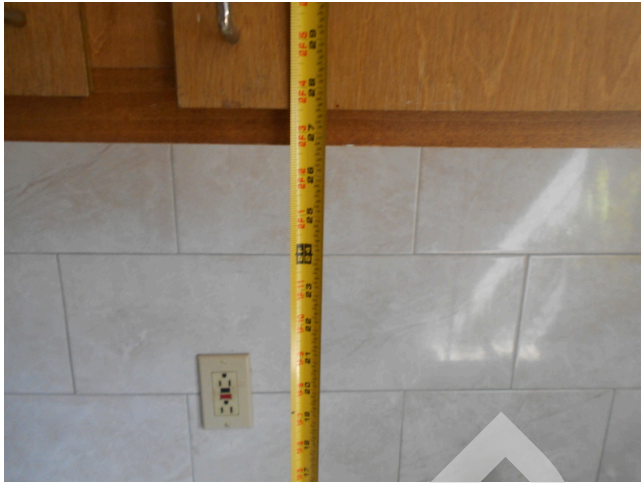
261. Community building, task force headquarters, kitchen cabinet height, 60"
