**CAPITAL NEEDS ASSESSMENT (CNA)  
FOLEY APARTMENTS (2-30)  
199 H STREET  
SOUTH BOSTON, MASSACHUSETTS 02127**

**D3G PROJECT NUMBER:  
2021-0372**

**FINAL REPORT ISSUE DATE:  
NOVEMBER 5, 2021**

**INSPECTION DATE:  
APRIL 19-20, 2021**

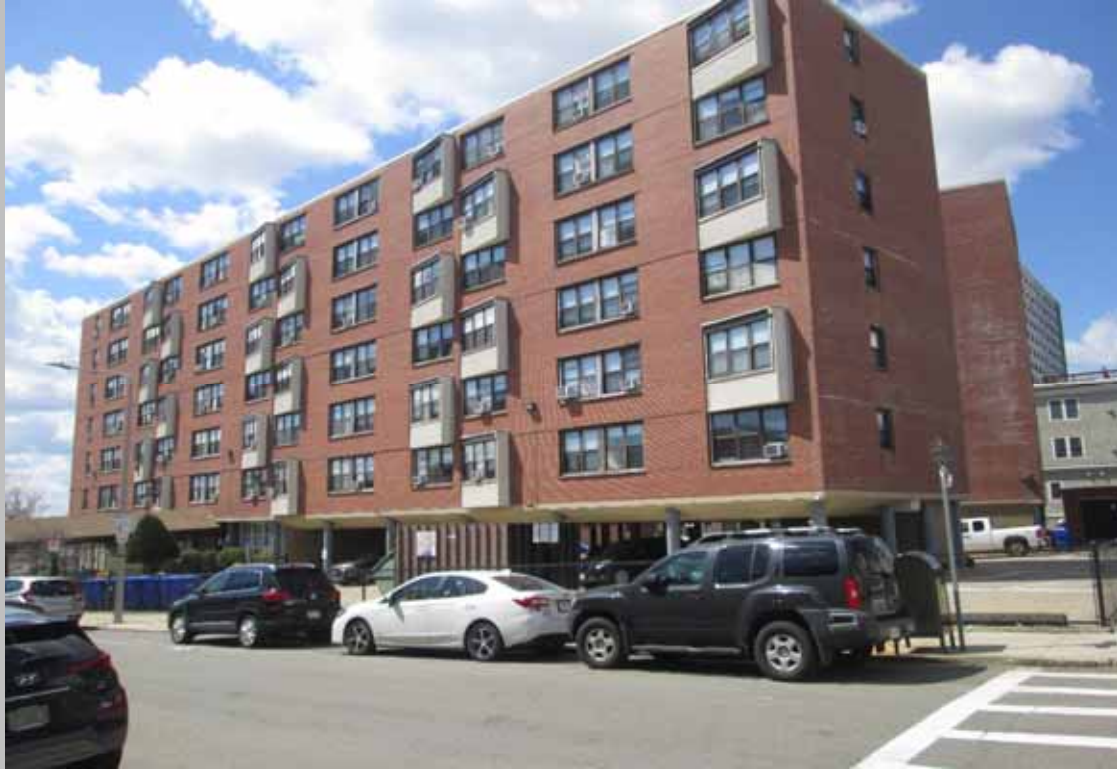
PHOTO #1

Front (east) elevation

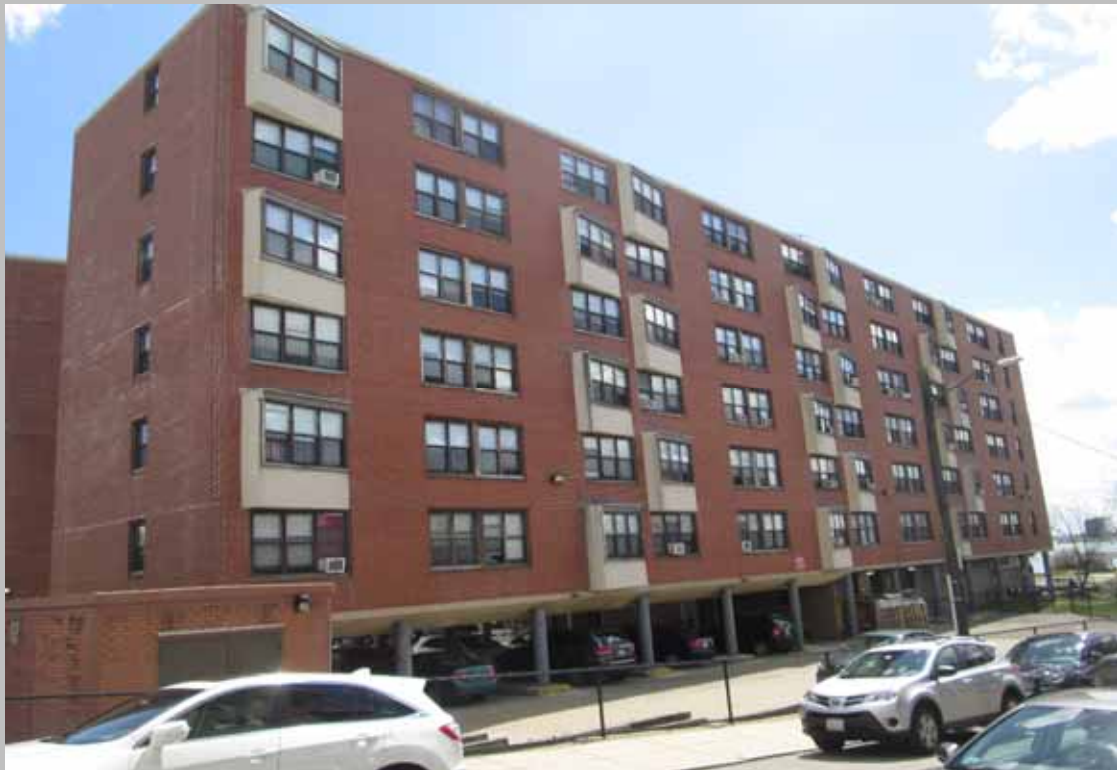
PHOTO #2

West elevation

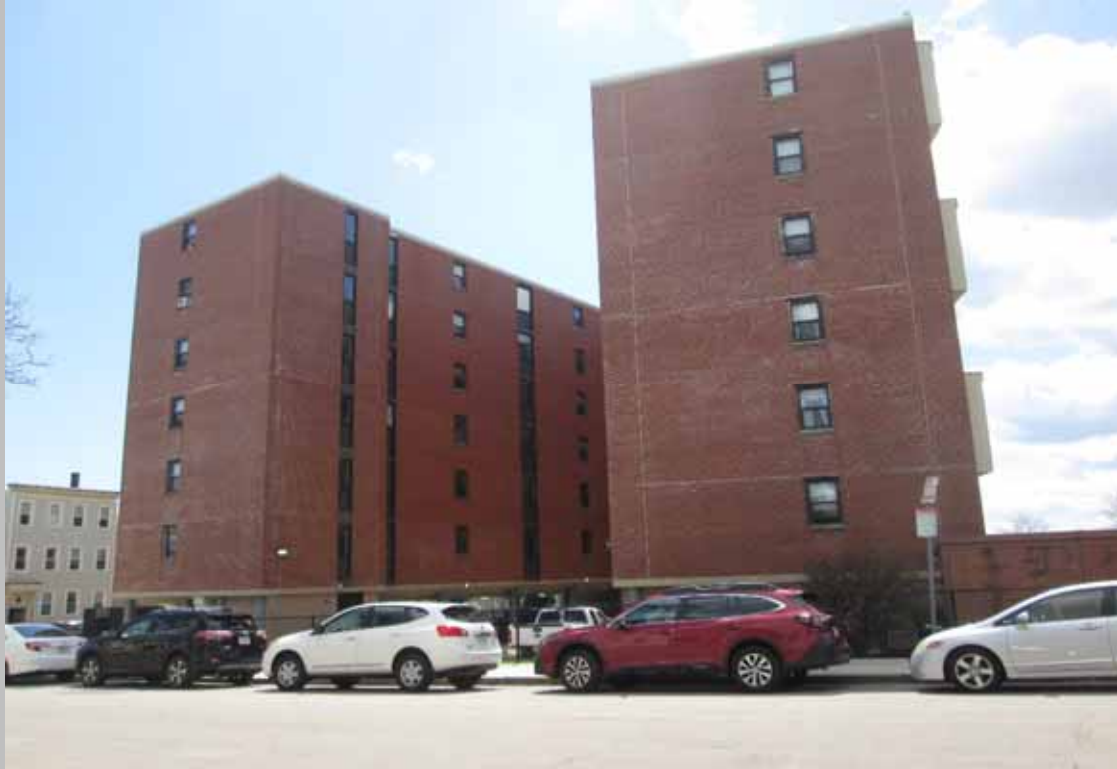
PHOTO #3

North elevation

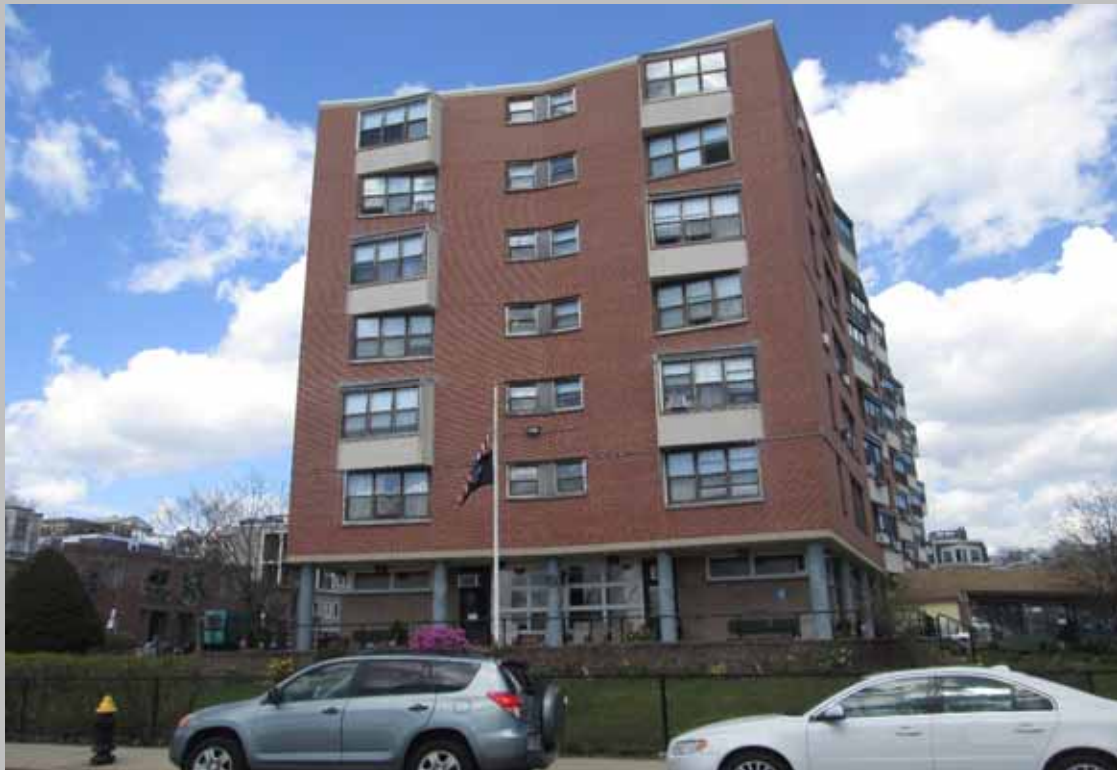
PHOTO #4

South elevation

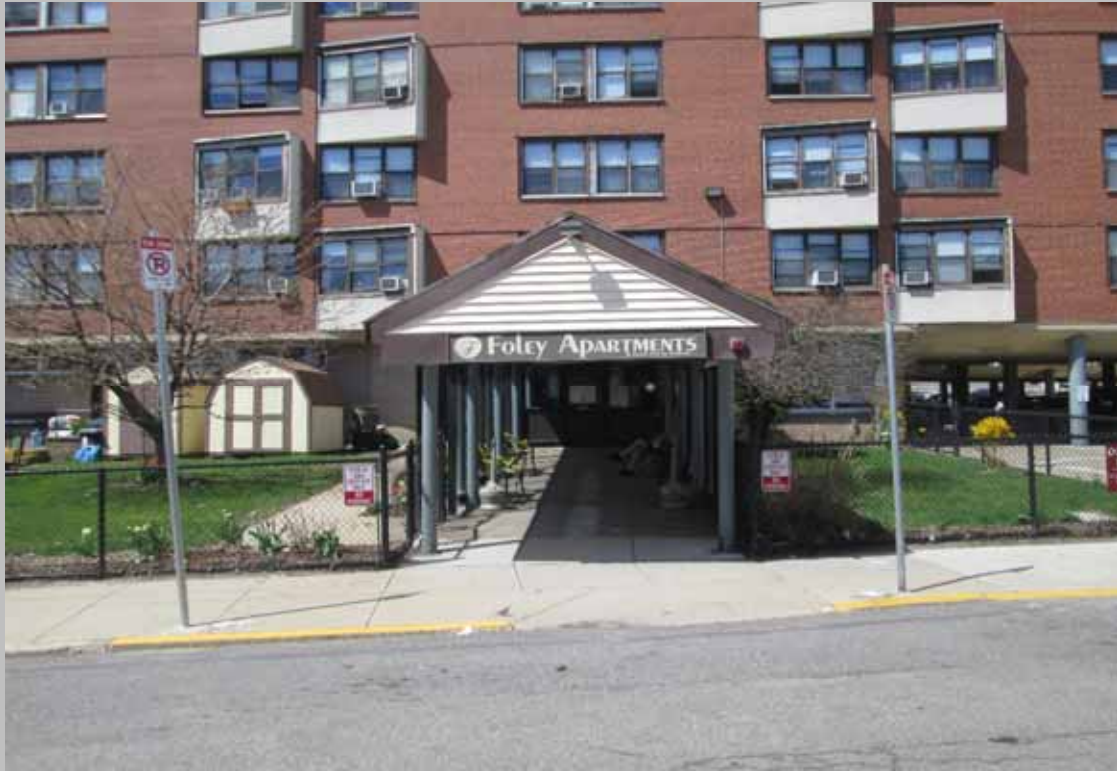
PHOTO #5

Main building entrance

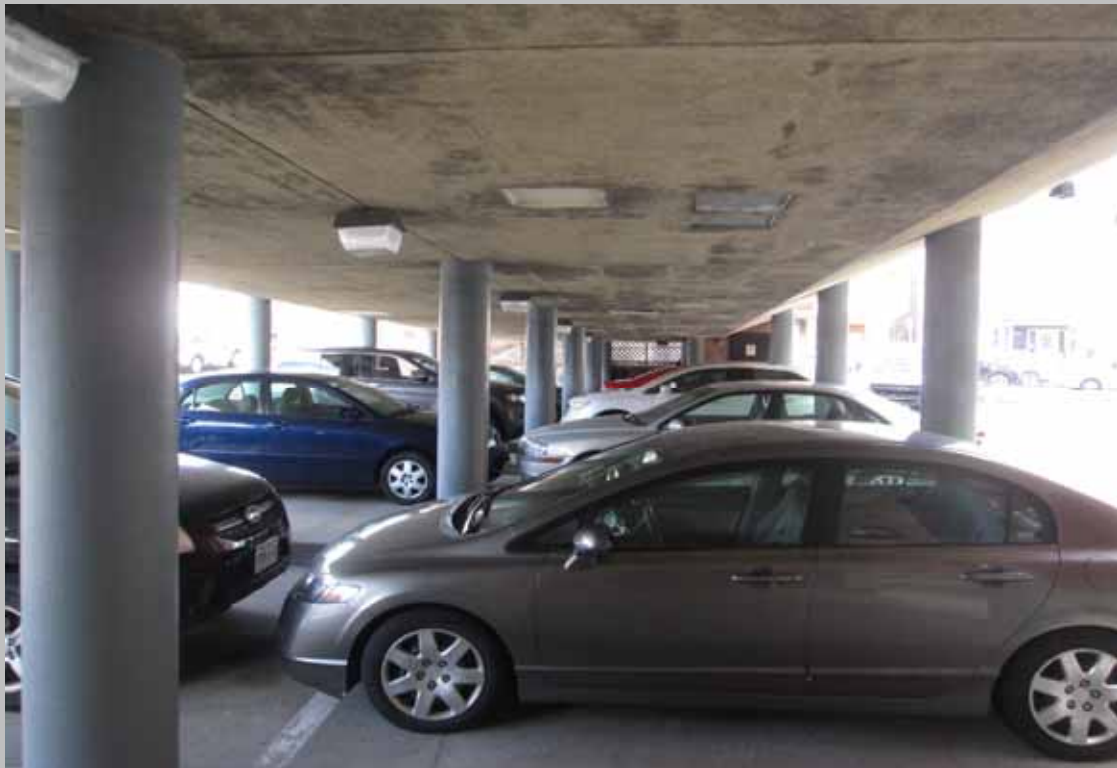
PHOTO #8

Covered/under-building parking

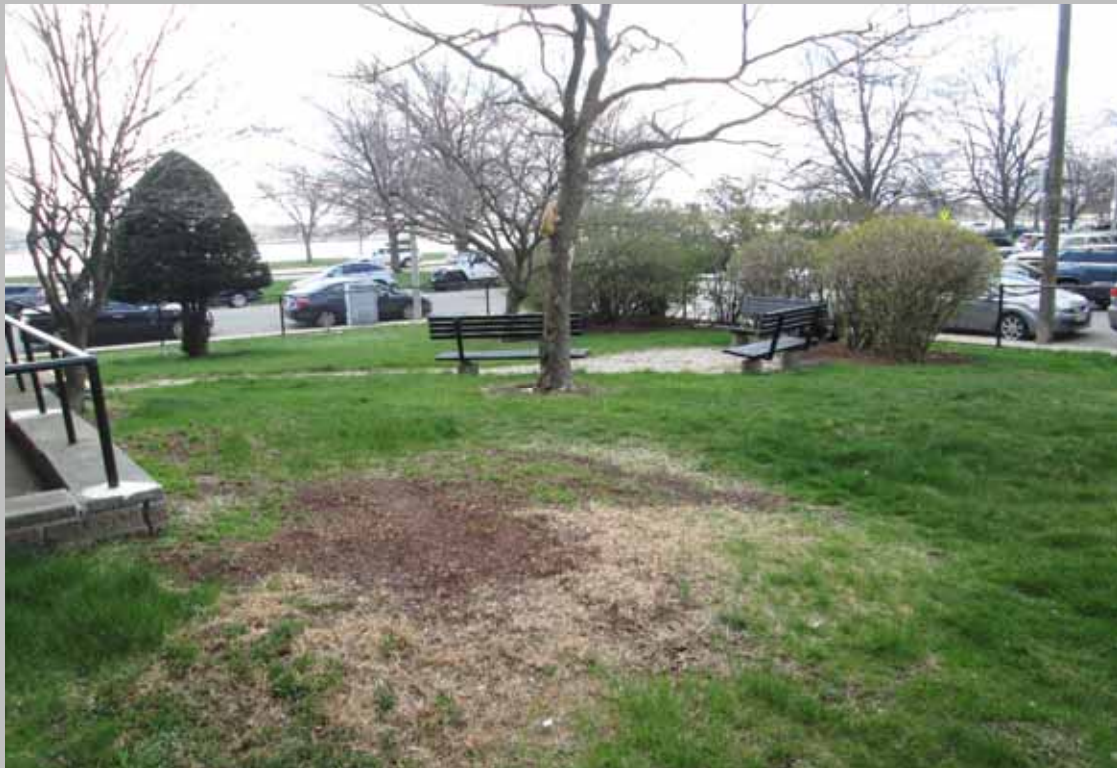
PHOTO #10

Outdoor sitting area

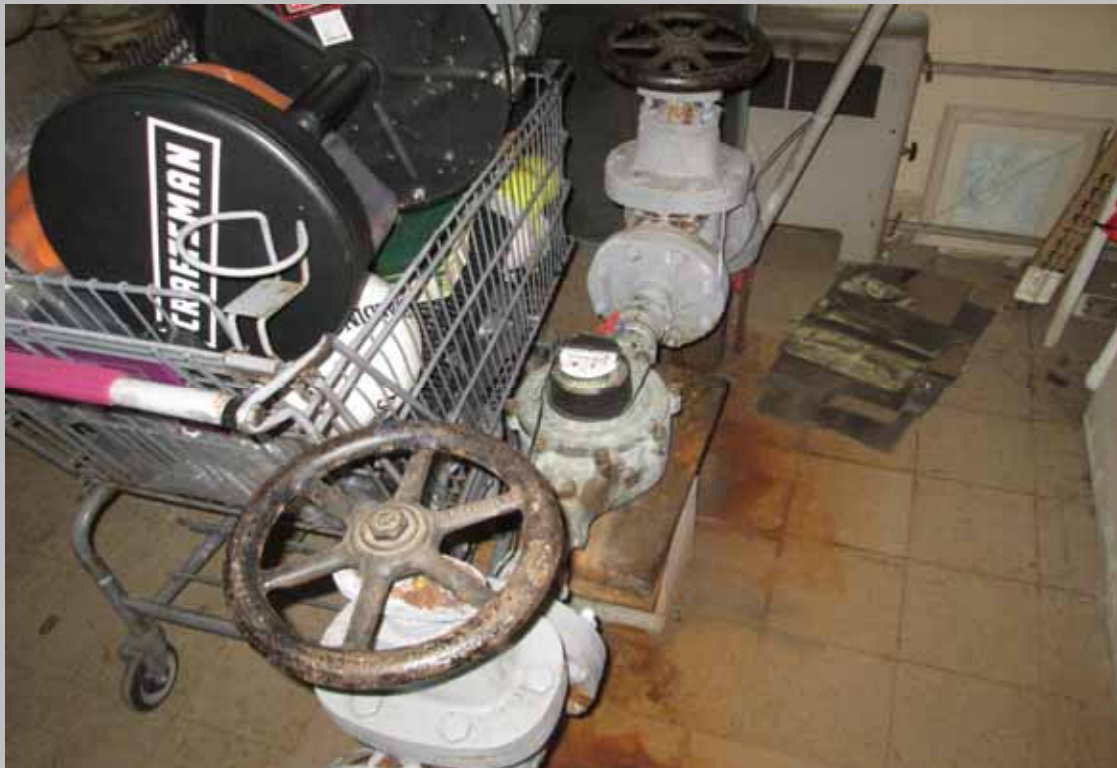
PHOTO #18

Water meter

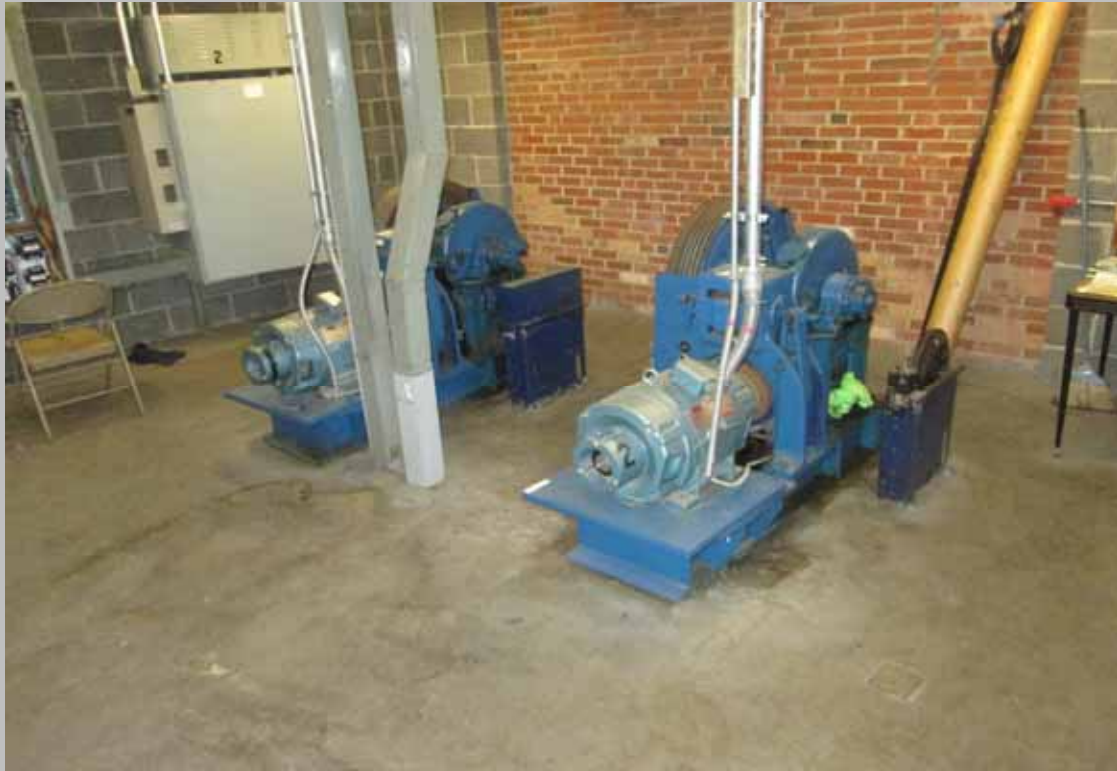
PHOTO #21

Elevator machinery

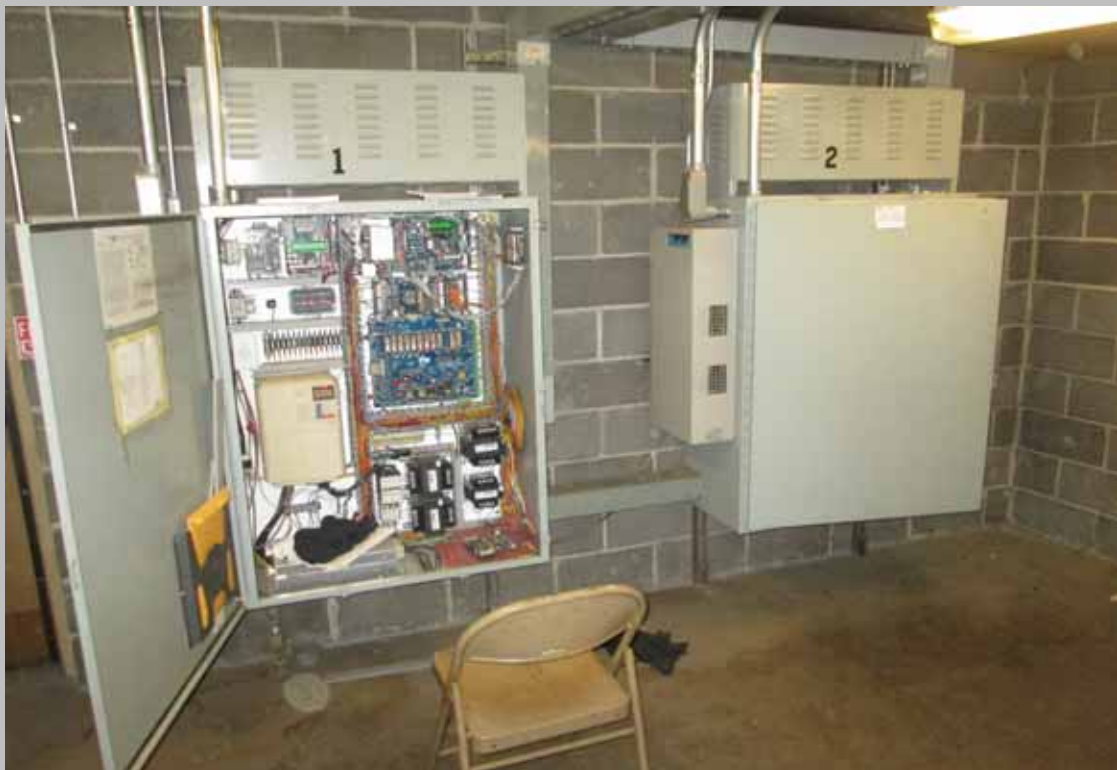
PHOTO #22

Elevator controls

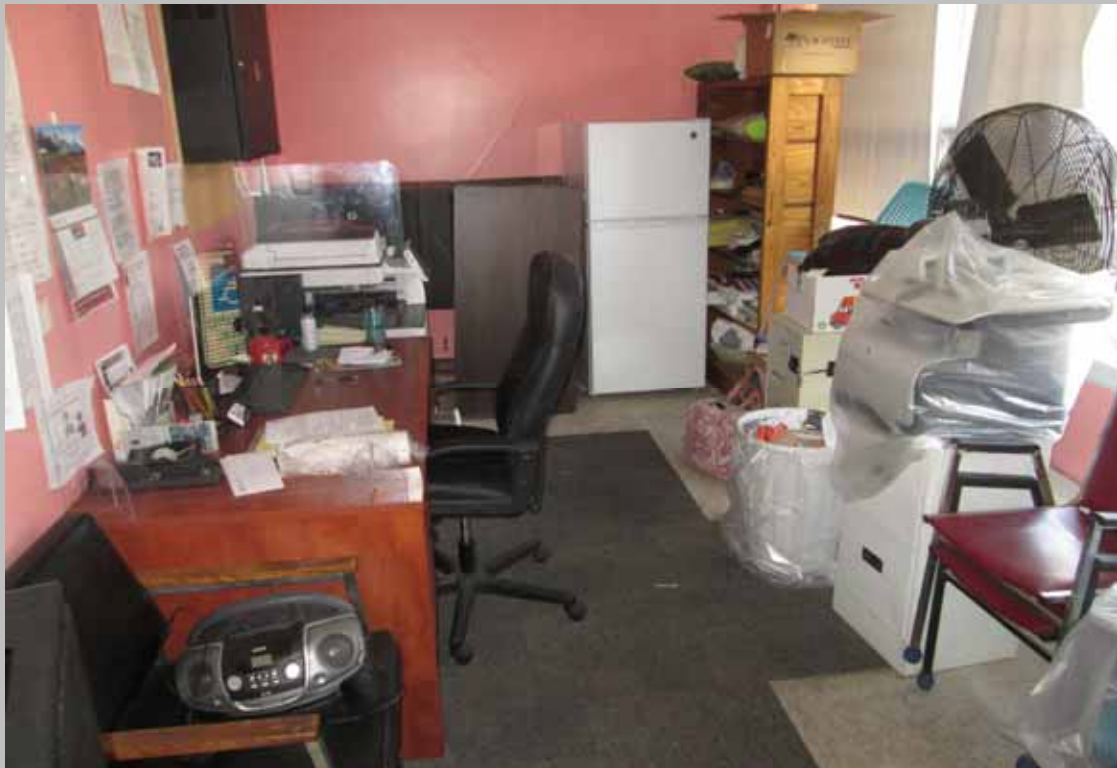
PHOTO #30

Property management office

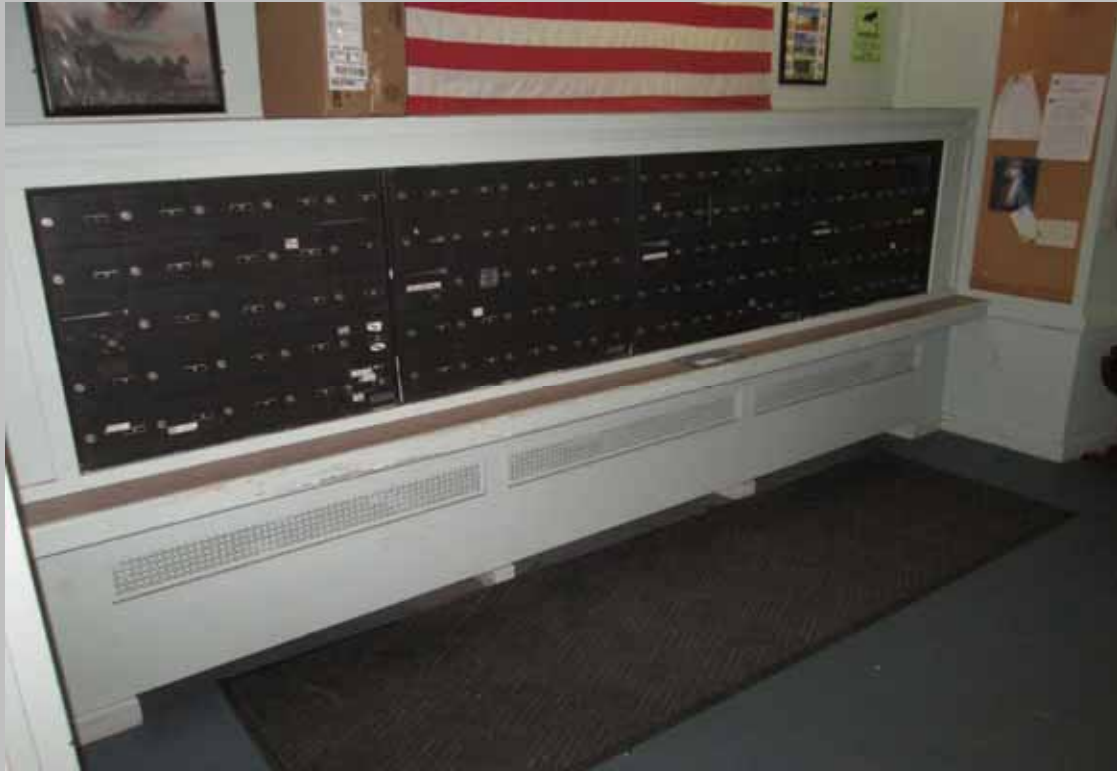
PHOTO #33

Mail kiosk

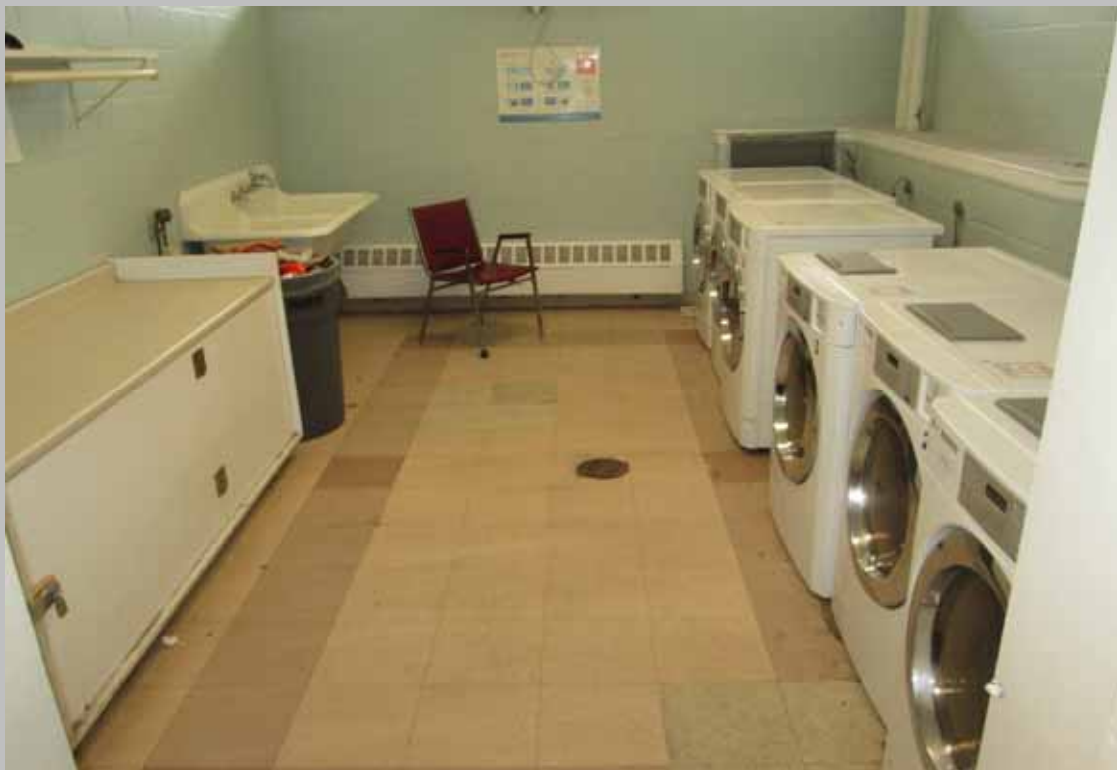
PHOTO #34

Common laundry room

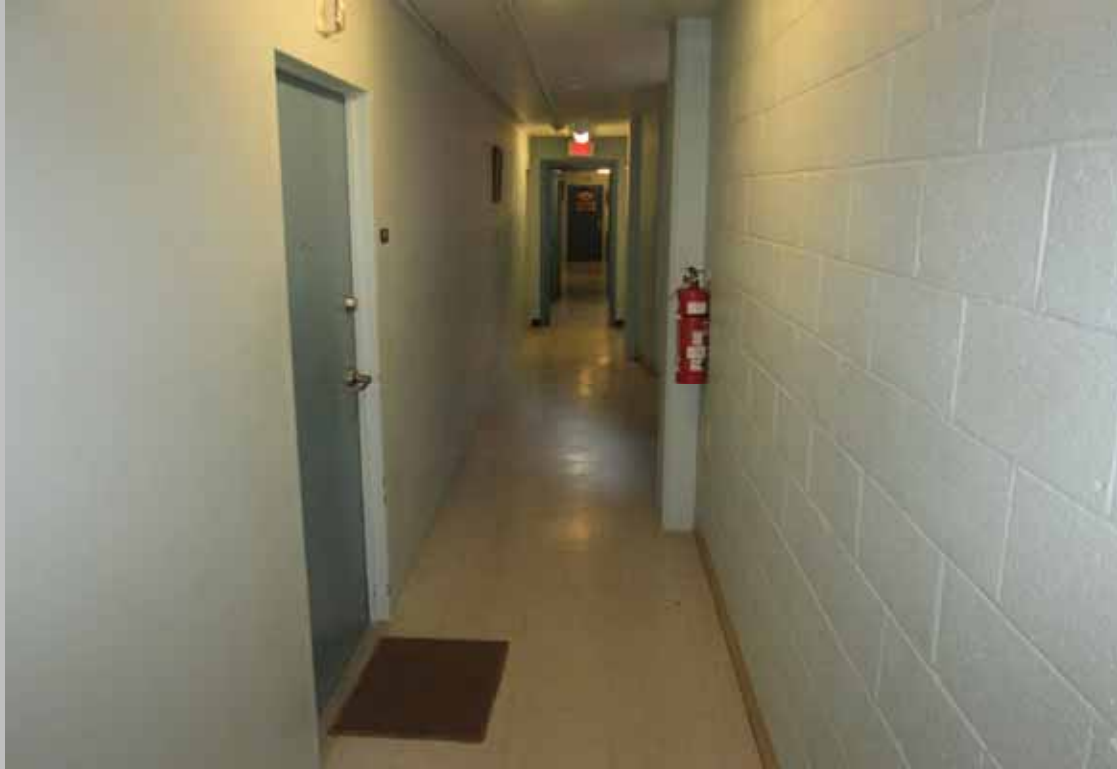
PHOTO #35

Common hallway/corridor

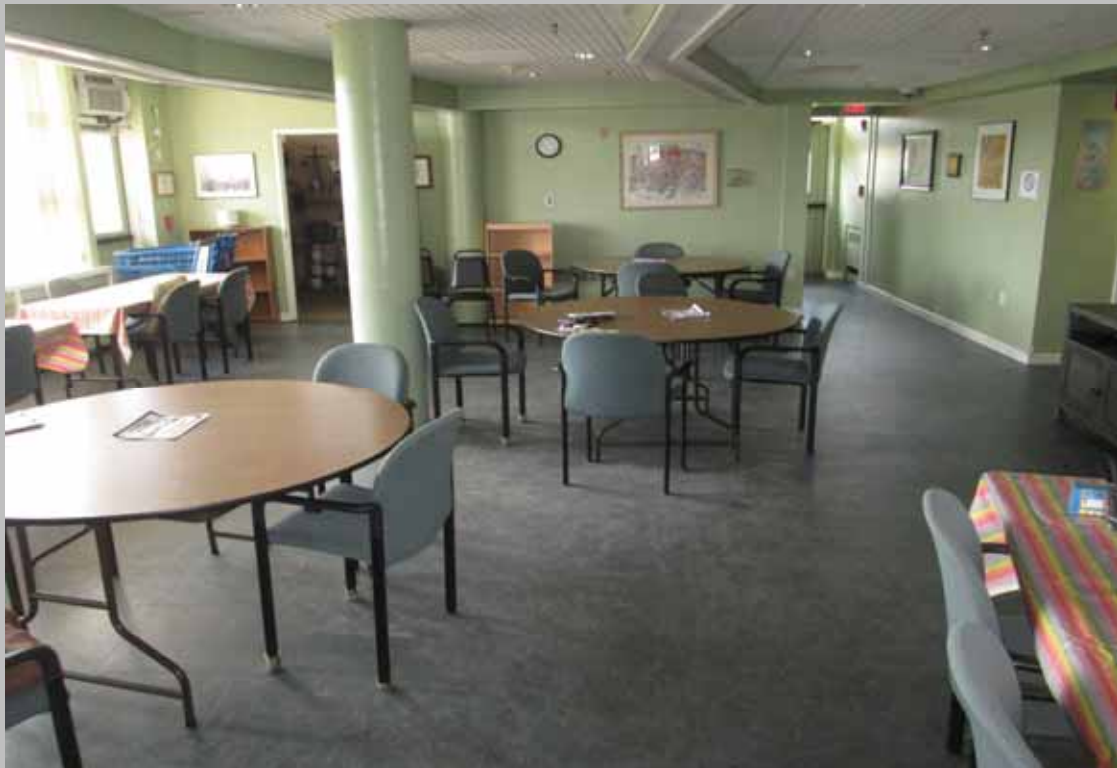
PHOTO #36

Community room

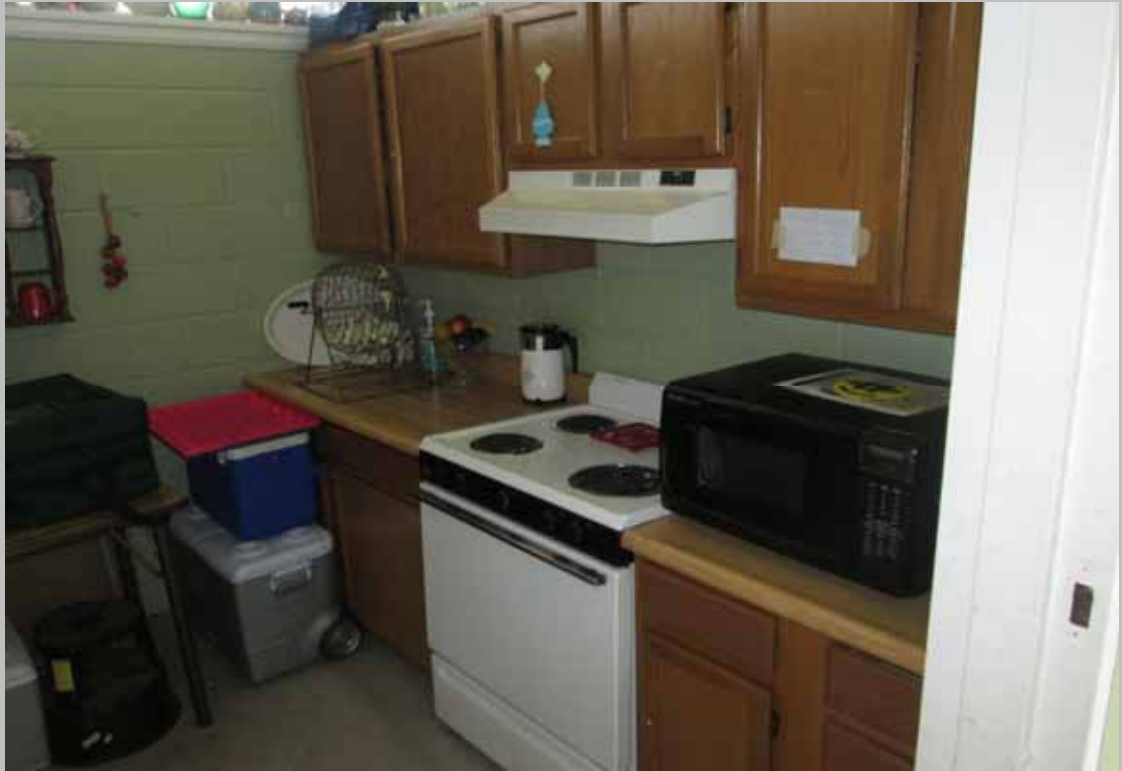
PHOTO #37

Community kitchen

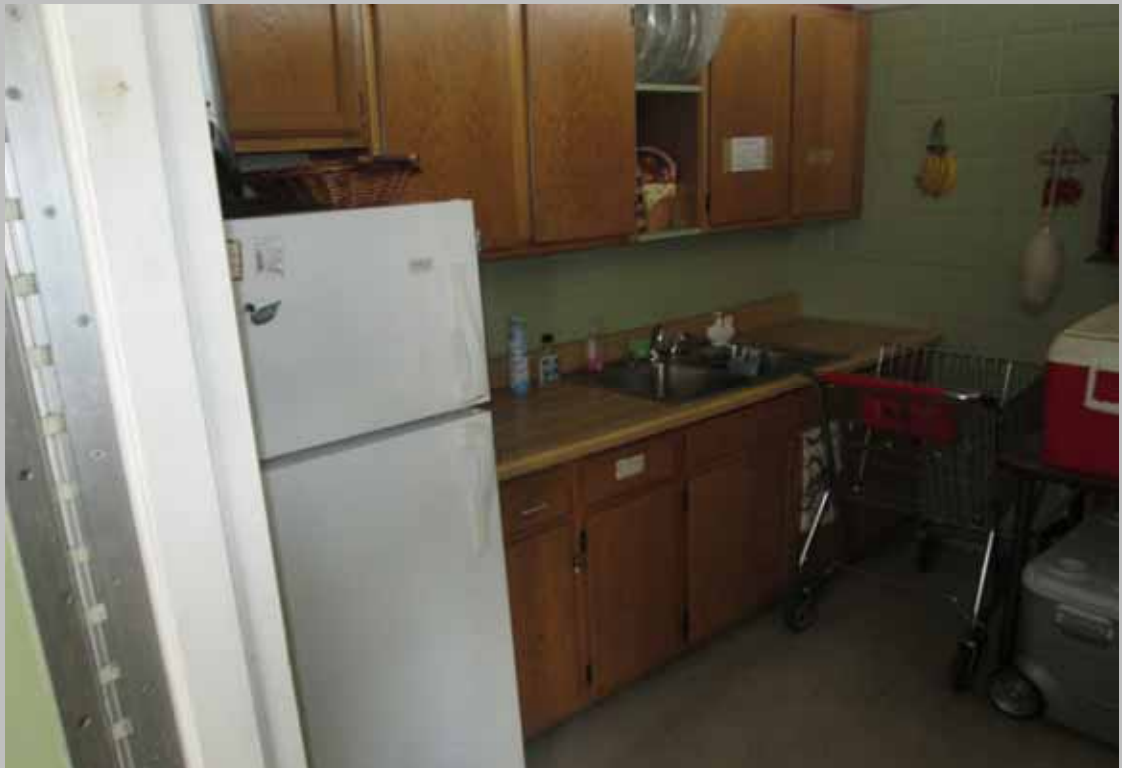
PHOTO #38

Community kitchen

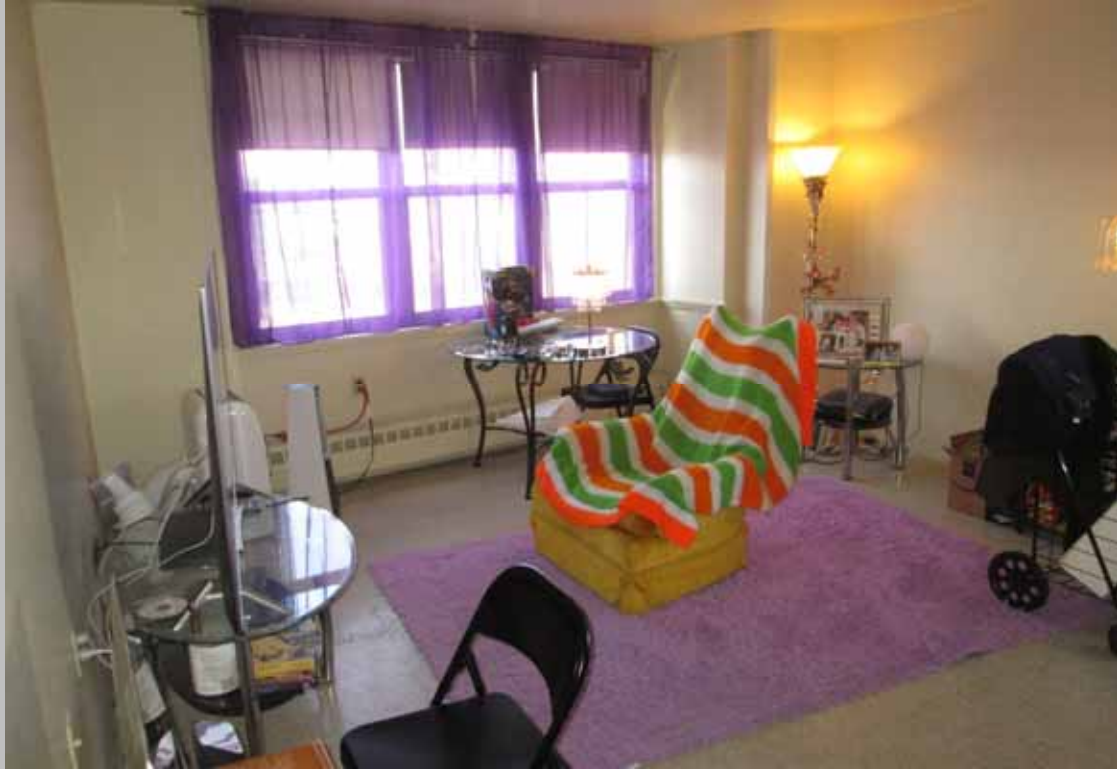
PHOTO #39

Typical dwelling unit living room

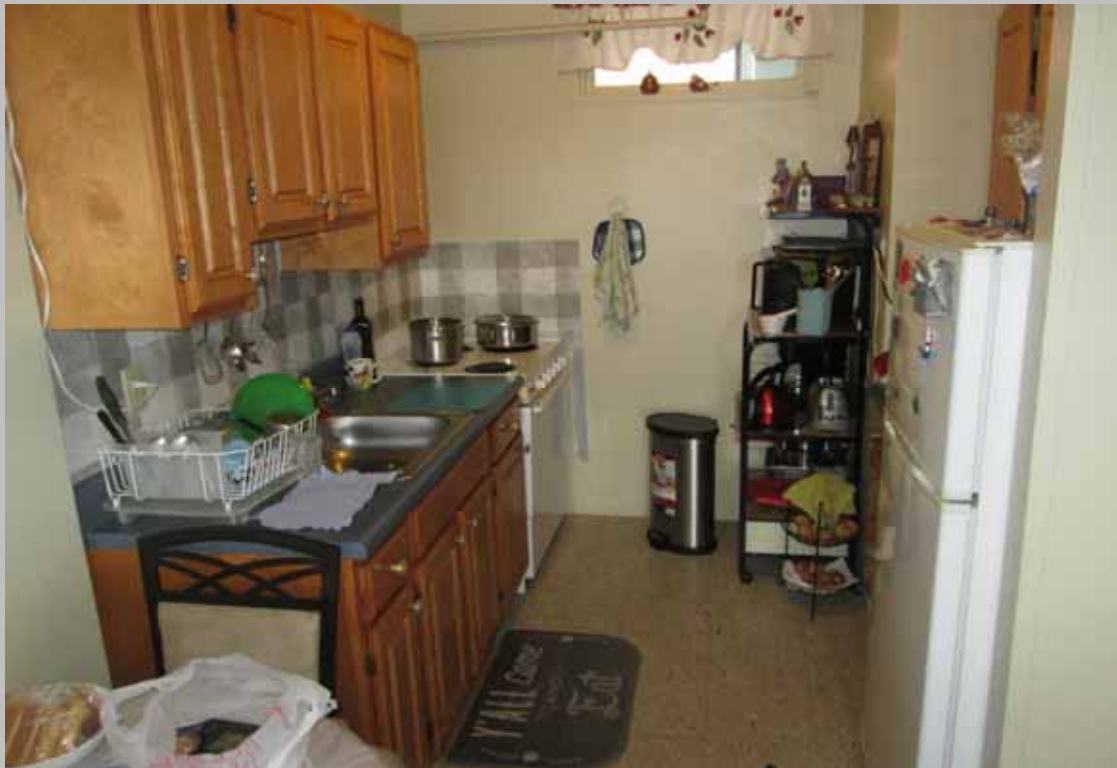
PHOTO #40

Typical dwelling unit kitchen

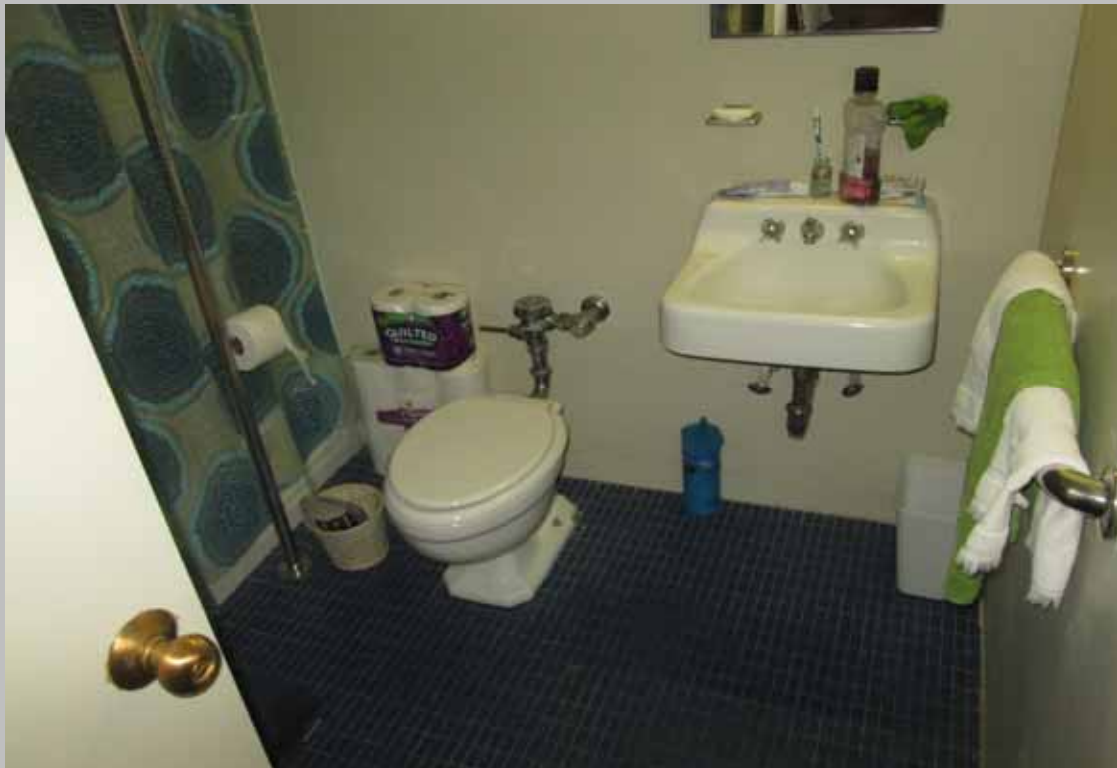
PHOTO #42

Typical dwelling unit bathroom

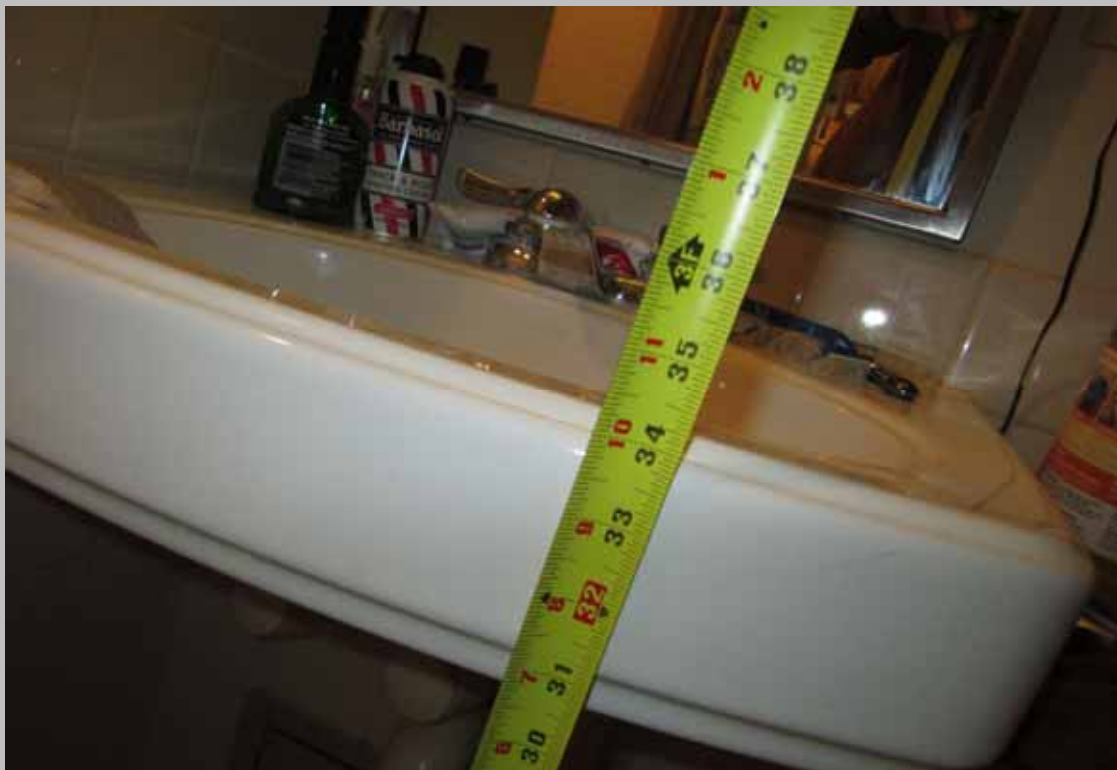
PHOTO #54

HC unit with compliant bathroom sink height

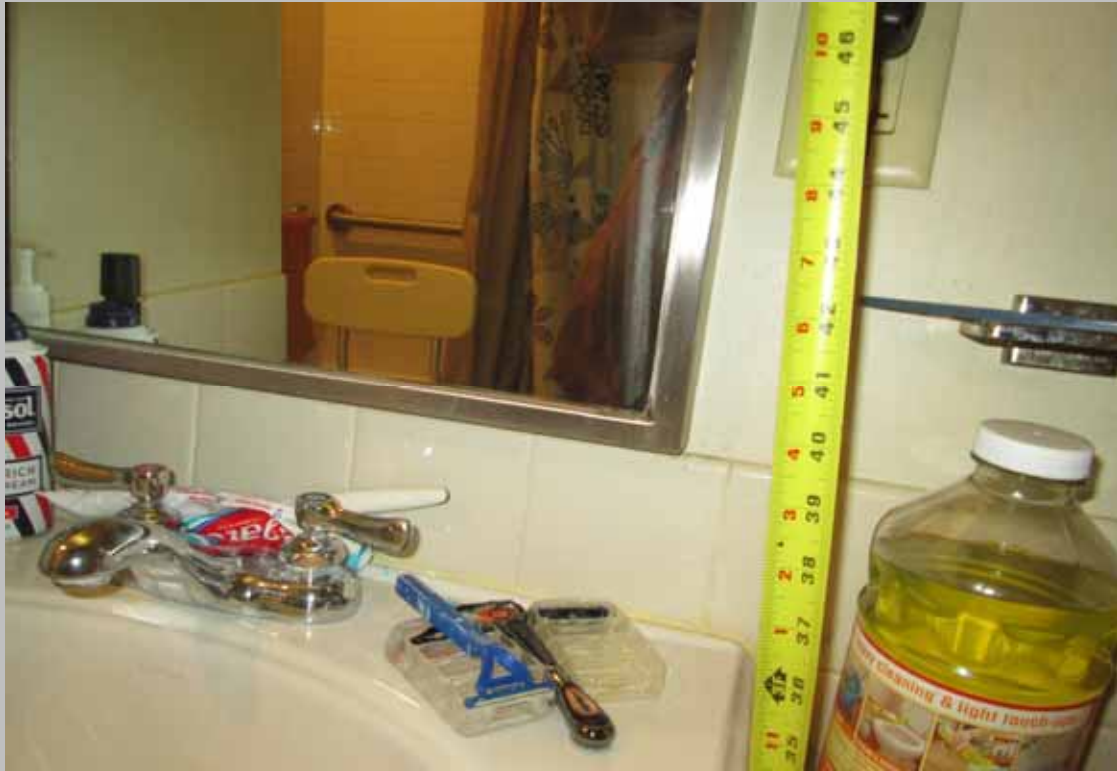
PHOTO #55

HC unit with compliant mirror height

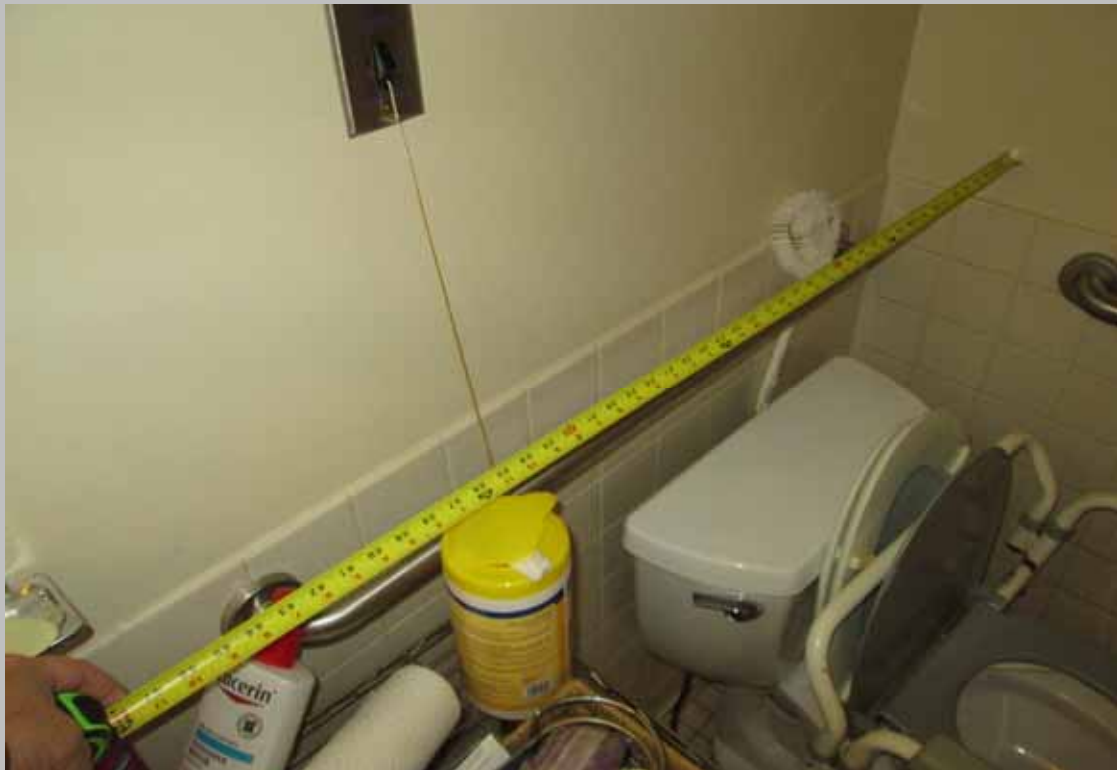
PHOTO #58

HC unit with compliant toilet rear grab bar

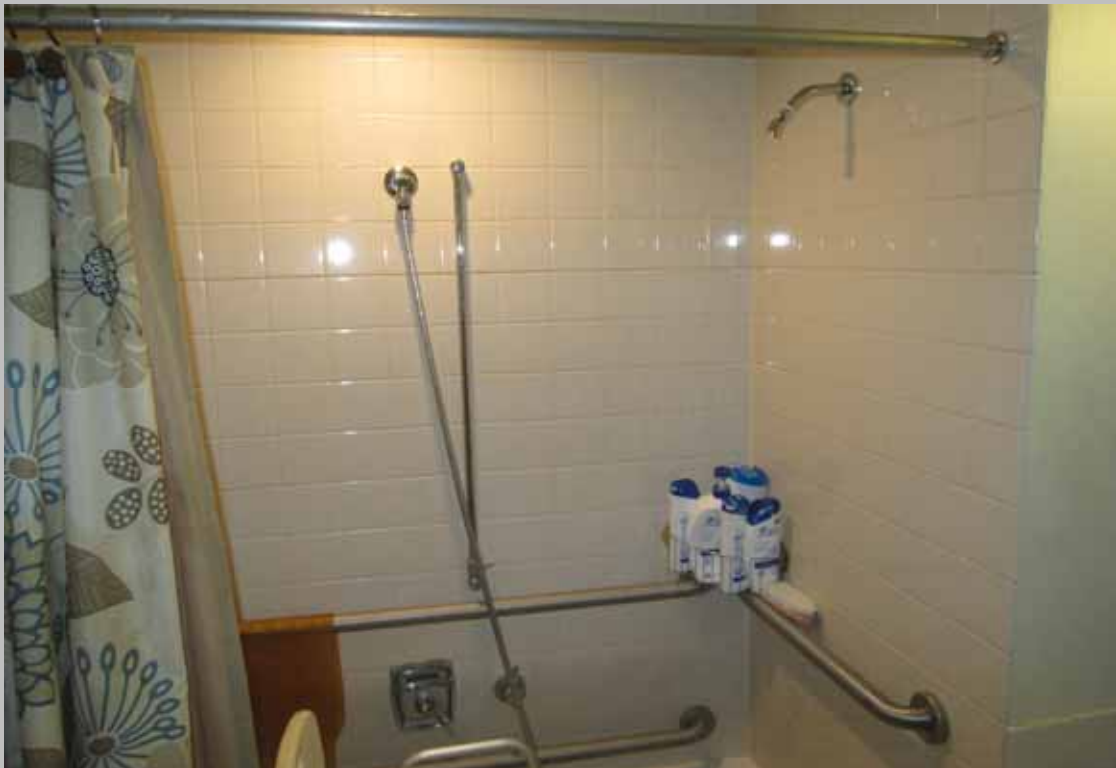
PHOTO #60

HC unit tub with compliant 60-inch shower spray unit
