HUD CAPITAL NEEDS ASSESSMENT

JJ Meade
5 Melville Avenue
Boston, Massachusetts 02124

AEI Project No. 463349
Site Inspection Date: July 27, 2022

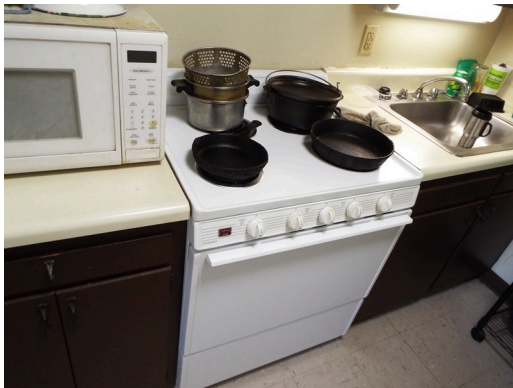
1-bed-1-bath - unit 6 - typical range

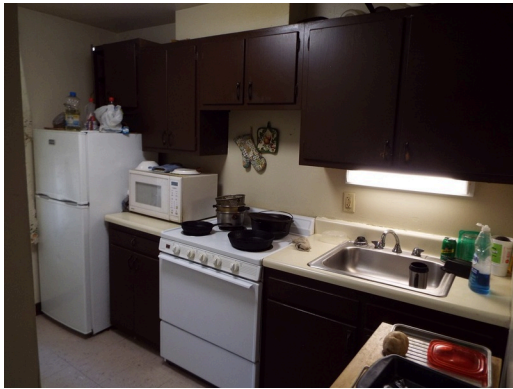
1-bed-1-bath - unit 6 - kitchen cabinets
(older)

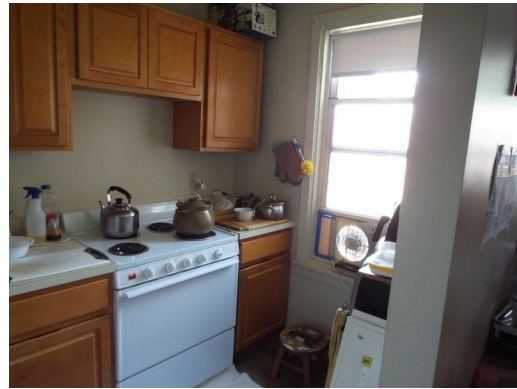
2-bed-1-bath - unit 40 - kitchen cabinets
(newer)

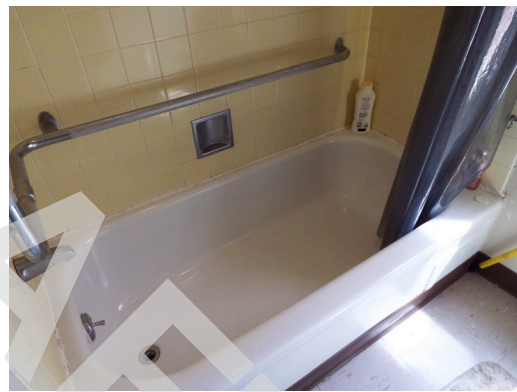
1-bed-1-bath - unit 6 - tub shower

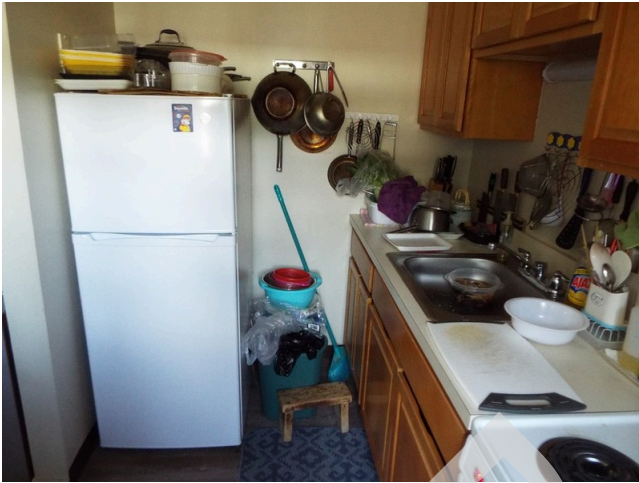
60. 2-bed-1-bath - unit 40 - kitchen cabinets (newer)

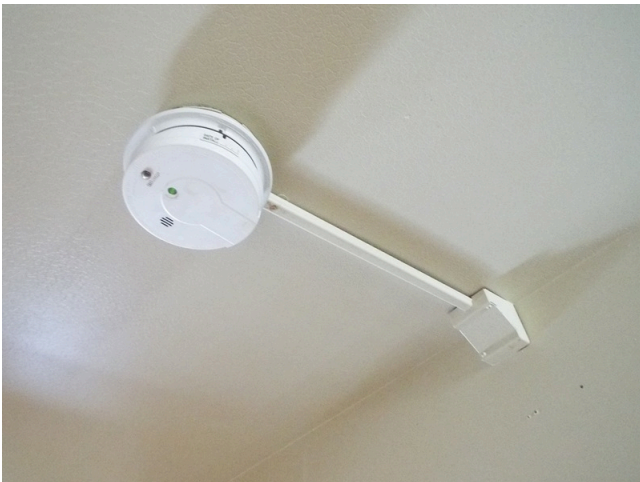
74. 1-bed-1-bath - unit 2 - ceiling condition (Non-Critical Repair)

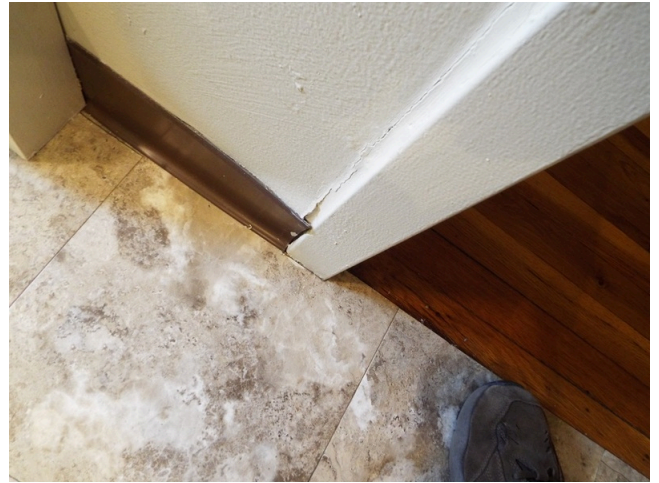
82. 1-bed-1-bath - unit 2

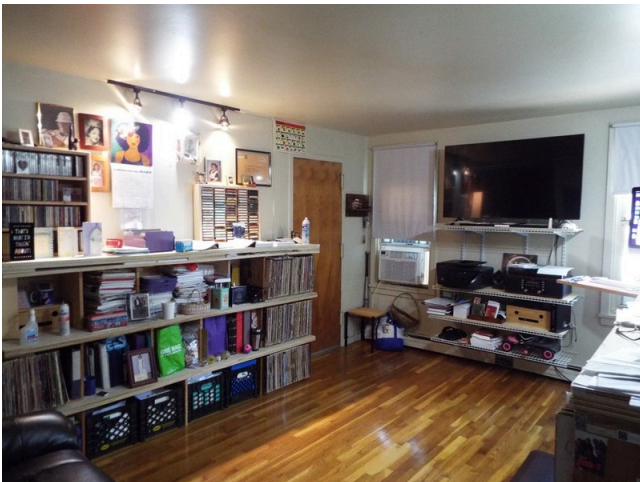
90. 1-bed-1-bath - unit 2 - baseboard heat cover condition (Non-Critical Repair)

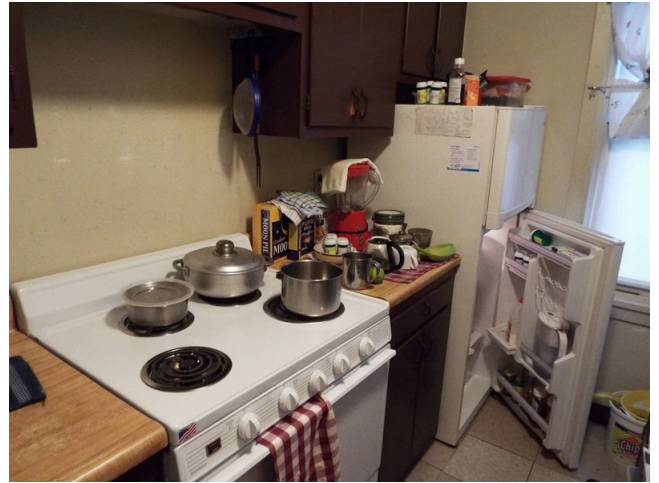
113. 1-bed-1-bath - unit 15 - typical kitchen GFCI receptacle

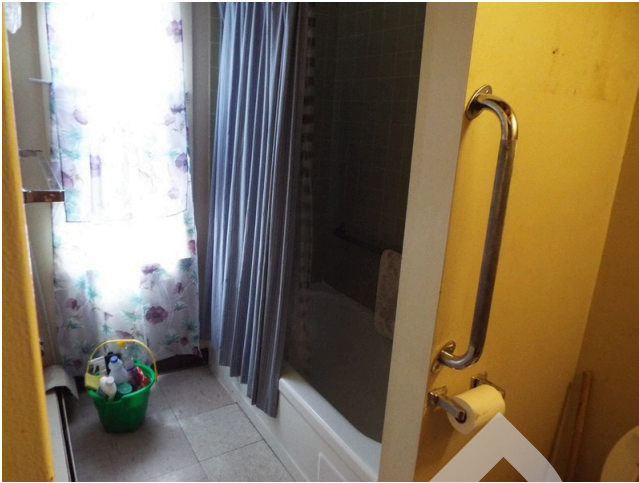
116. 1-bed-1-bath - unit 15 - ceiling condition (Non-Critical Repair)

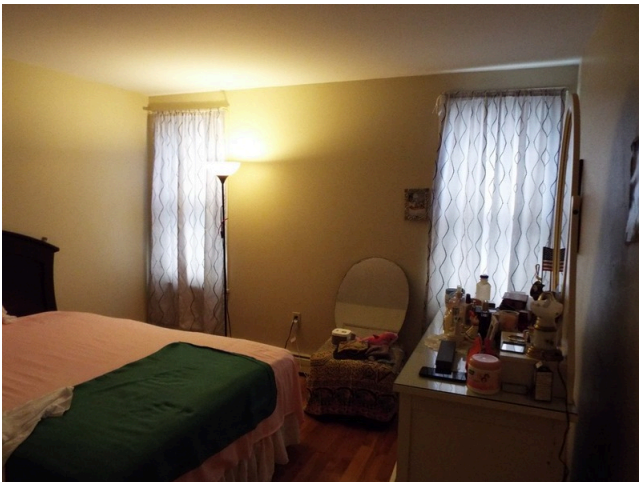
118. 1-bed-1-bath - unit 15 - ceiling condition (Non-Critical Repair)

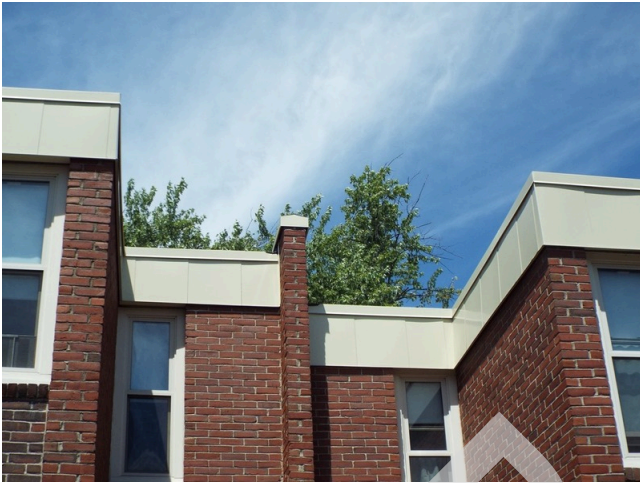
48. Brick masonry condition
