HUD CAPITAL NEEDS ASSESSMENT

Groveland
15 Mary Moore Beatty Circle
Mattapan, Massachusetts 02126

AEI Project No. 463353
Site Inspection Date: July 7, 2022

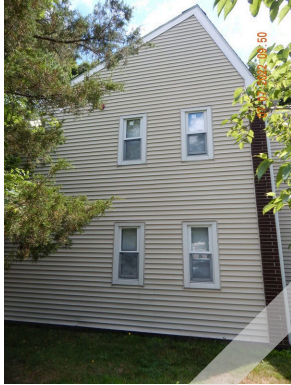
Windows: Typical single-hung style double-pane vinyl windows found throughout the site.

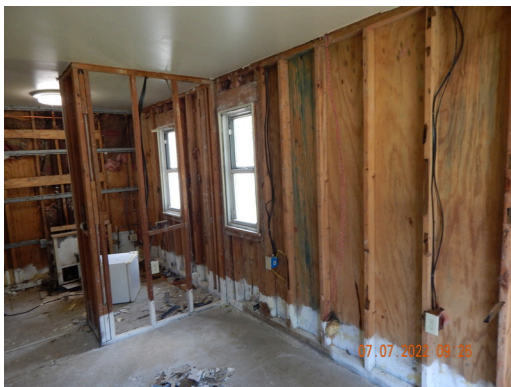
Dwelling Unit Interior Elements: Unit 26 gutted and unfinished. (Critical Repair)

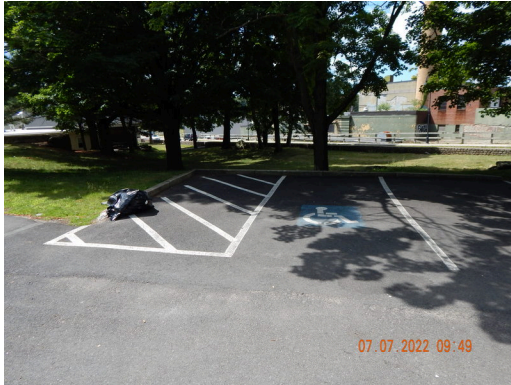
Paving, Curbing, & Parking: Typical accessible parking spaces found throughout the property, missing vertical sign (Critical Repair)

- The common unisex accessible restroom was observed to not have wheelchair-accessible designation signage. Installation of signage is recommended to comply with ADAAG design requirements. (Critical Repair)
- The HDCP parking space is missing a vertical sign (Critical Repair).

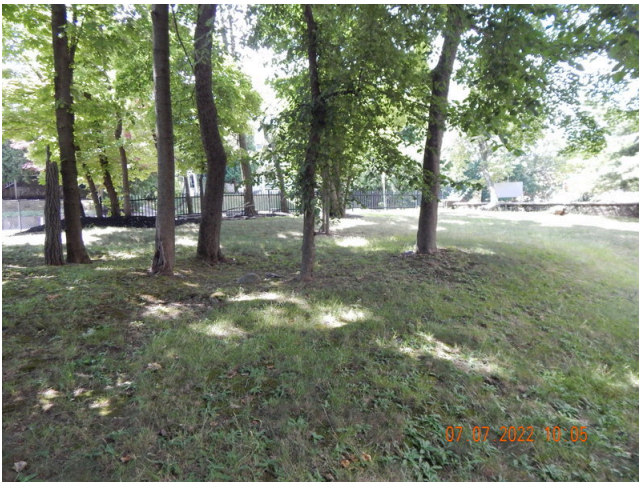
26. Landscaping & Appurtenances: Typical landscaping found throughout at the property.

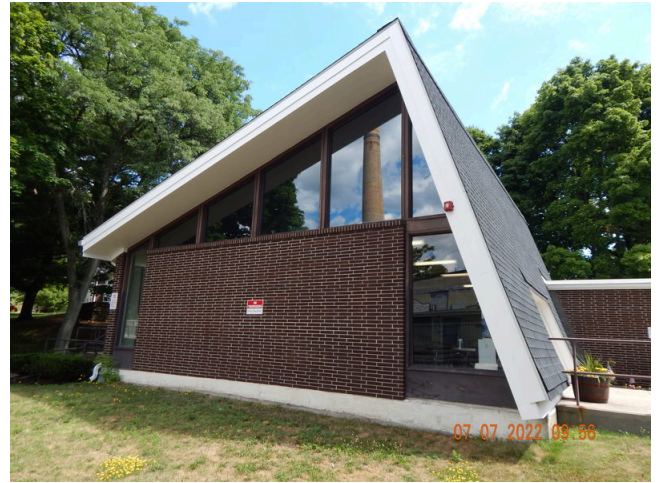
97. Sidewall System: Community Building east facade.

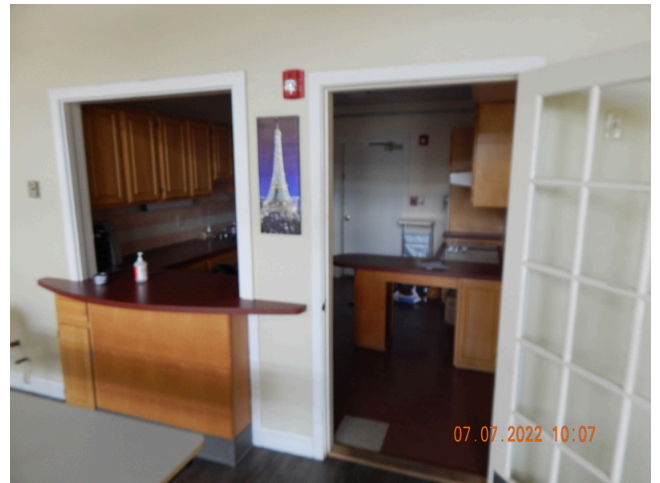
138. Common Area Interior Elements: Community Kitchen.

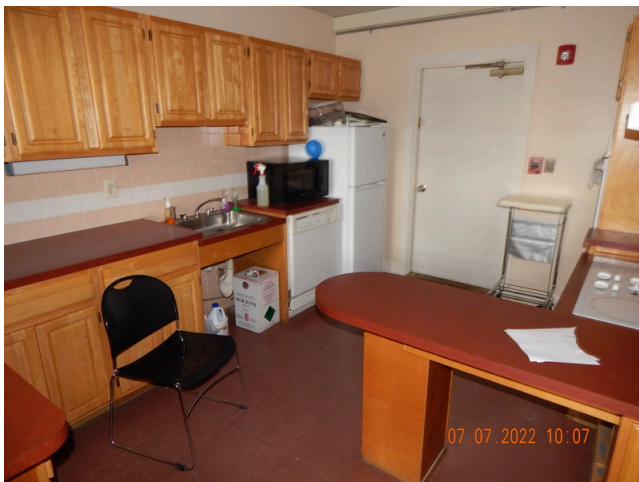
139. Common Area Interior Elements: Community Kitchen.

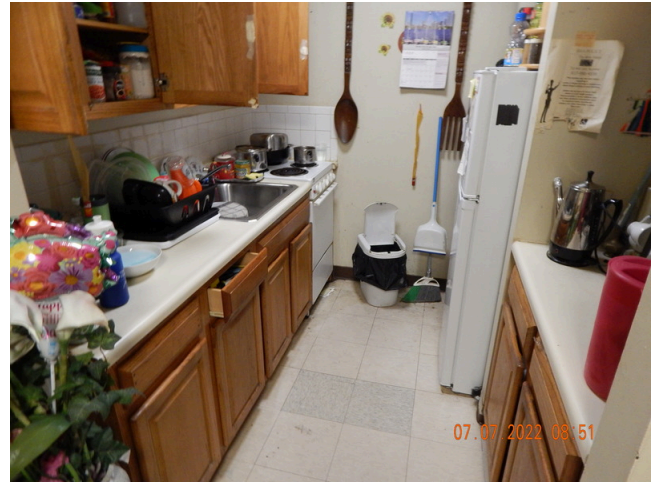
150. Appliances: Typical appliance package found throughout the site.

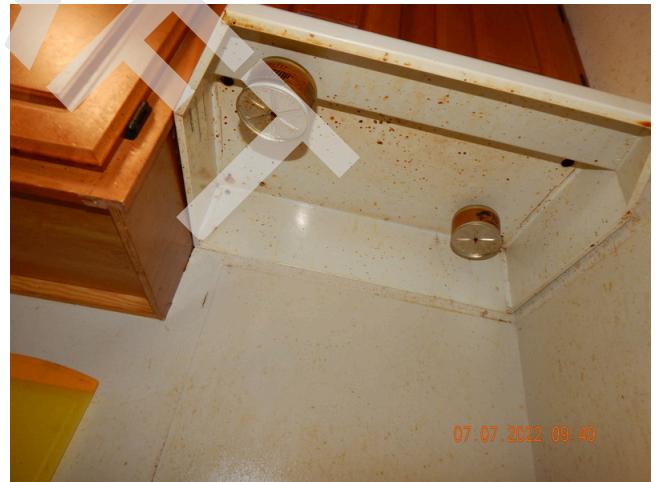
152. Appliances: Typical faux rangehood found throughout the site.
