## HUD MAP CAPITAL NEEDS ASSESSMENT

Annapolis  
52 Sumner Street  
Dorchester, Massachusetts 02125

AEI Project No. 463356  
Site Inspection Date: July 6, 2022

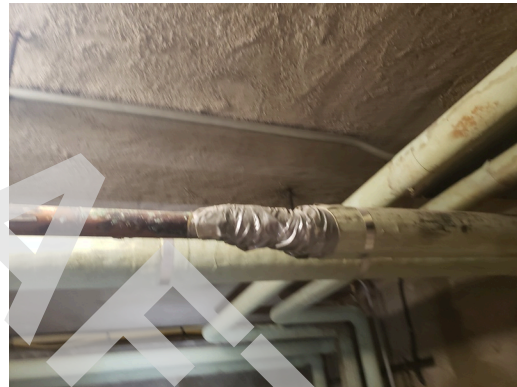
Plumbing: Typical corroded pipes found throughout the property. (Non-Critical Repair)

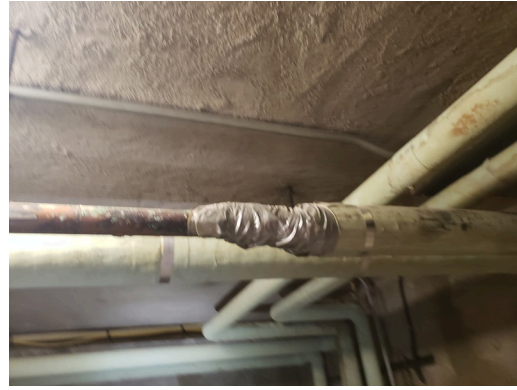
Sections of pipe corrosion were observed in the basement on 15-19 Basketfield st. The pipes showed signs of deterioration that will cause significant leaks in the short term. Therefore, AEI recommends addressing the issue causing the corrosion and replacing any damaged piping sections. (Non-Critical Repair)

Plumbing: Typical corroded pipes found throughout the property. (Non-Critical Repair)

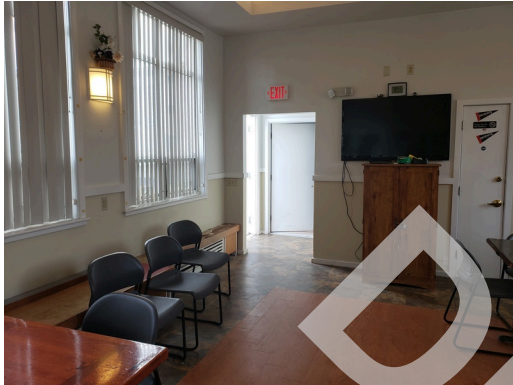
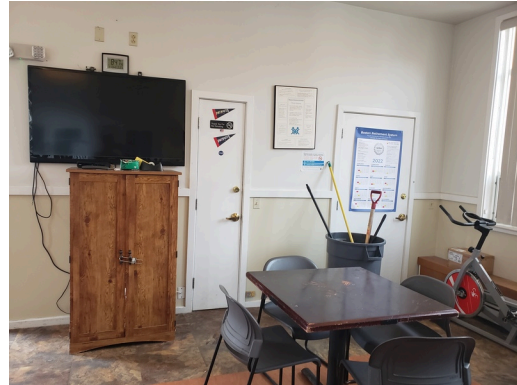
Common Area Interior Elements: Community room.

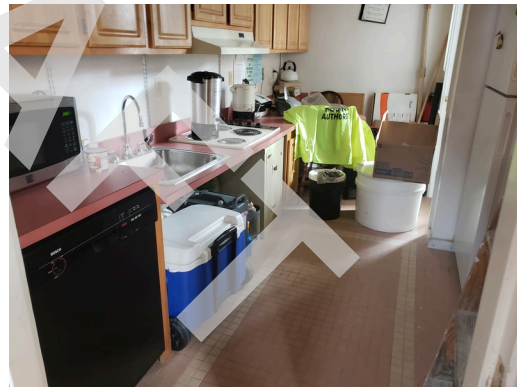
Common Area Interior Elements: Community Kitchen.

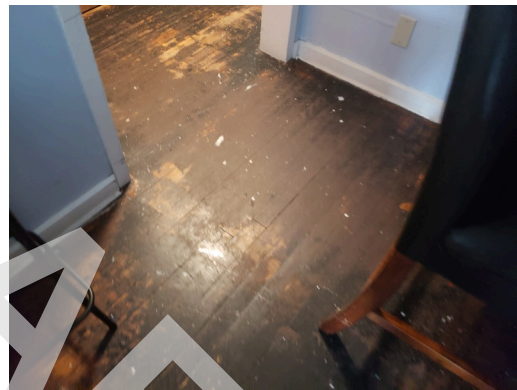
Dwelling Unit Interior Elements: Damaged finishes observed in unit 4. (Non-Critical Repair)

Units 4 and 20 were observed with damaged finishes ranging from damaged doors, wood flooring, vinyl flooring, and paint. The tenants reported that the damages were present when they moved in, and work orders had been issued. AEI recommends addressing this and any other work order that has not been addressed. (Non-Critical Repair)

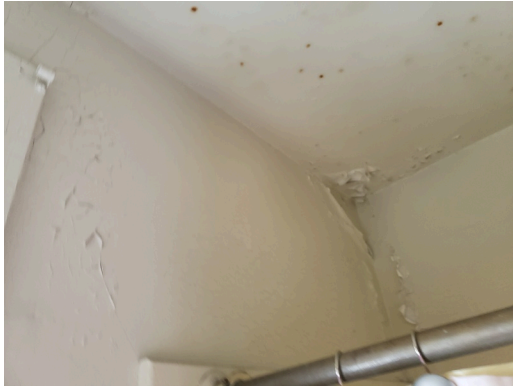
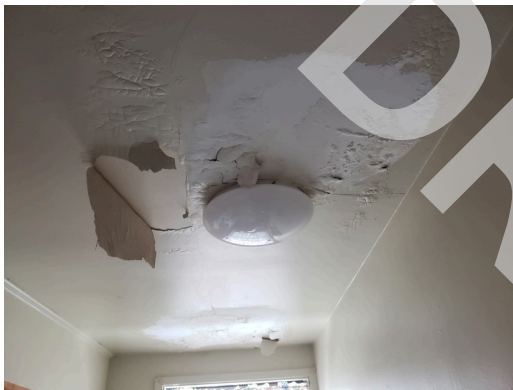
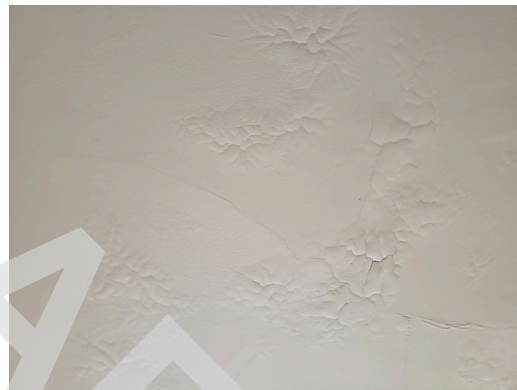
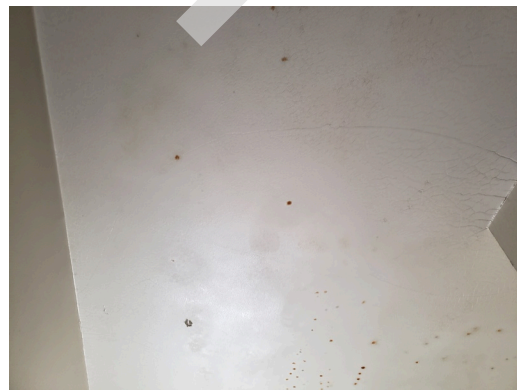
Dwelling Unit Interior Elements: Damaged finishes observed in unit 20. (Non-Critical Repair)

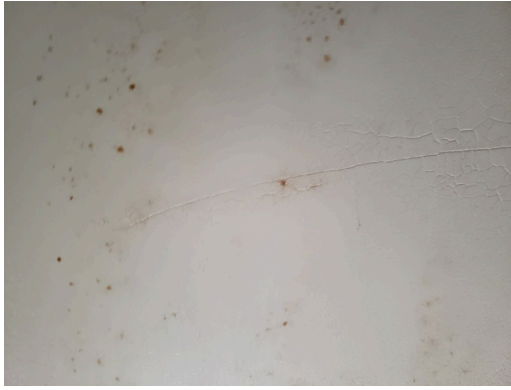
Dwelling Unit Interior Elements: Damaged finishes observed in unit 20. (Non-Critical Repair)

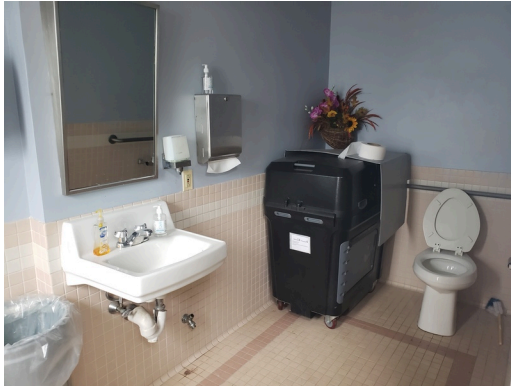
6.	Are grab bars provided in toilet stalls?	✓			
7.	Are sinks provided with clearance for a wheelchair to roll under?	✓			
8.	Are sink handles operable with one hand without grasping, pinching or twisting?		✓		The common restroom sink was observed with knob-style hardware.

UFAS Concern: Common accessible restroom without levered sink hardware. (Critical Repair)

- The common restroom sink was observed with knob-style hardware. Accessibility standards require all sink hardware to be levered style hardware. AEI recommended replacing existing sink hardware to comply with accessibility design standards. (Critical Repair)

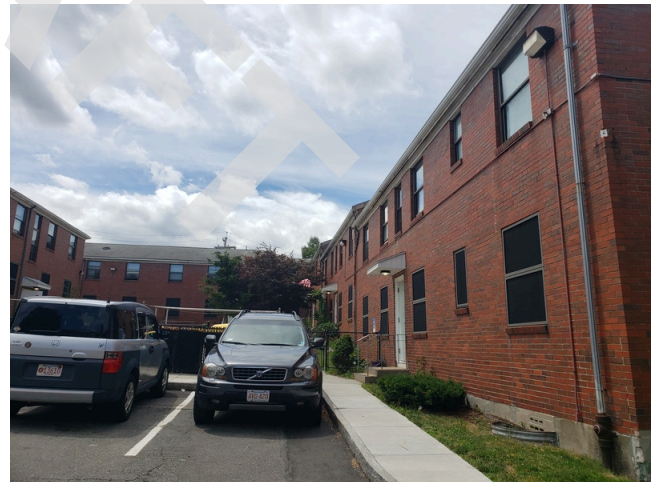
11. Paving, Curbing, & Parking: Typical accessible parking spaces found throughout the property.

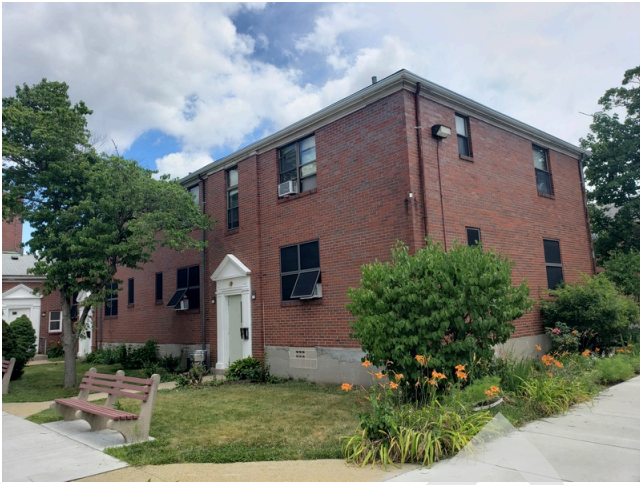
16. Flatwork (Walks, Plazas, Terraces, Patios): Typical concrete sidewalks found at the property.

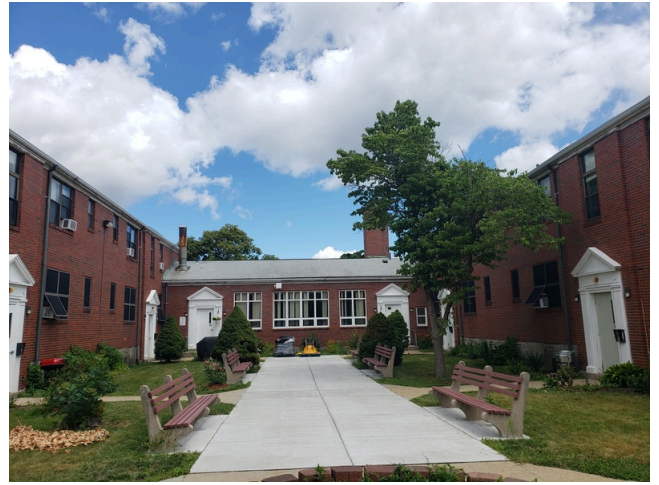
17. Landscaping & Appurtenances: Typical landscaping found throughout at the property.

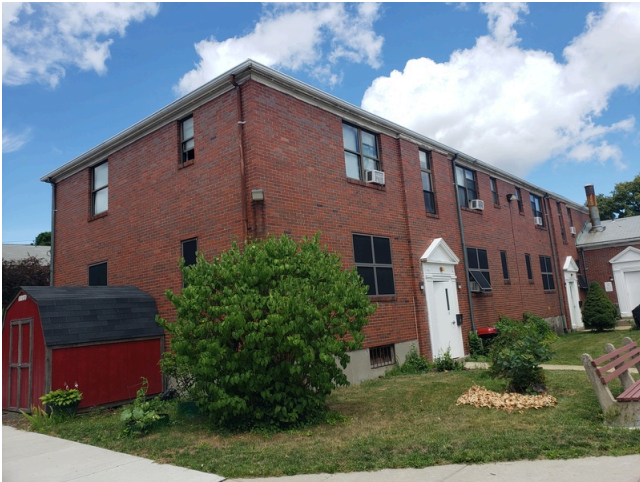
18. Landscaping & Appurtenances: Typical landscaping found throughout at the property.

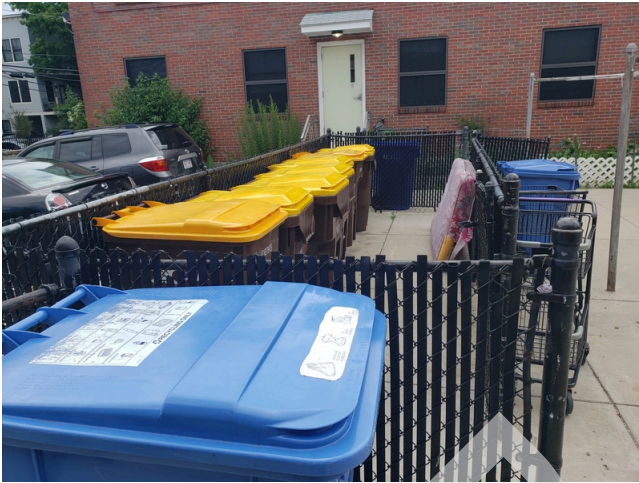
20. Landscaping & Appurtenances: Perimeter wrought iron fencing found on north of the property.

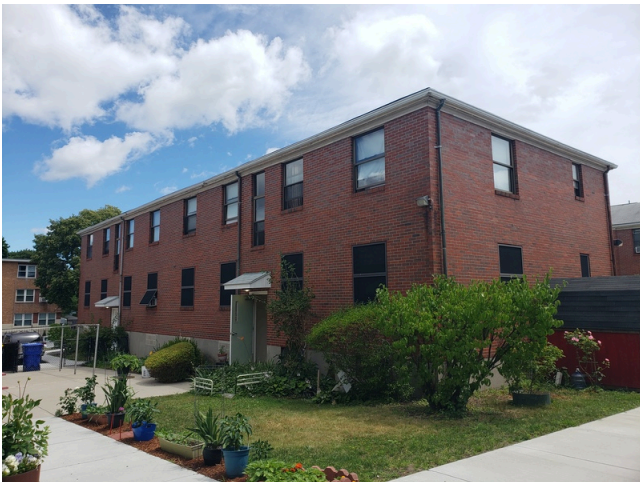
67. Windows: Typical single-hung style double-pane aluminum windows found throughout the site.

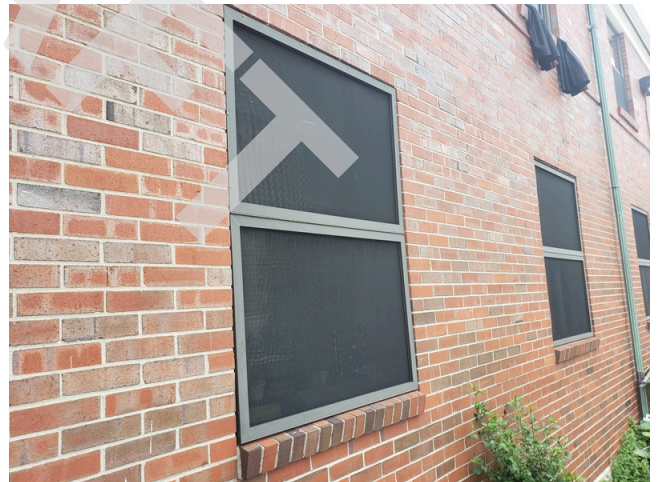
68. Windows: Typical single-hung style double-pane aluminum windows found throughout the site.

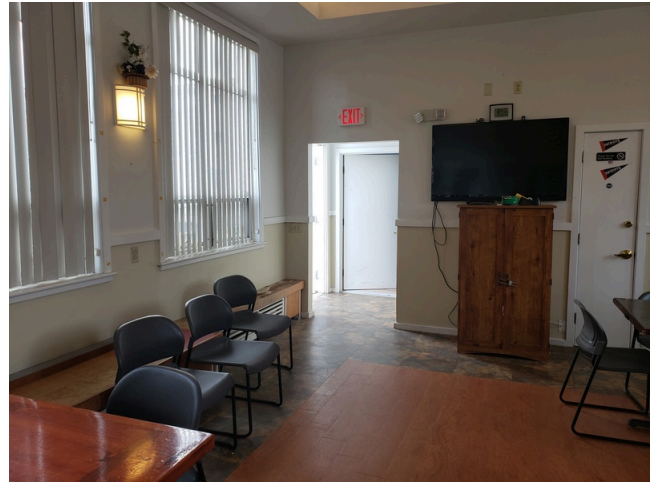
98. Common Area Interior Elements: Community room.

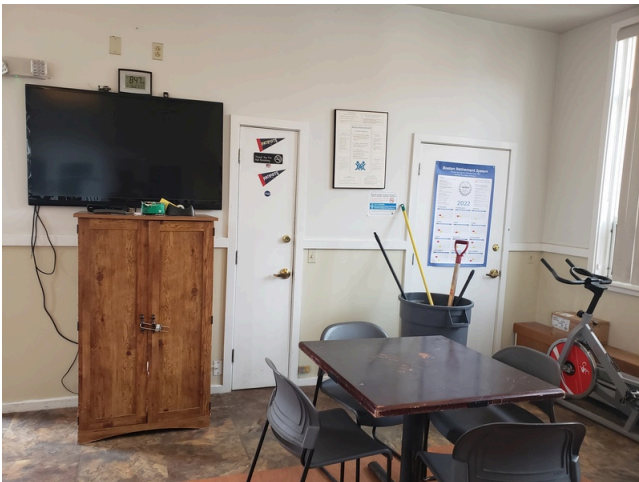
99. Common Area Interior Elements: Community room.

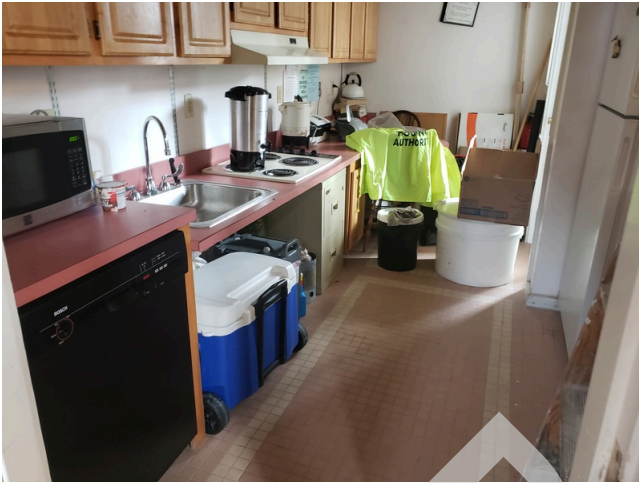
101. Common Area Interior Elements: Community Kitchen.
