**CAPITAL NEEDS ASSESSMENT (CNA)
GENERAL WARREN APARTMENTS (2-44)
114 RUTHERFORD AVENUE
CHARLESTOWN, MASSACHUSETTS 02129**

D3G PROJECT NUMBER:

2021-0374

FINAL REPORT ISSUE DATE:

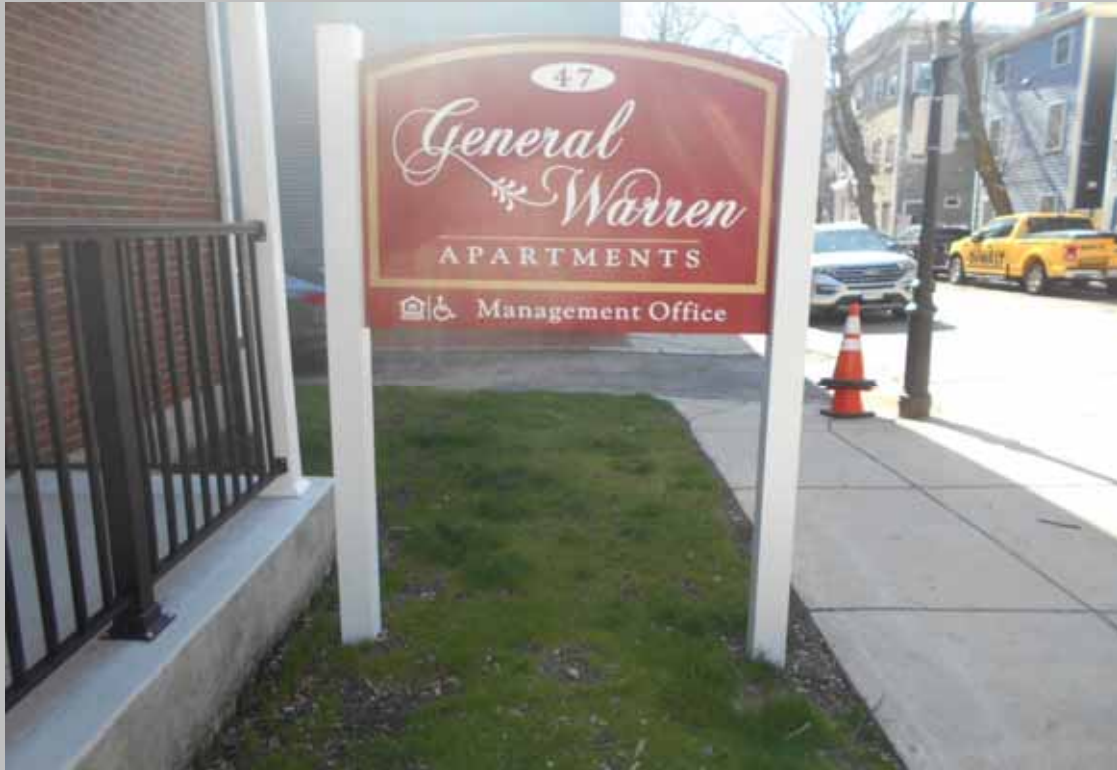
PHOTO #1

Property identification sign

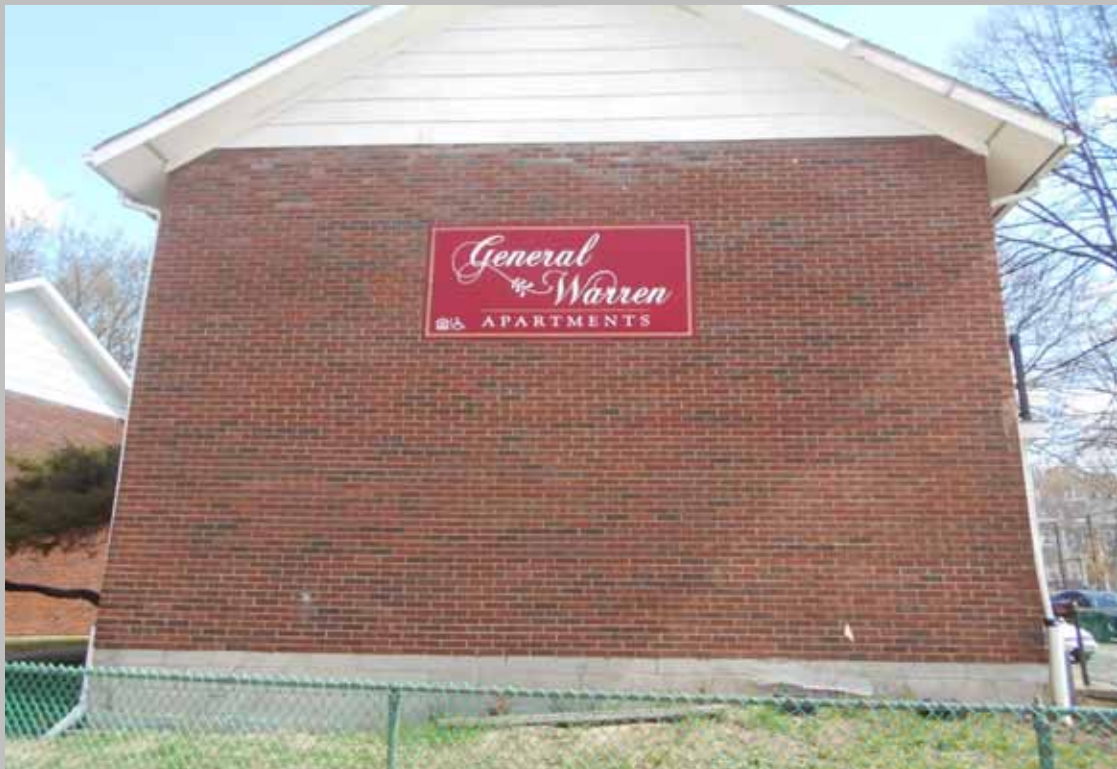
PHOTO #2

Wall-mounted property identification sign

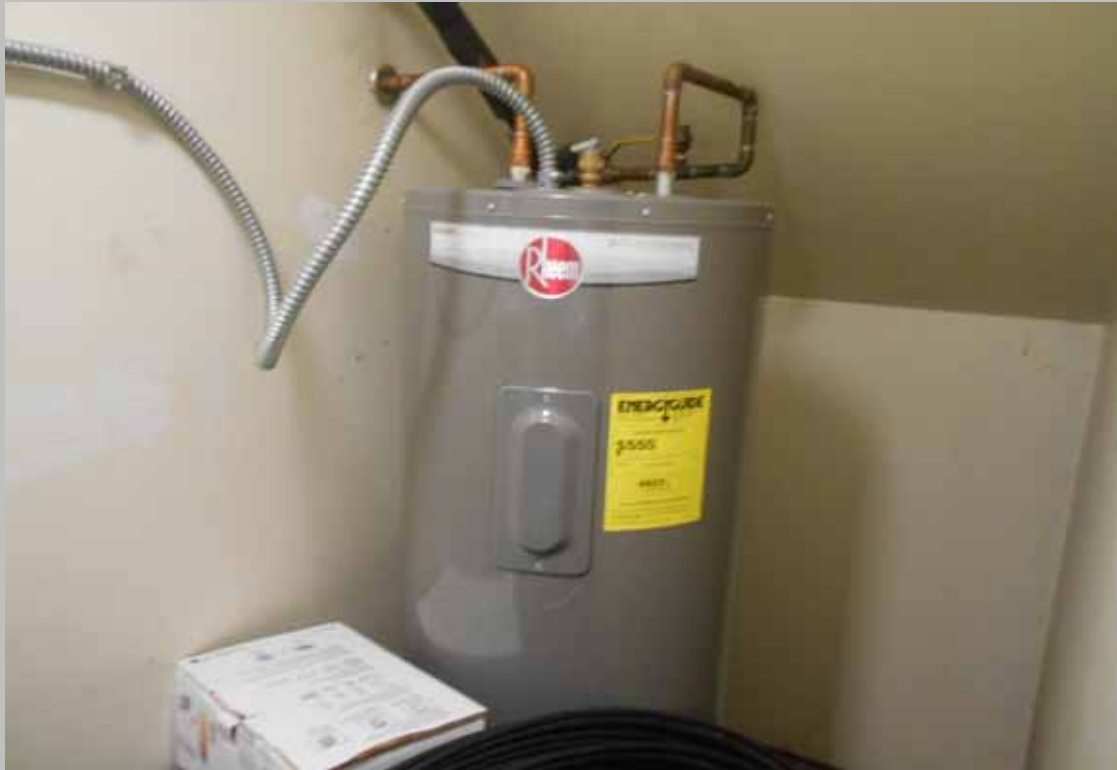
PHOTO #21

Typical electric water heater (dwelling units)

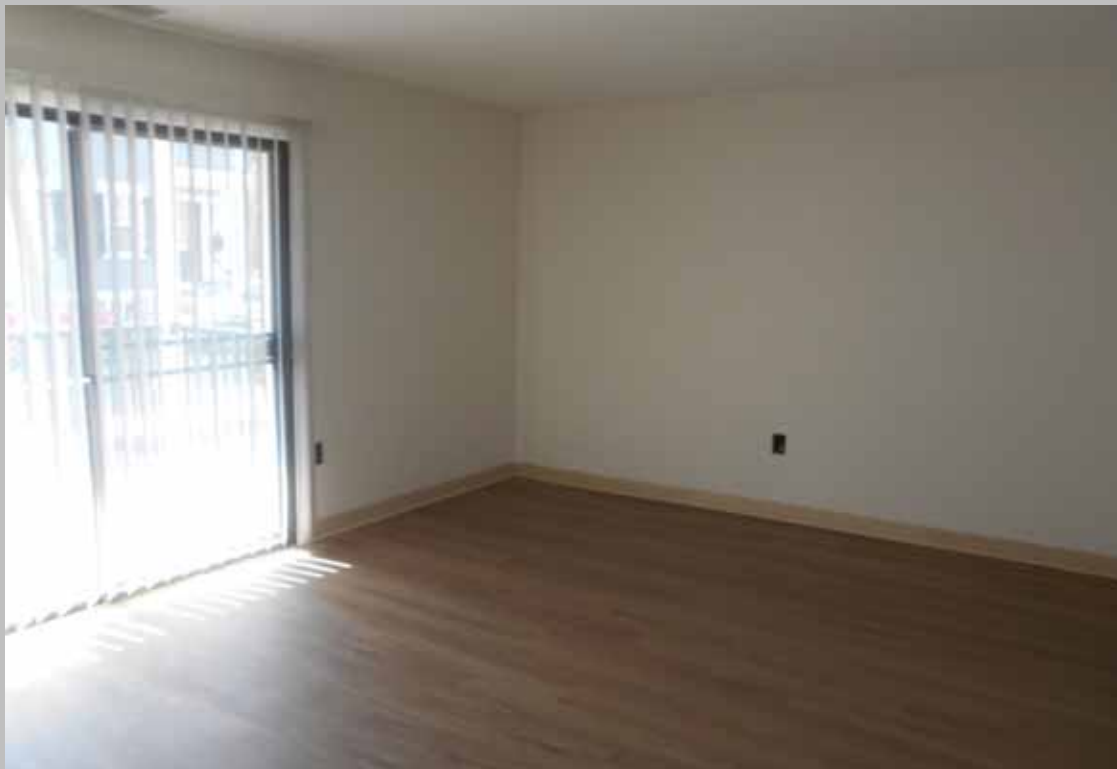
PHOTO #38

1-bedroom dwelling unit – typical living room (new flooring in select units)

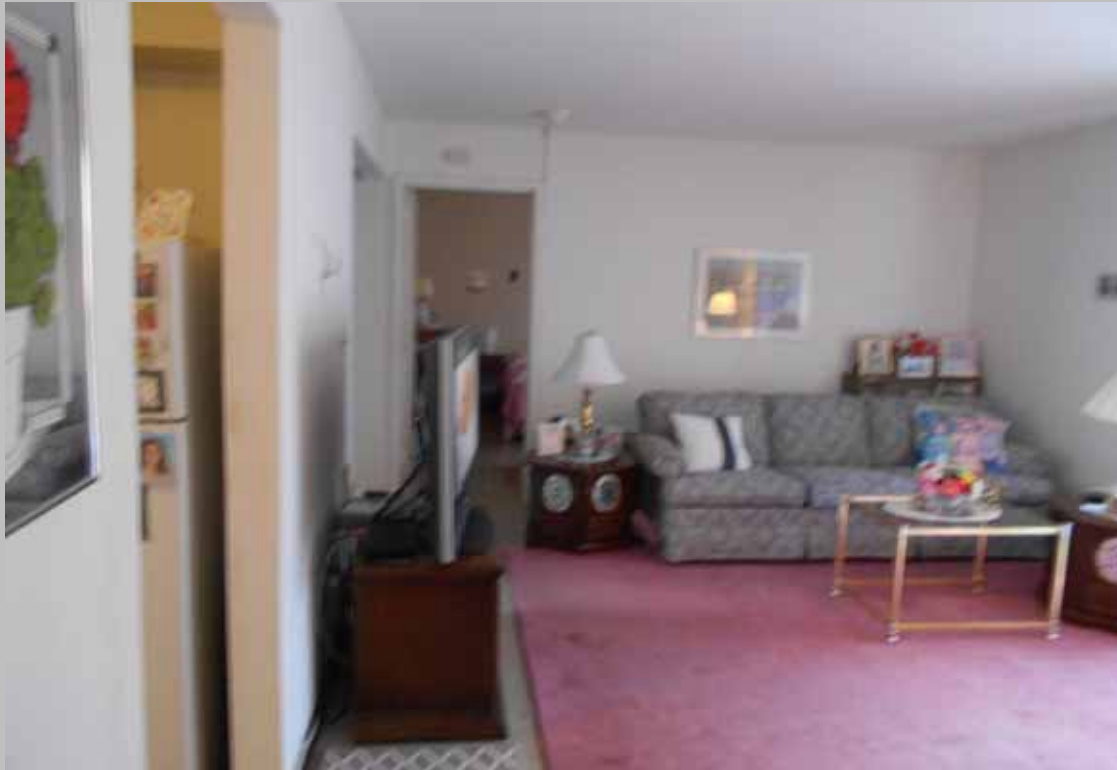
PHOTO #43

2-bedroom dwelling unit – typical living room

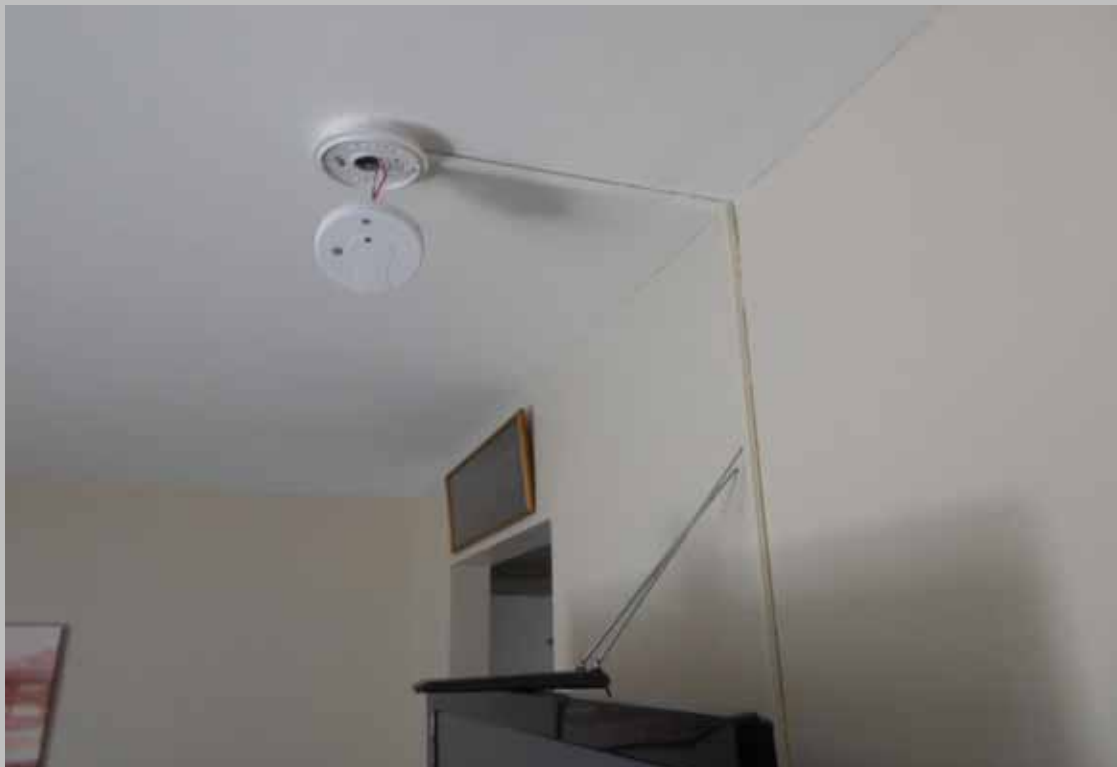
PHOTO #48

Typical hardwired smoke alarm (dwelling units)
