**CAPITAL NEEDS ASSESSMENT (CNA)
PATRICIA WHITE APARTMENTS
20 WASHINGTON STREET
BRIGHTON, MASSACHUSETTS 02135**

**D3G PROJECT NUMBER:
2020-2130**

**FINAL REPORT ISSUE DATE:
FEBRUARY 4, 2021**

**INSPECTION DATES:
NOVEMBER 23 AND 24, 2020**

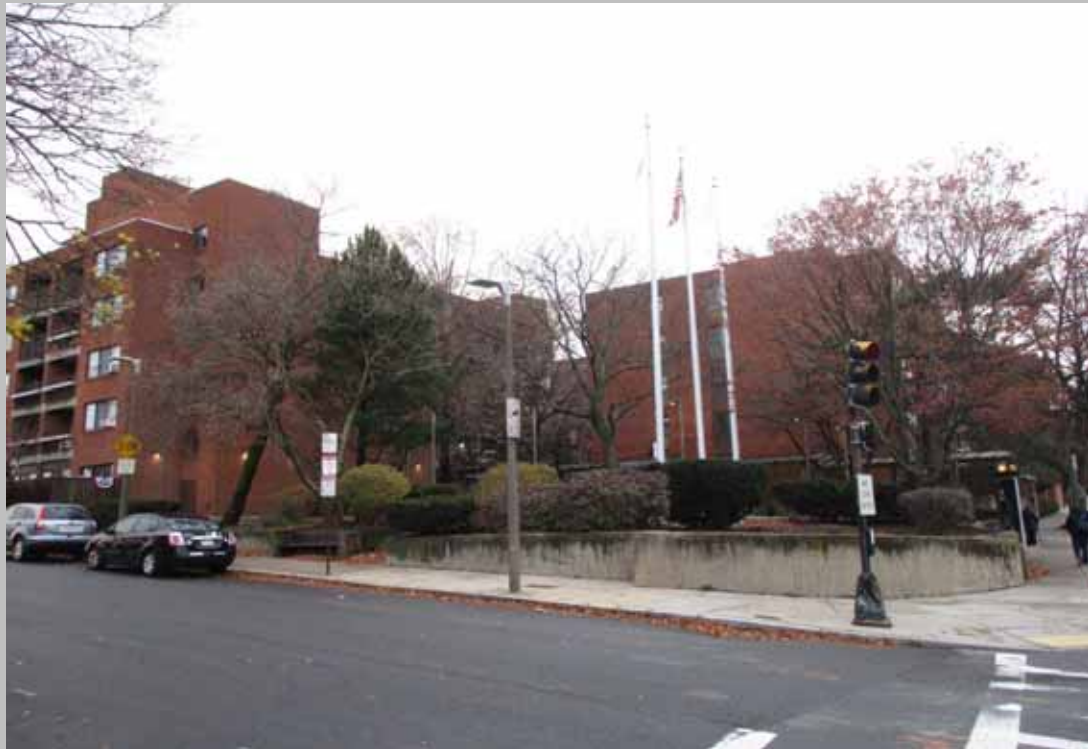
PHOTO #1

Patricia White Apartments.

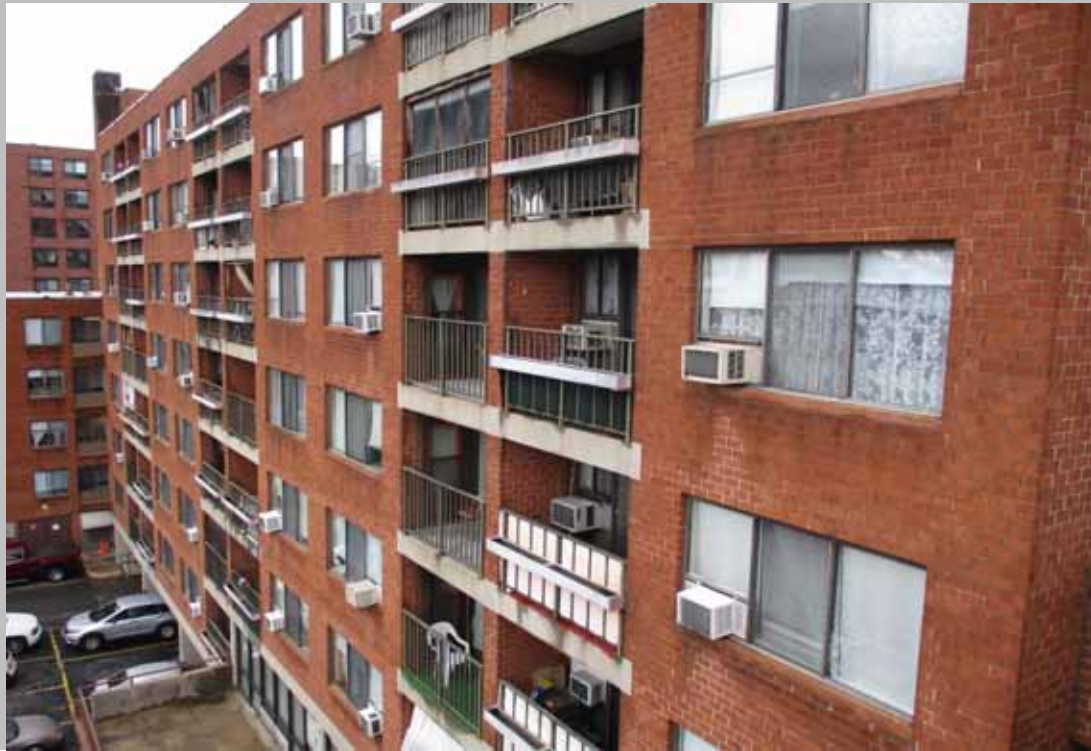
PHOTO #3

Close up of southern façade.

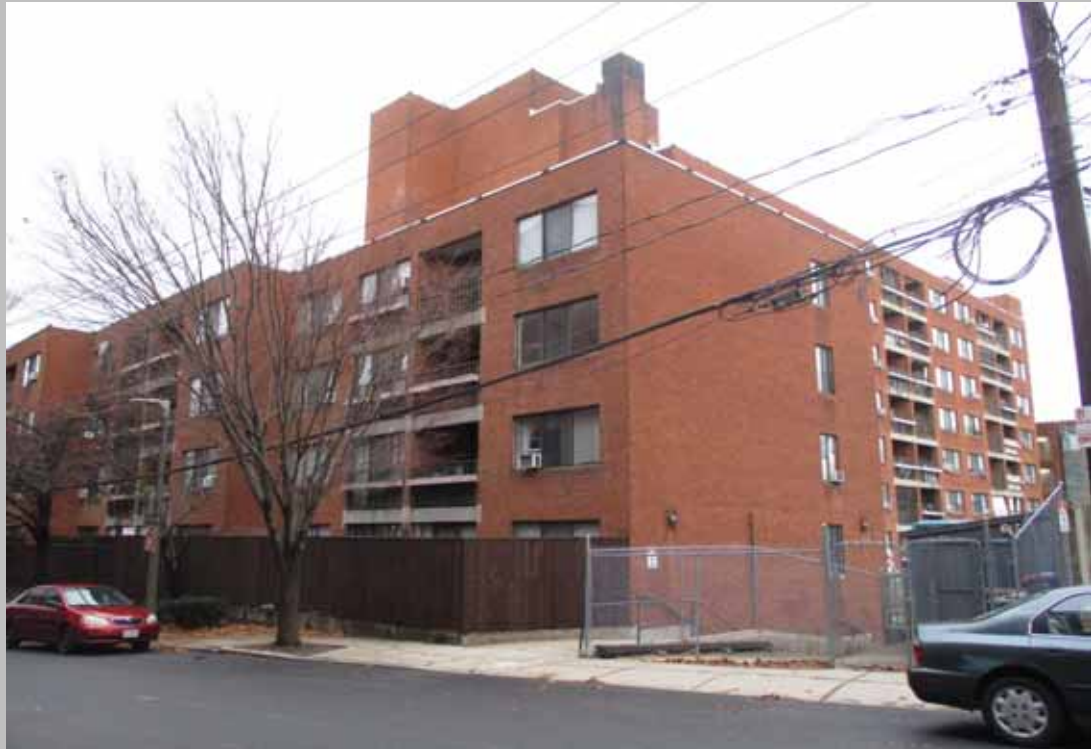
PHOTO #4

Northwestern façade on Egremont Road.

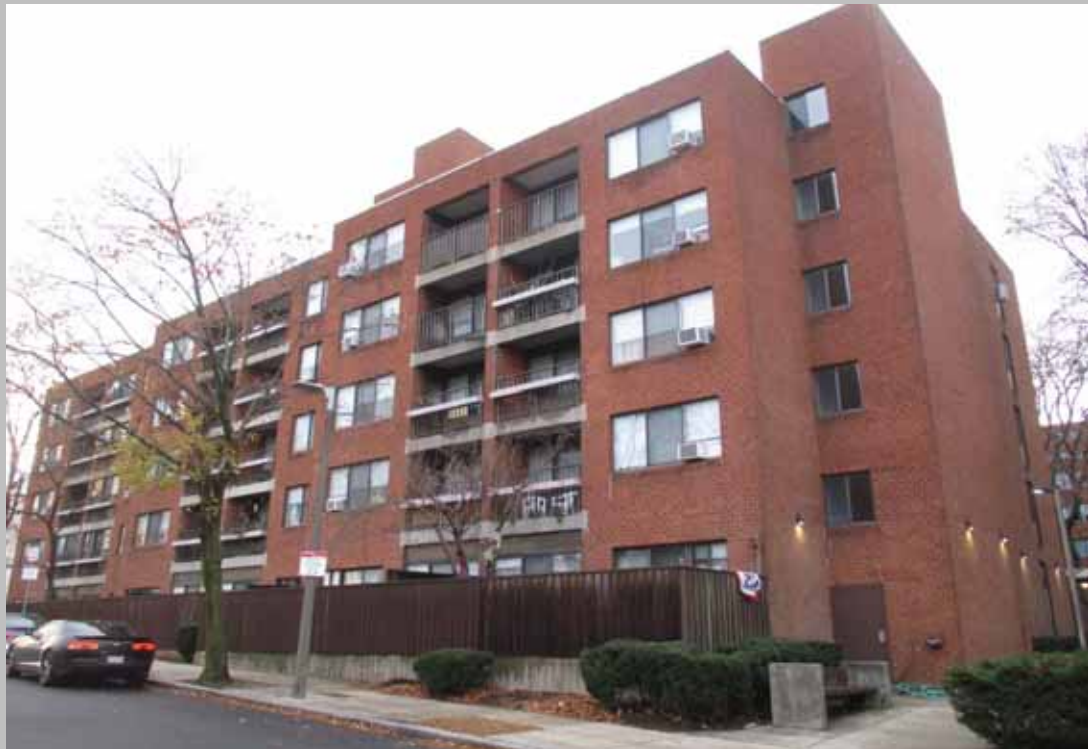
PHOTO #6

Easterly façade on Corey Road.

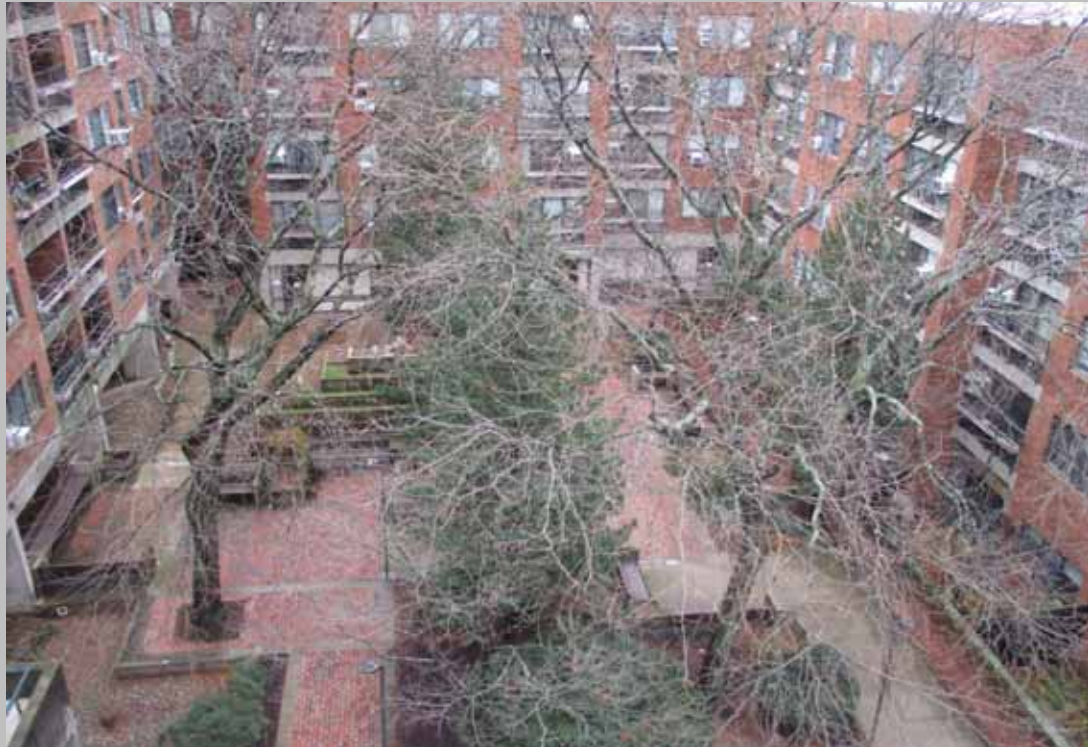
PHOTO #8

Buildings surrounding open-air courtyard.

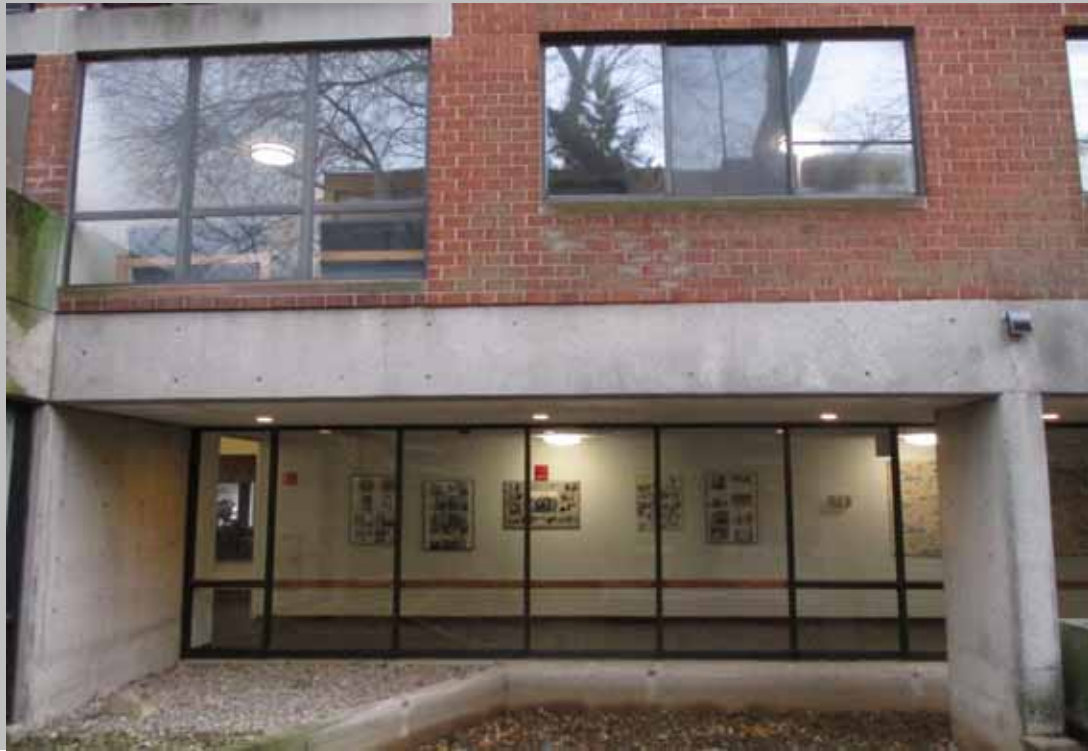
PHOTO #11

First and second floor common space and hallway windows.

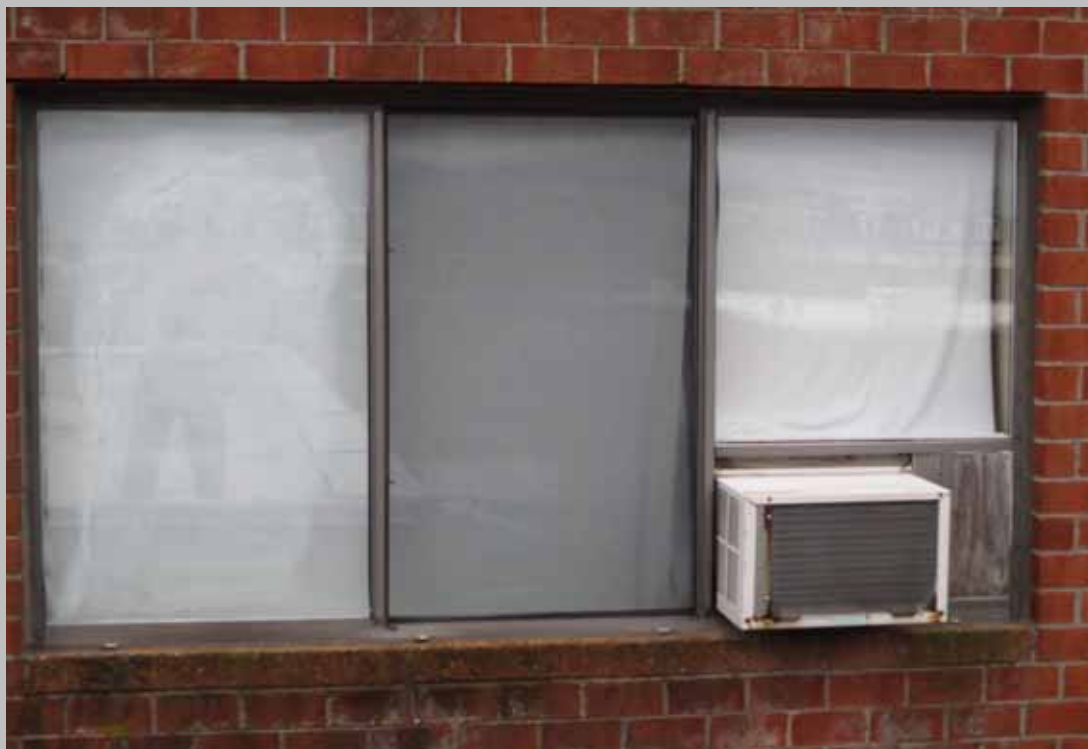
PHOTO #13

Close up of typical sliding windows.

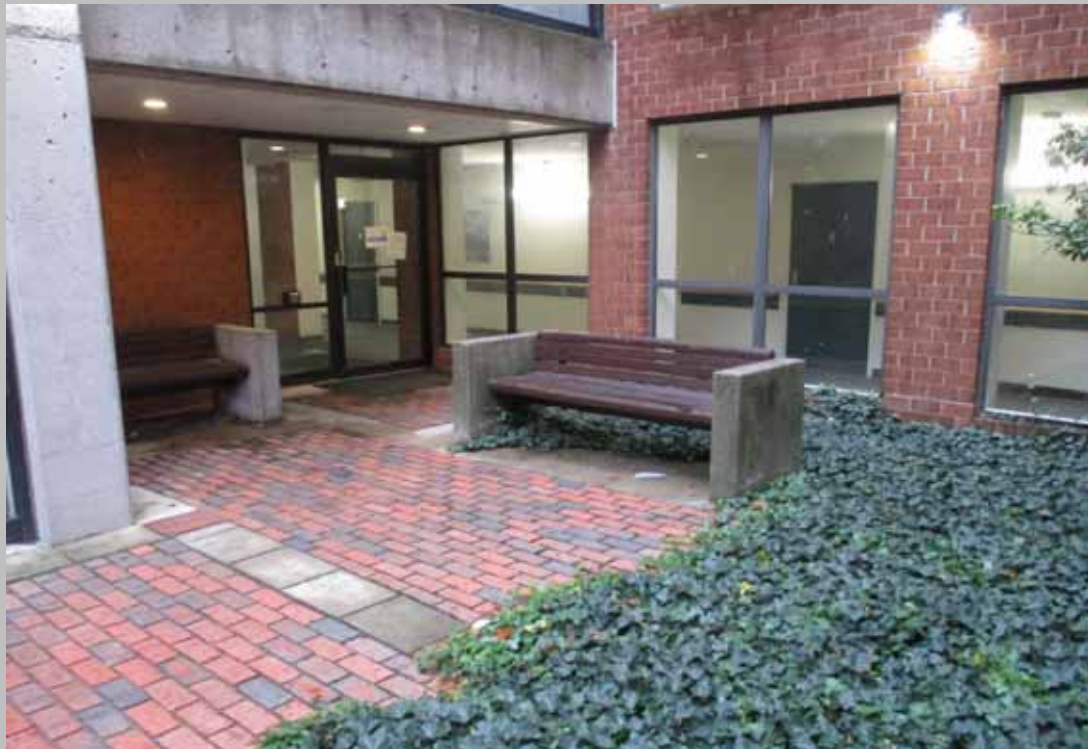
PHOTO #17

A side entrance.

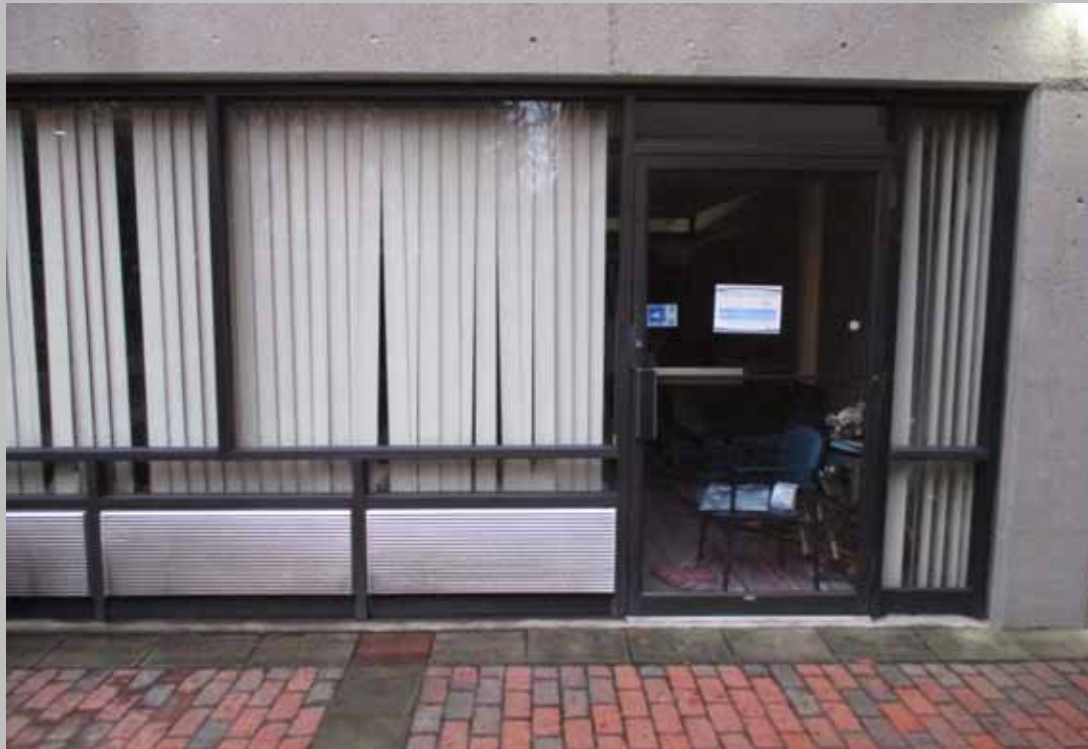
PHOTO #18

Exterior access to first floor community areas.

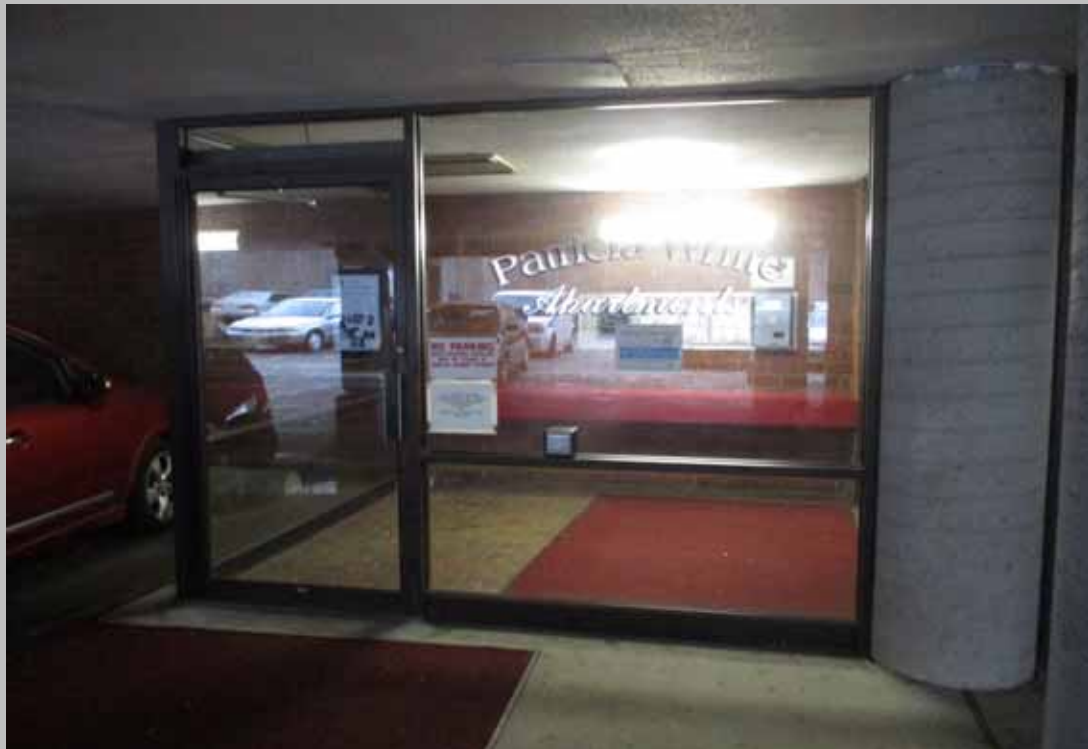
PHOTO #19

Entrance from parking lot and passenger drop-off.

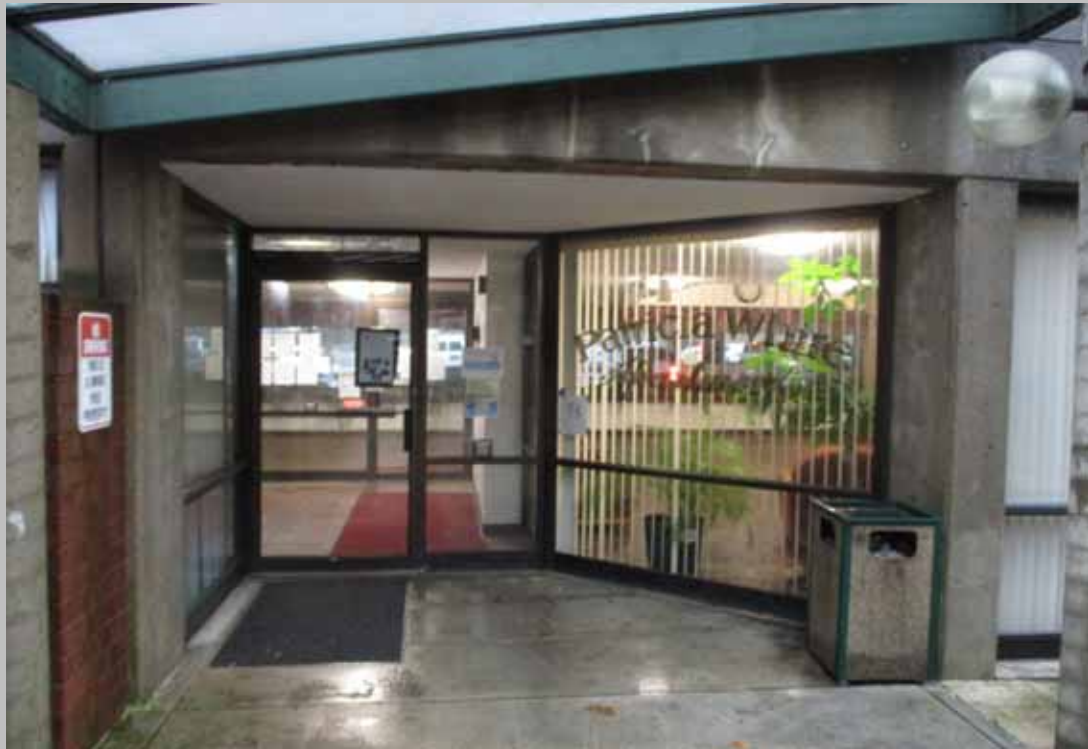
PHOTO #20

Main entrance.

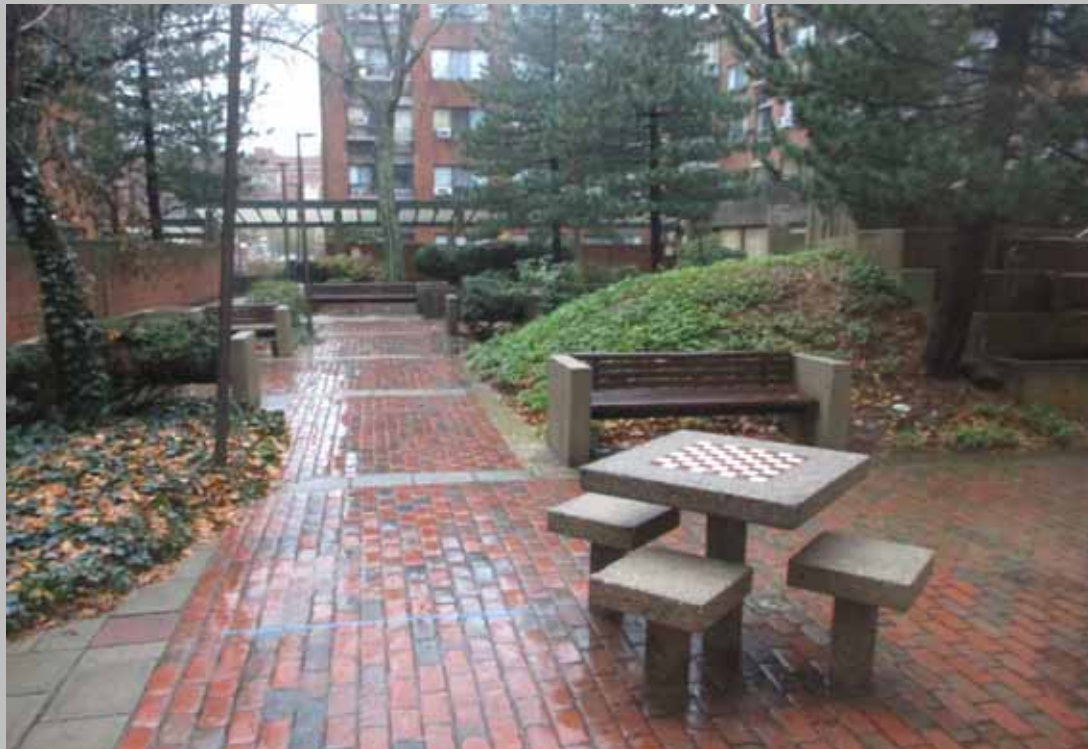
PHOTO #21

Playing tables, benches, cobblestone walks in open air courtyard.

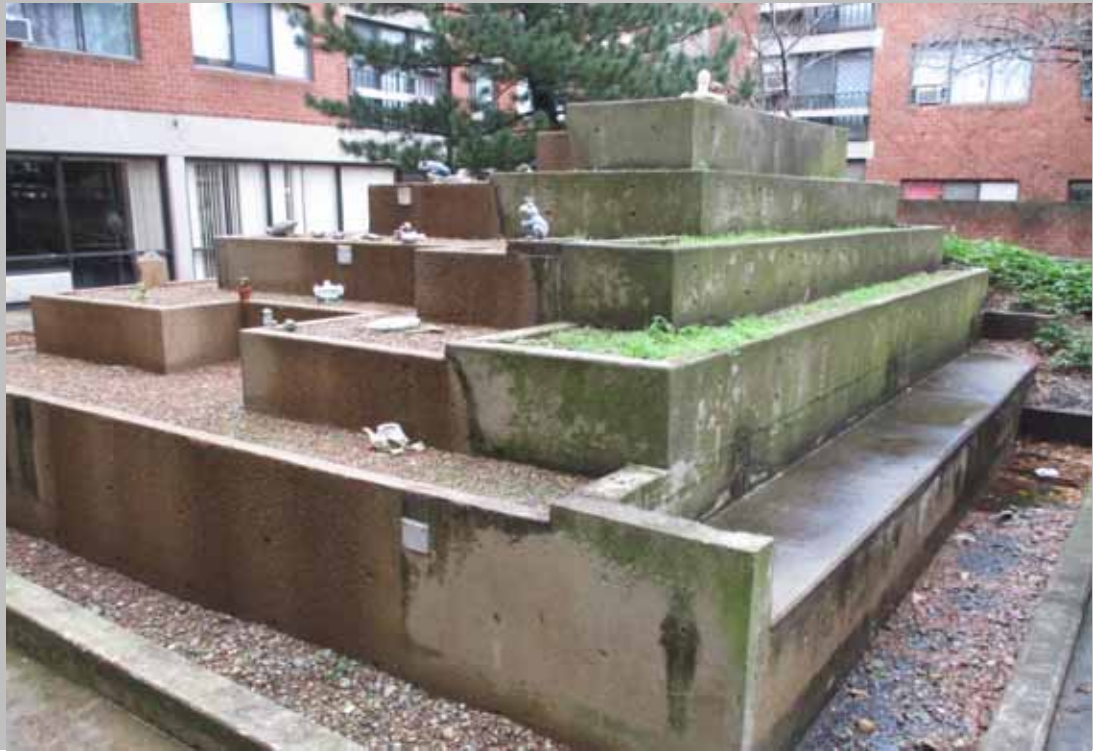
PHOTO #22

The property also features extensive concrete ground forms for water management as well as a tiered concrete waterfall feature within the open air courtyard. Concrete walls were also observed as bases for wooden privacy fences around the west, east, and northern sides of the building. Refurbishment/replacement of the concrete forms, fountain, and fence bases are anticipated during the estimate period. Concrete and wood benches, concrete gaming tables, and a metal kiosk were observed around the courtyard.

Fountain feature in courtyard.

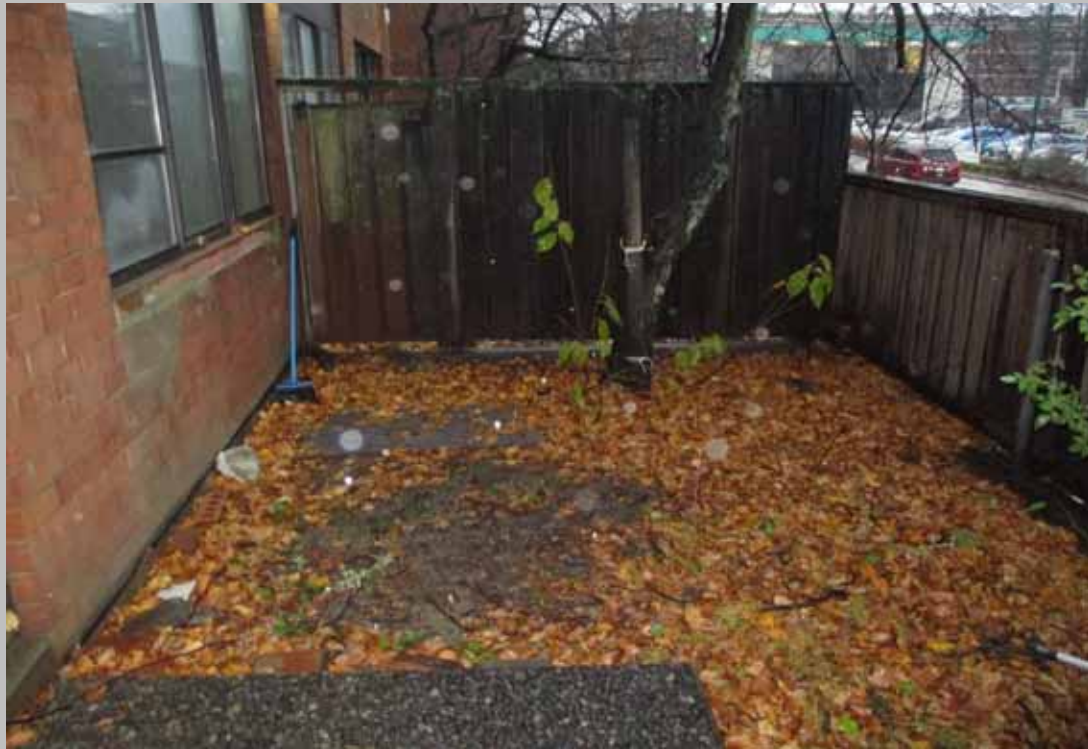
PHOTO #28

Typical apartment patio.

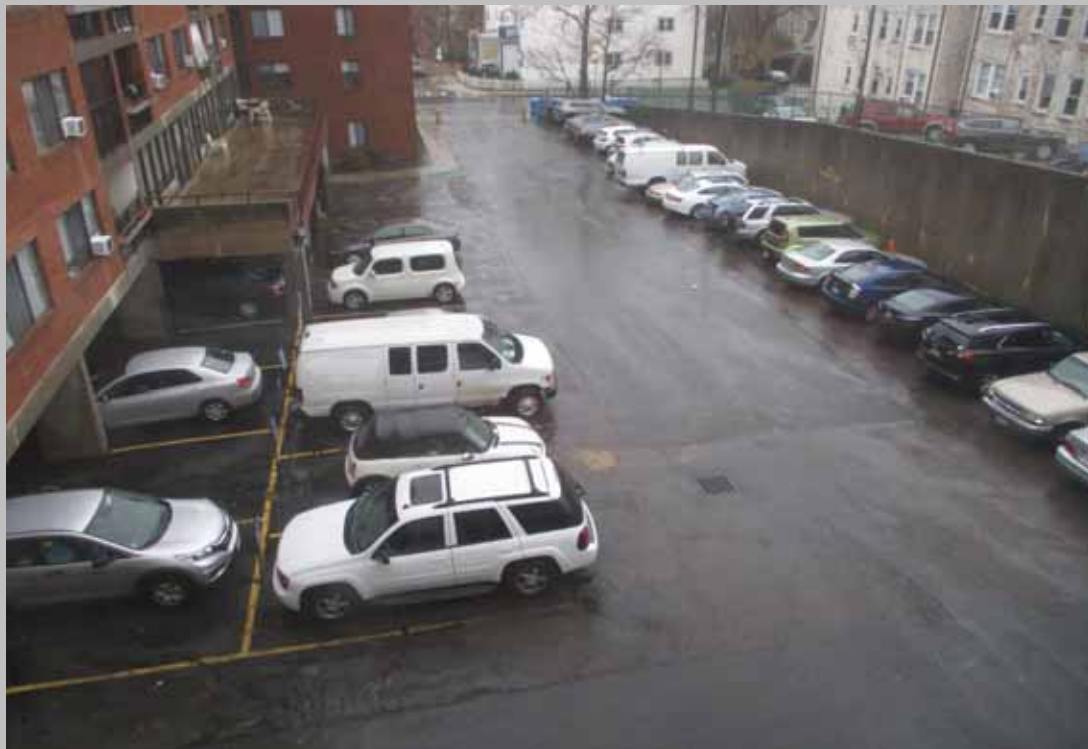
PHOTO #29

The site features asphalt driveways and parking areas with select areas of extruded concrete curbing. Vehicular capacity is approximately forty-eight (48) parking spaces, with parking space configuration designed for continuous traffic flow and convenient access to dwelling units. Concrete curbing and asphalt parking areas were observed in fair physical condition. Repair/replacement of the asphalt parking area is anticipated during the estimate period.

Parking lot.

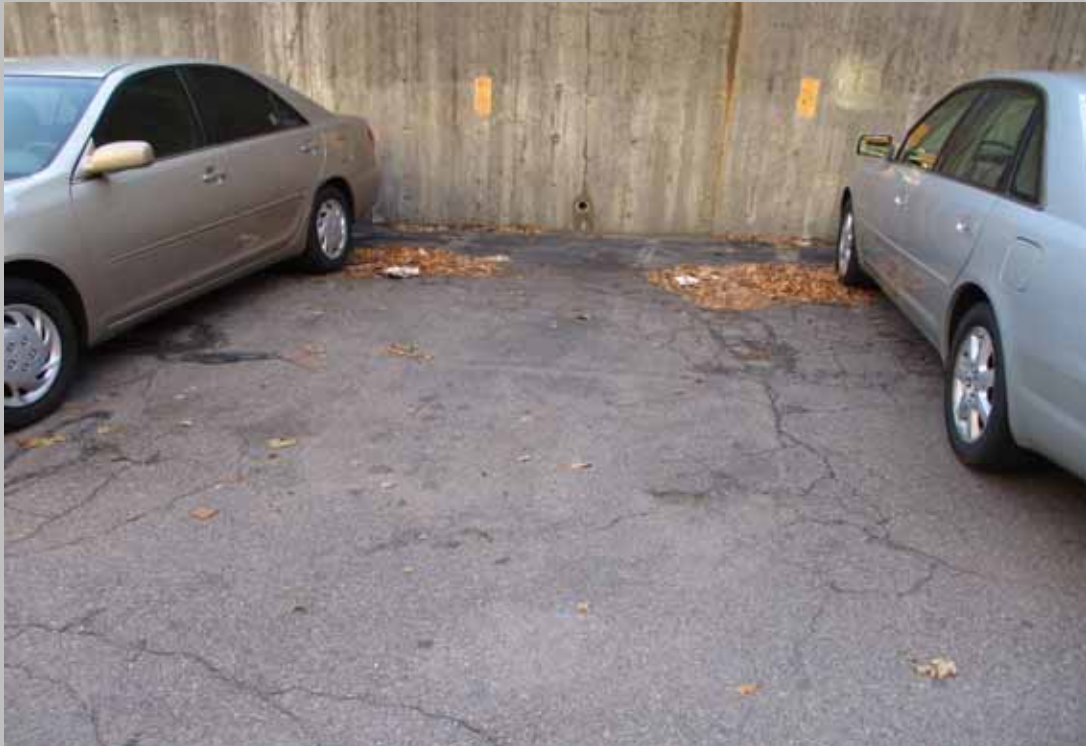
PHOTO #31

Example of faded striping.

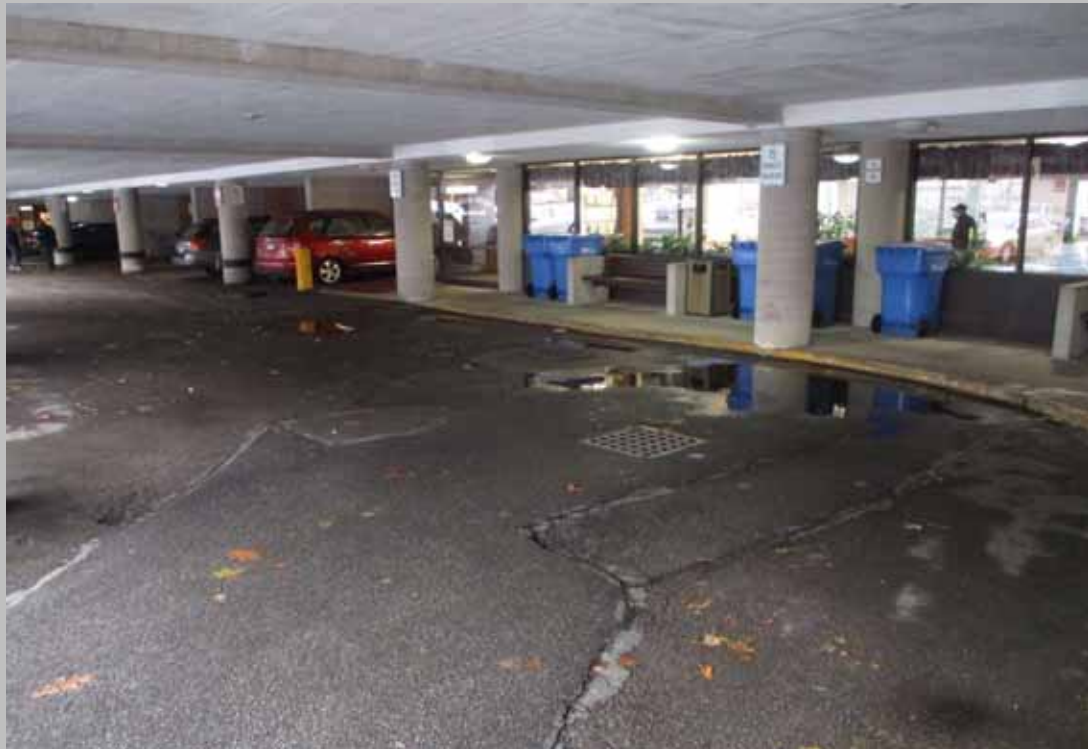
PHOTO #32

Under carport.

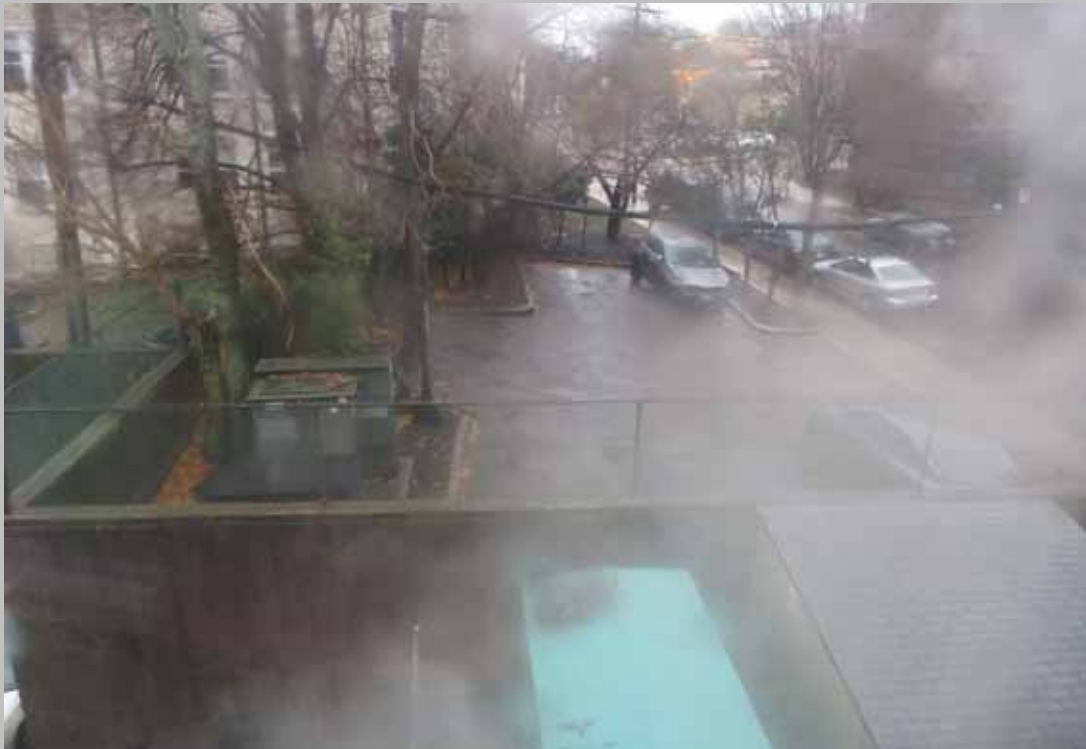
PHOTO #34

Upper, employee parking lot.

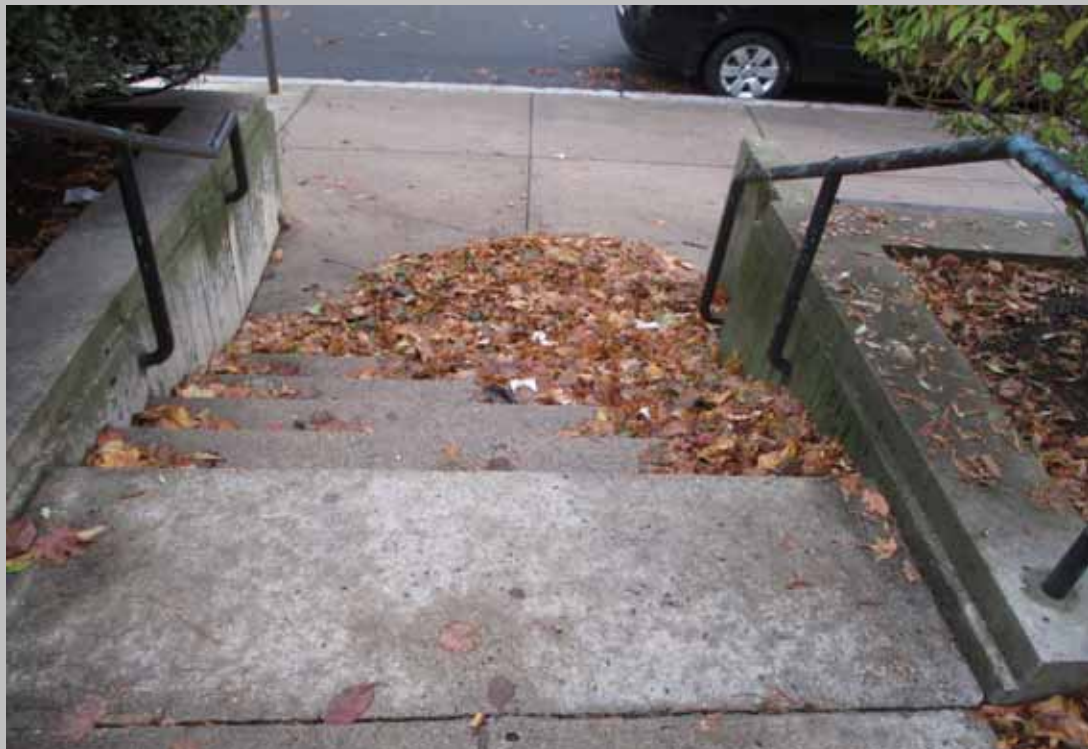
PHOTO #37

Steps up from Washington Street.

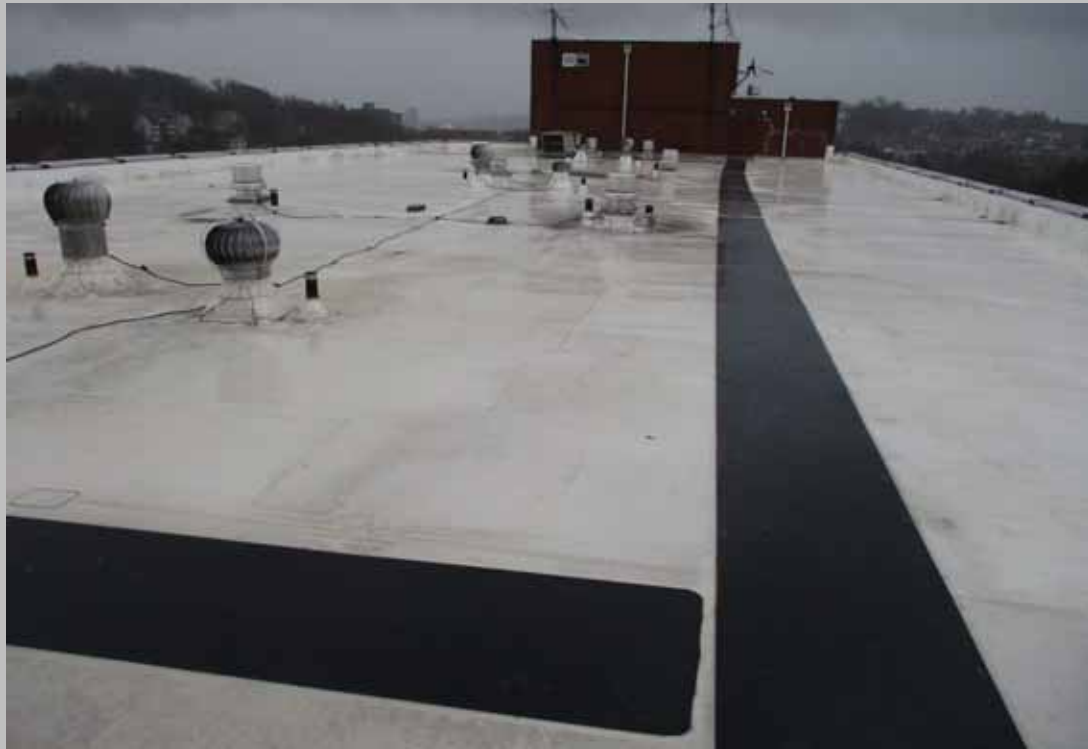
PHOTO #38

TPO roofing.

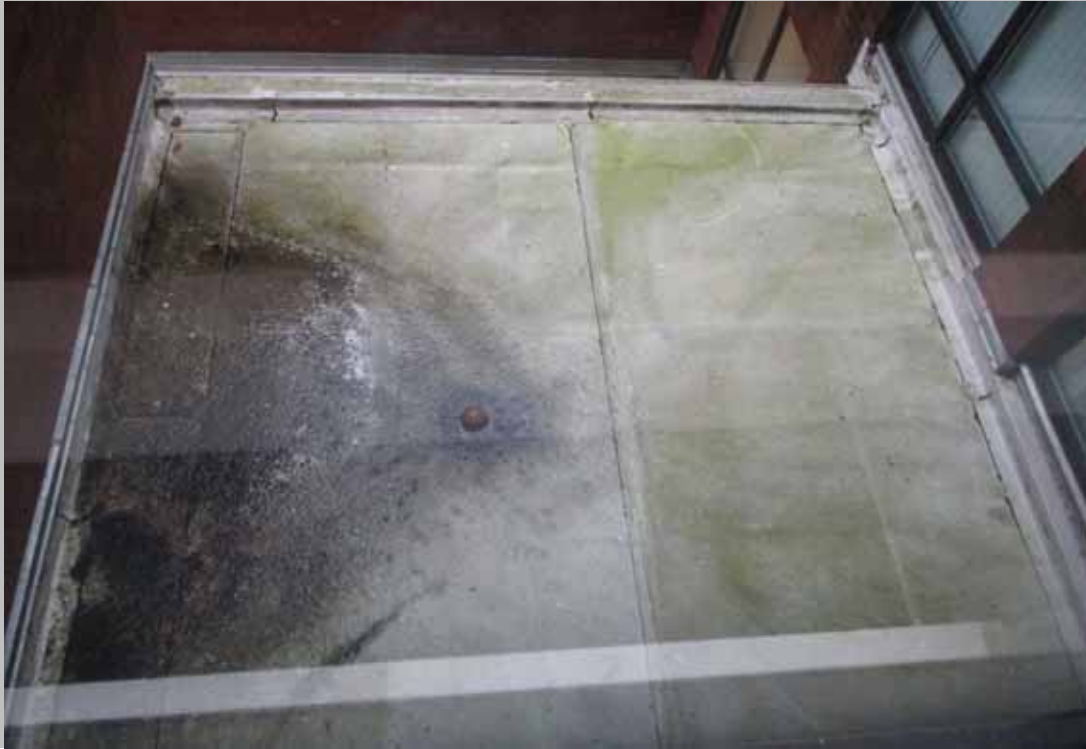
PHOTO #40

Smaller side roof.

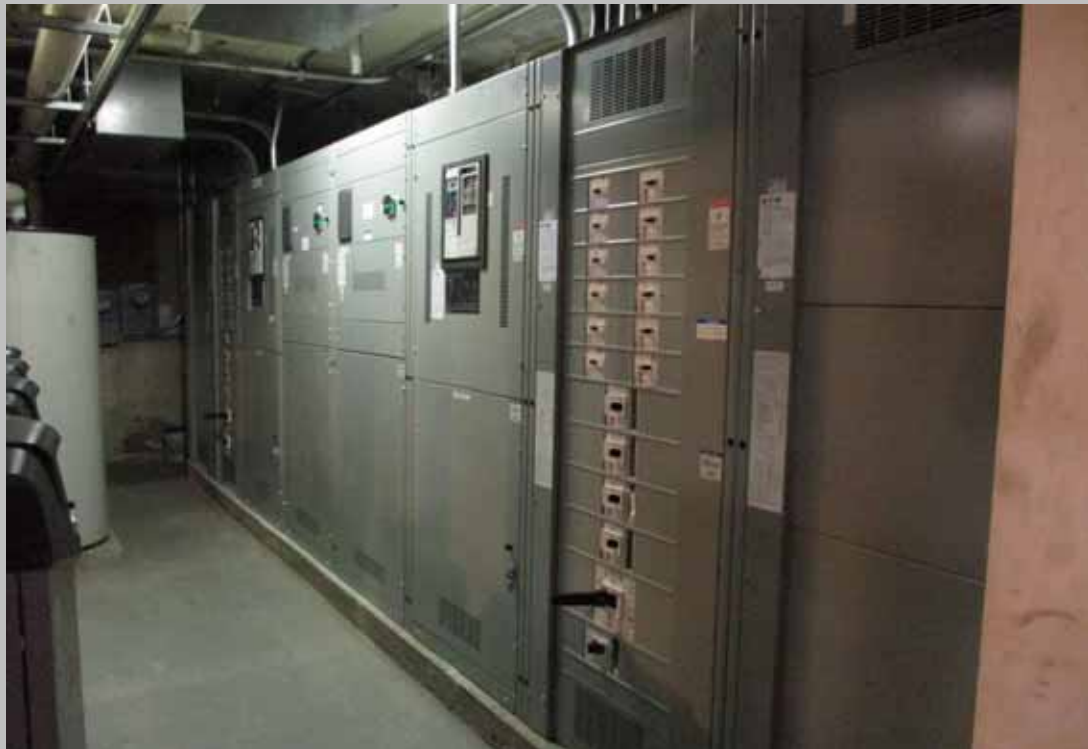
PHOTO #59

New switchgear.

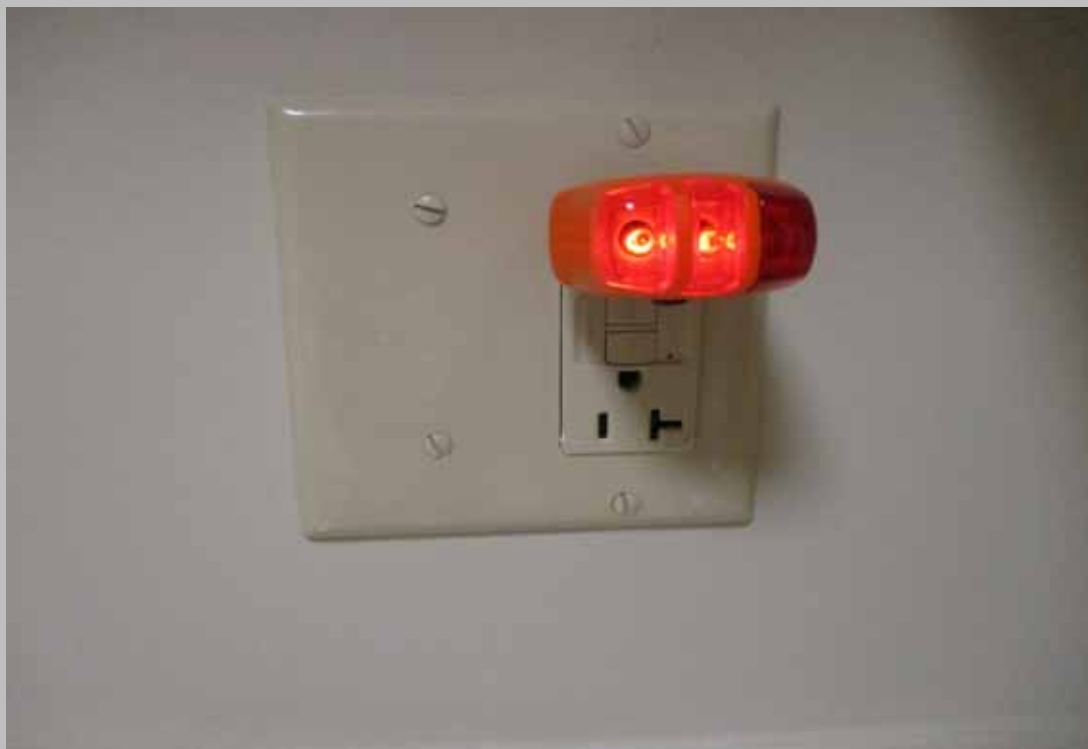
PHOTO #63

Typical GFI circuit in dwelling units.

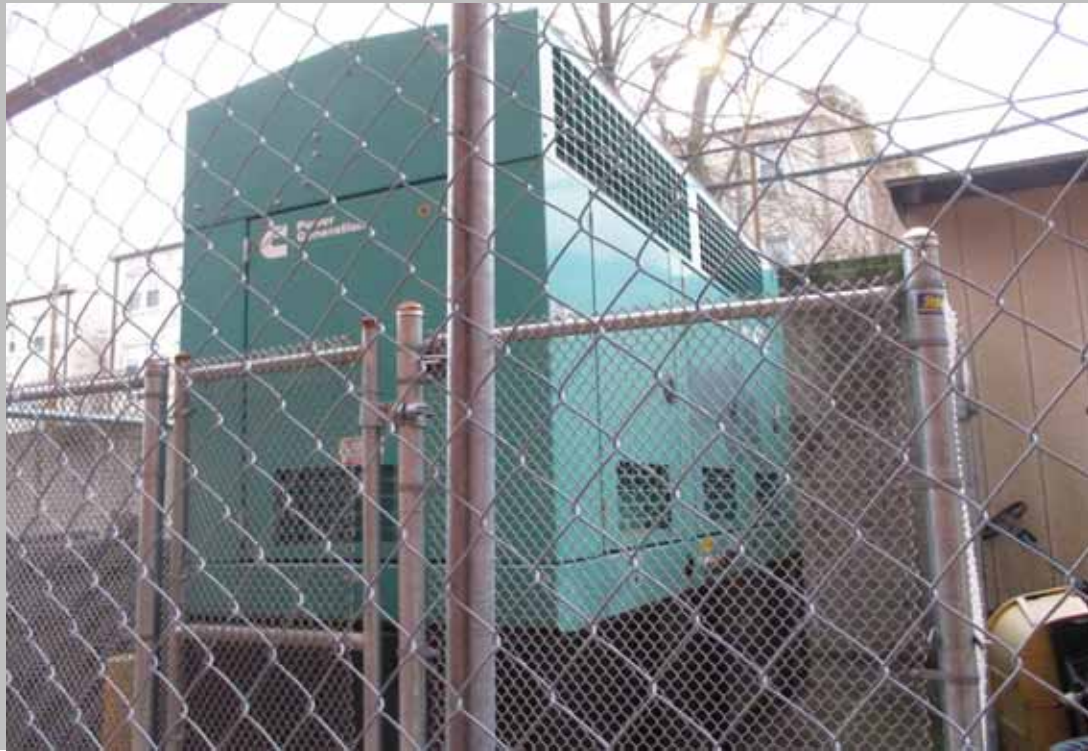
PHOTO #64

Emergency generator.

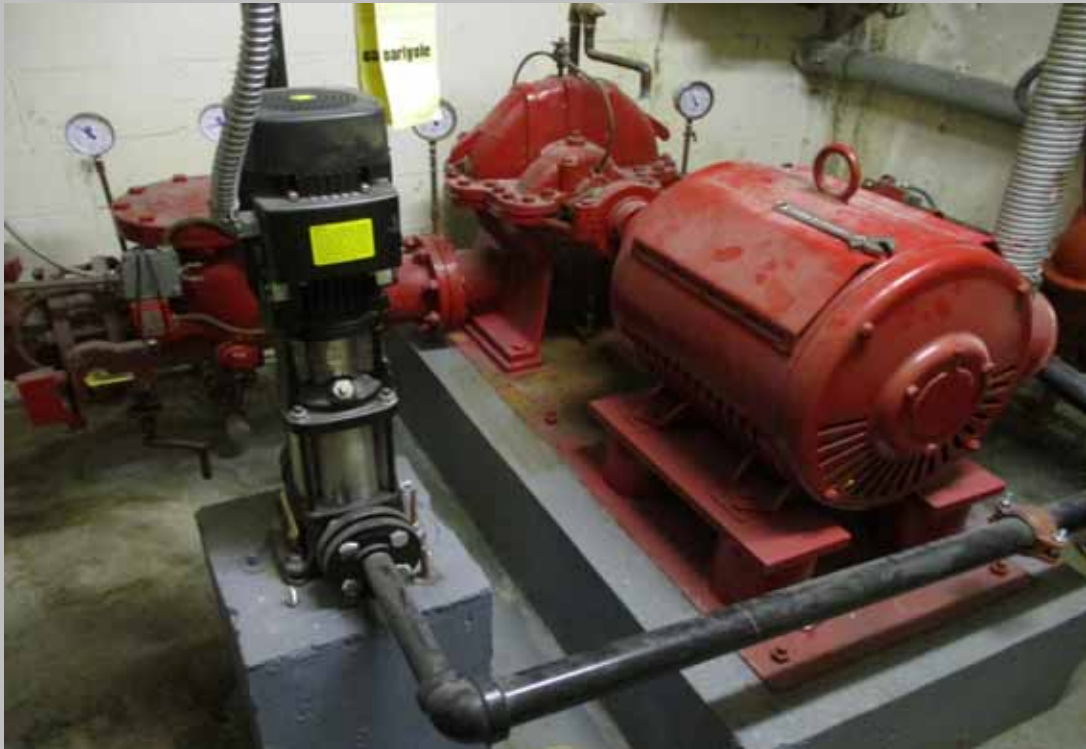
PHOTO #68

Fire pump.

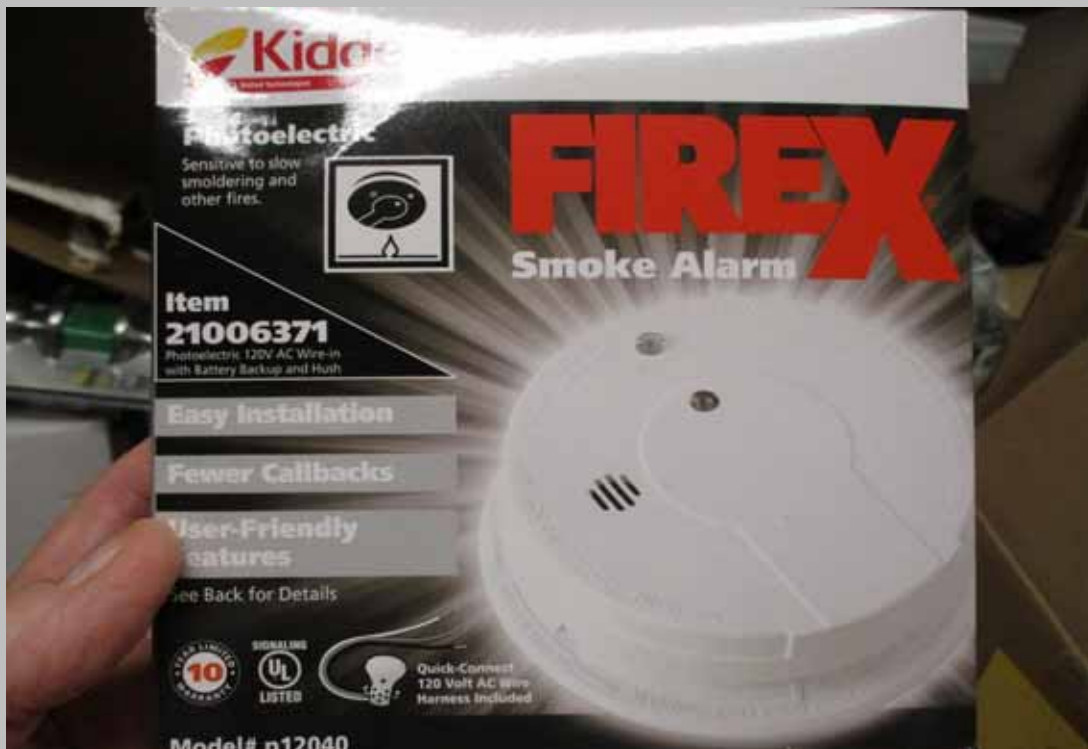
PHOTO #71

Typical smoke detector.

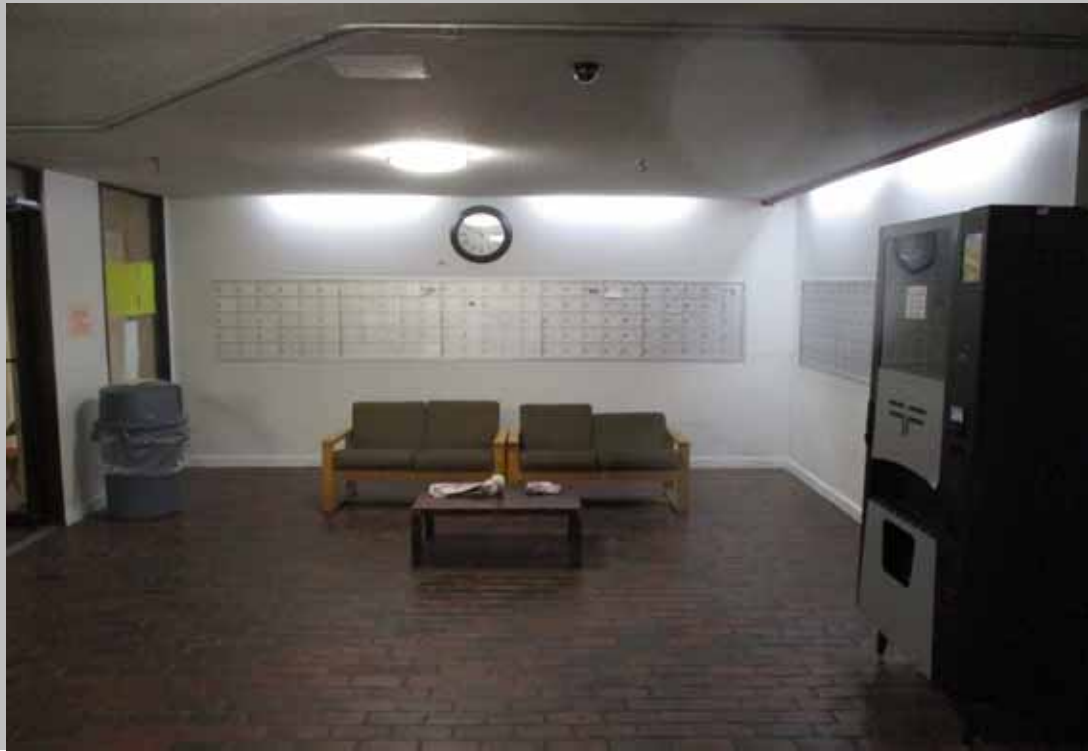
PHOTO #82

Mailboxes and sitting area.
