**CAPITAL NEEDS ASSESSMENT (CNA)
PATRICIA WHITE APARTMENTS
20 WASHINGTON STREET
BRIGHTON, MASSACHUSETTS 02135**

**D3G PROJECT NUMBER:
2020-2130**

**FINAL REPORT ISSUE DATE:
FEBRUARY 4, 2021**

**INSPECTION DATES:
NOVEMBER 23 AND 24, 2020**

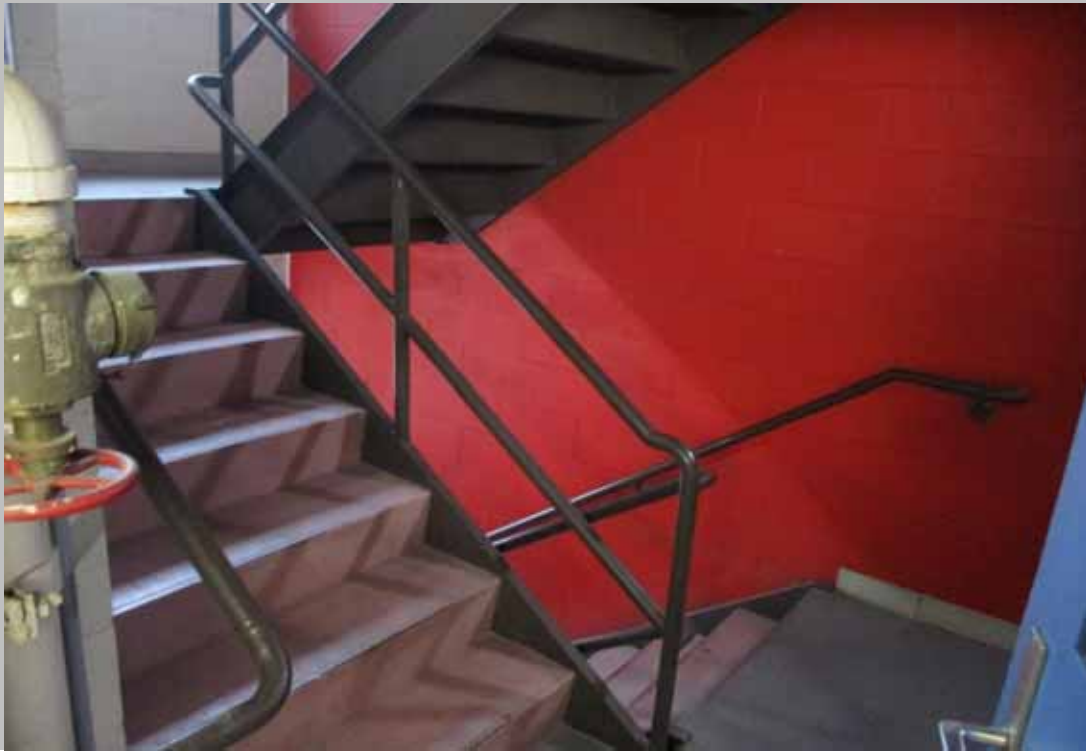
PHOTO #84

Typical stairwell.

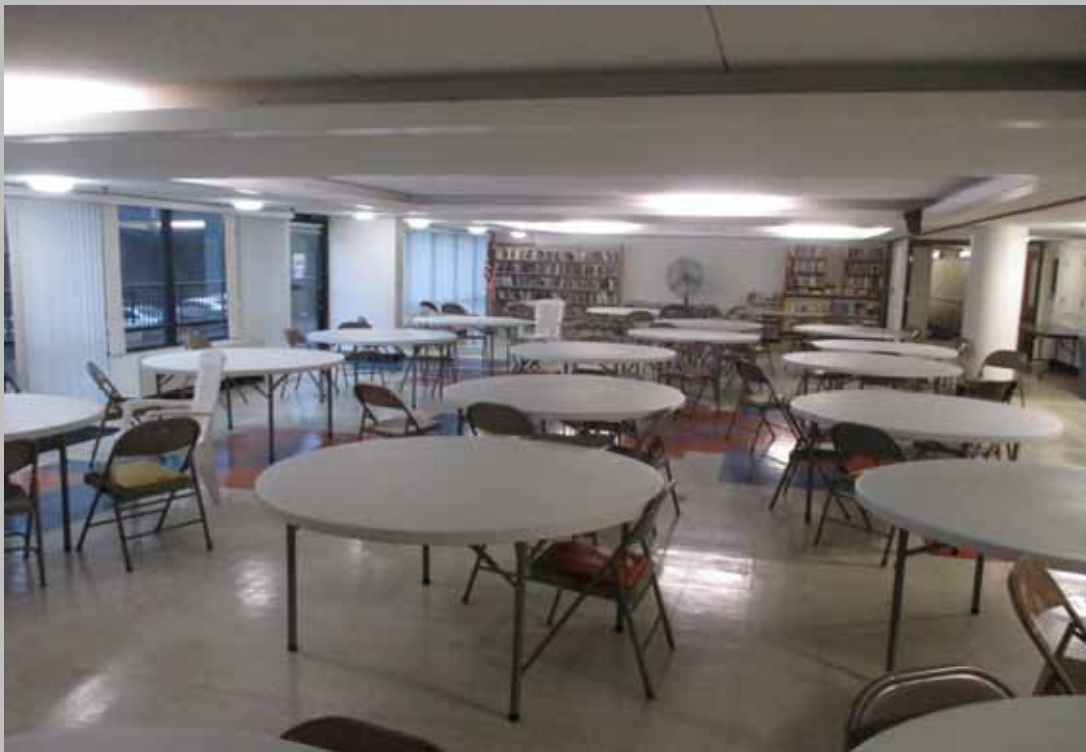
PHOTO #85

Main community room on second floor.

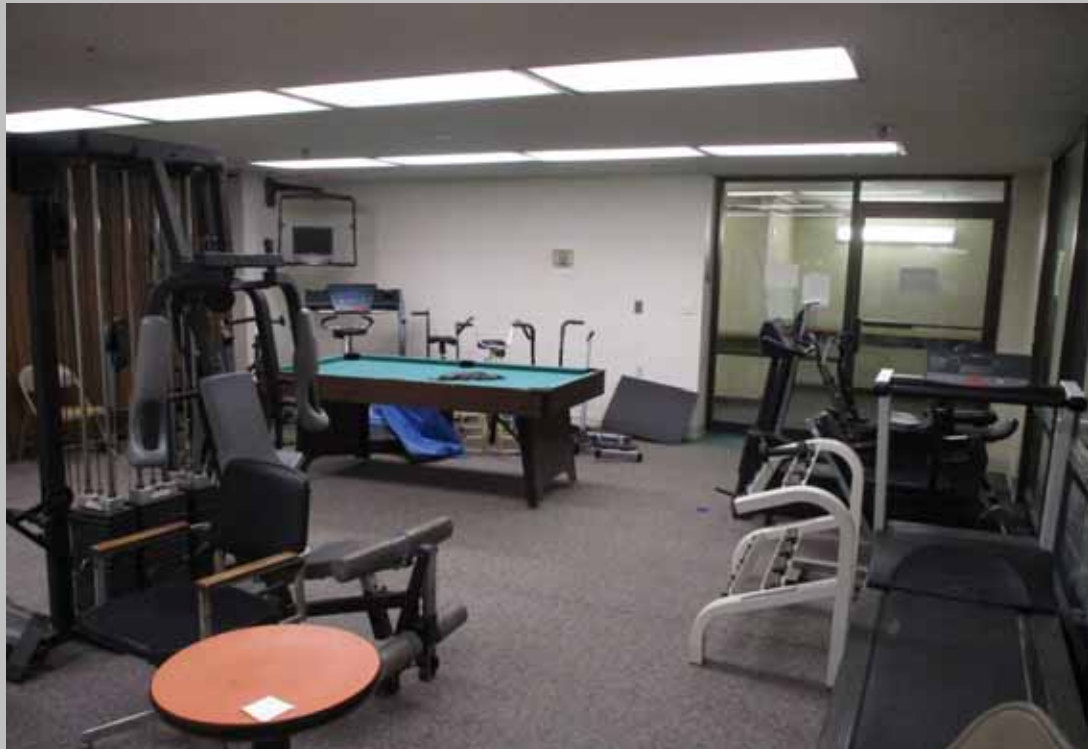
PHOTO #86

Gym/game room.

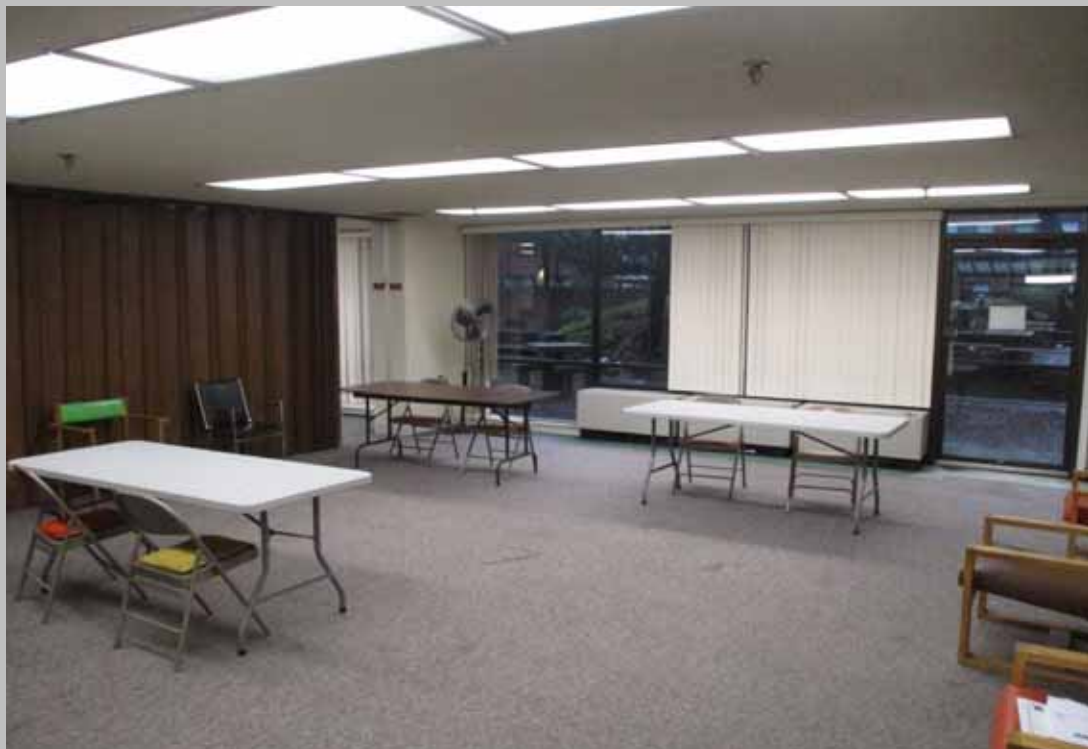
PHOTO #87

First floor community room.

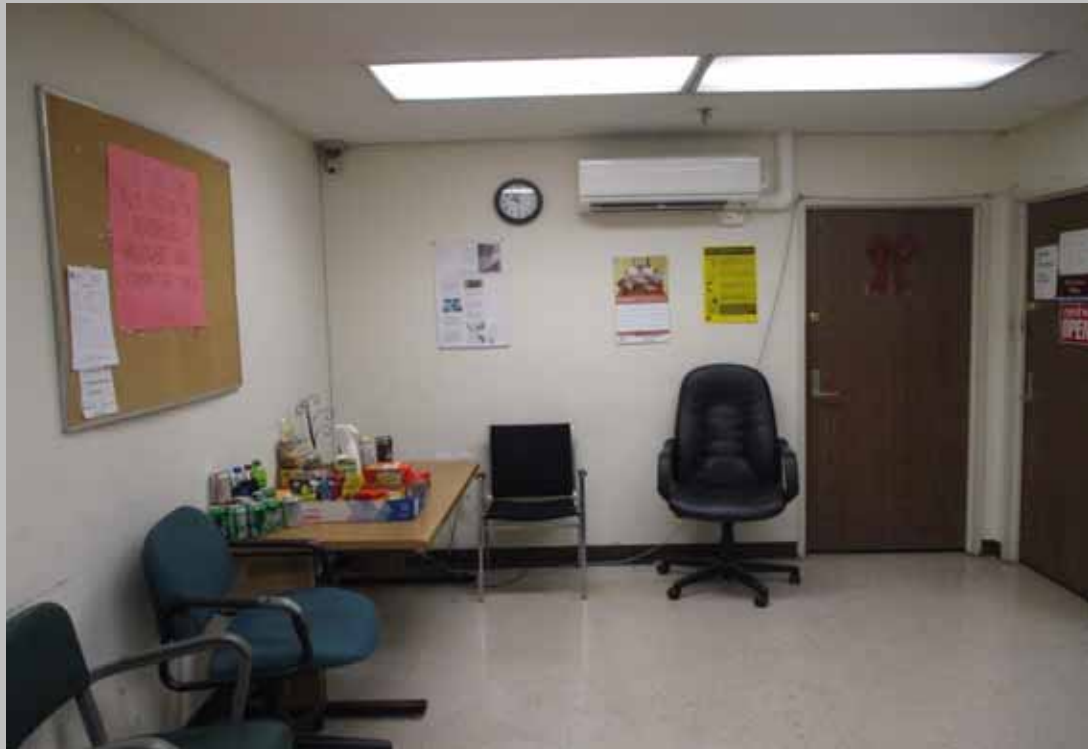
PHOTO #88

Task Force offices.

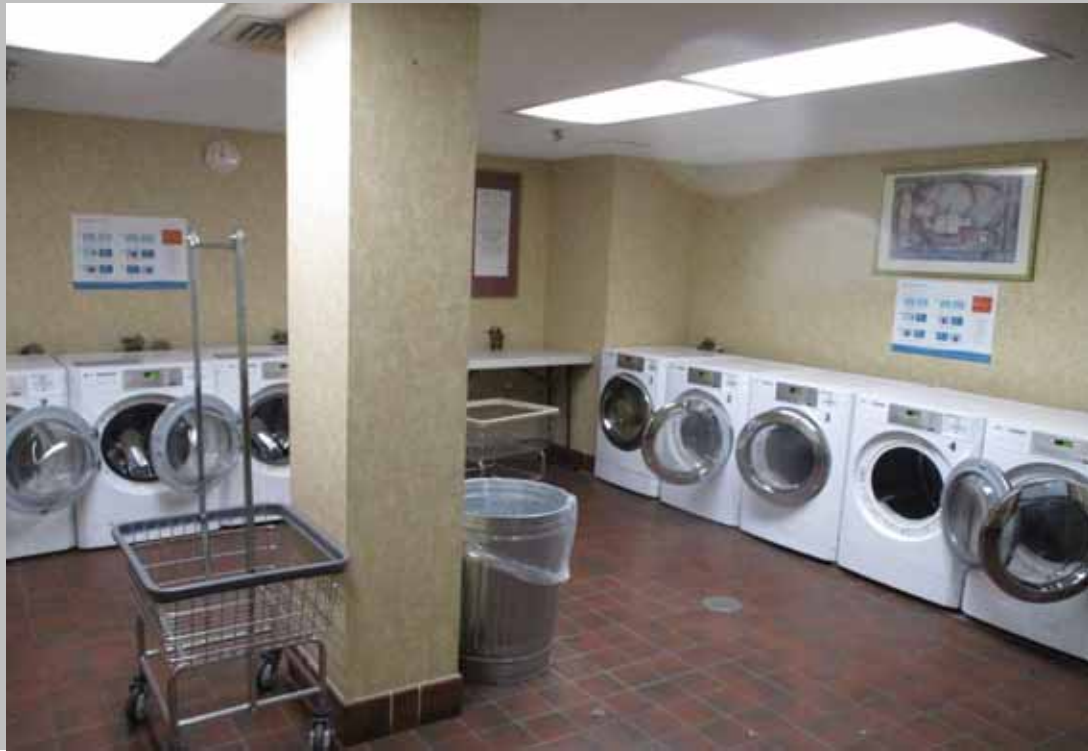
PHOTO #90

Community laundry.

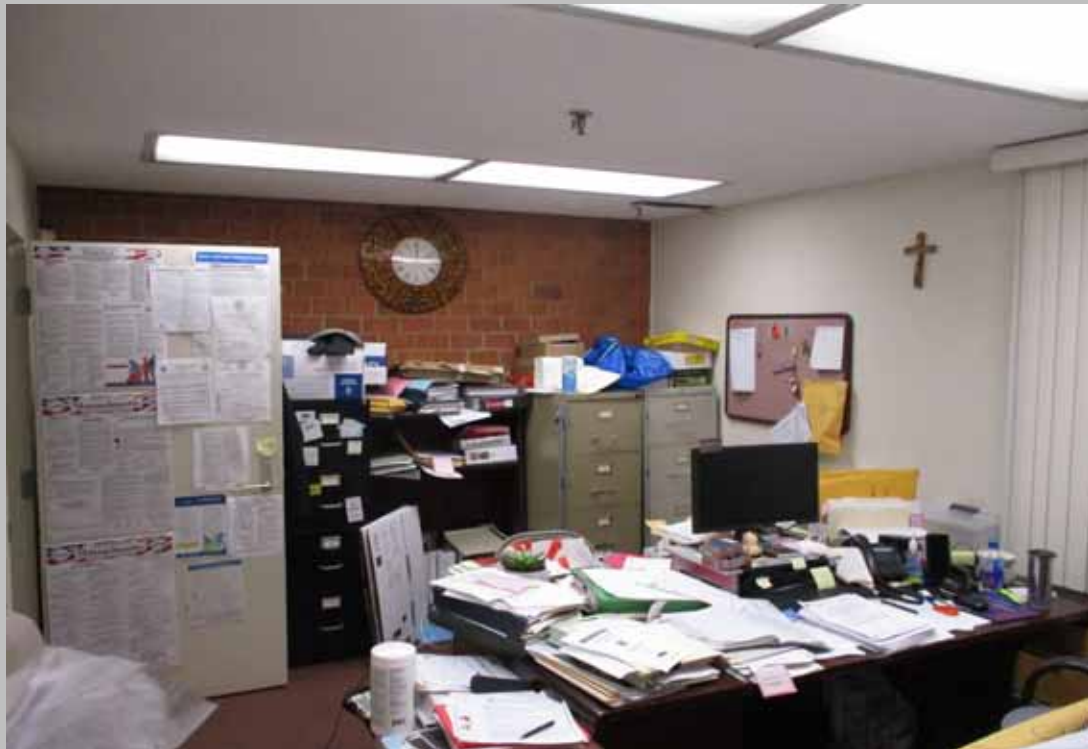
PHOTO #91

Management offices.

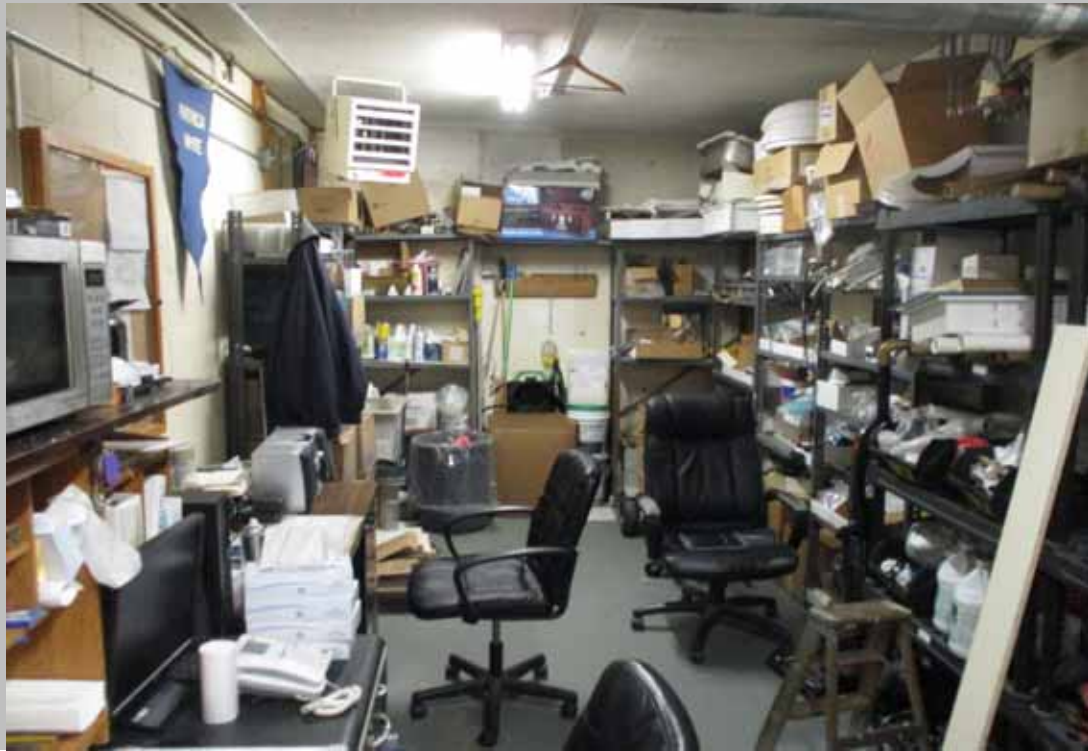
PHOTO #92

Maintenance shop.

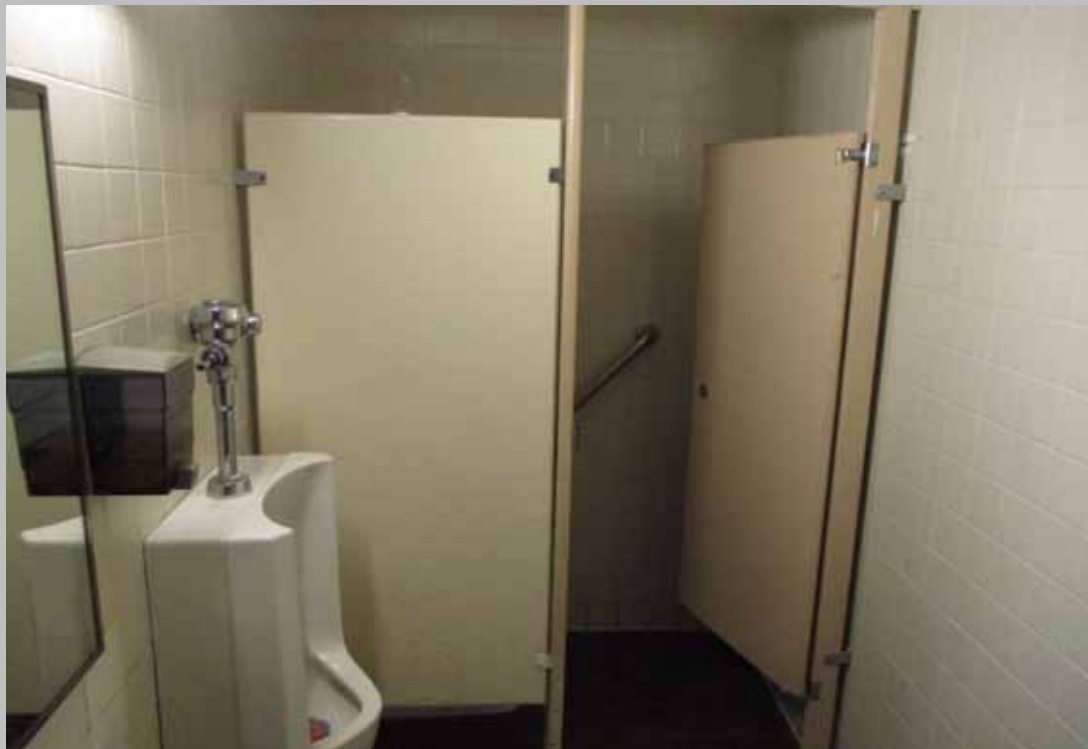
PHOTO #93

Men's bathroom.

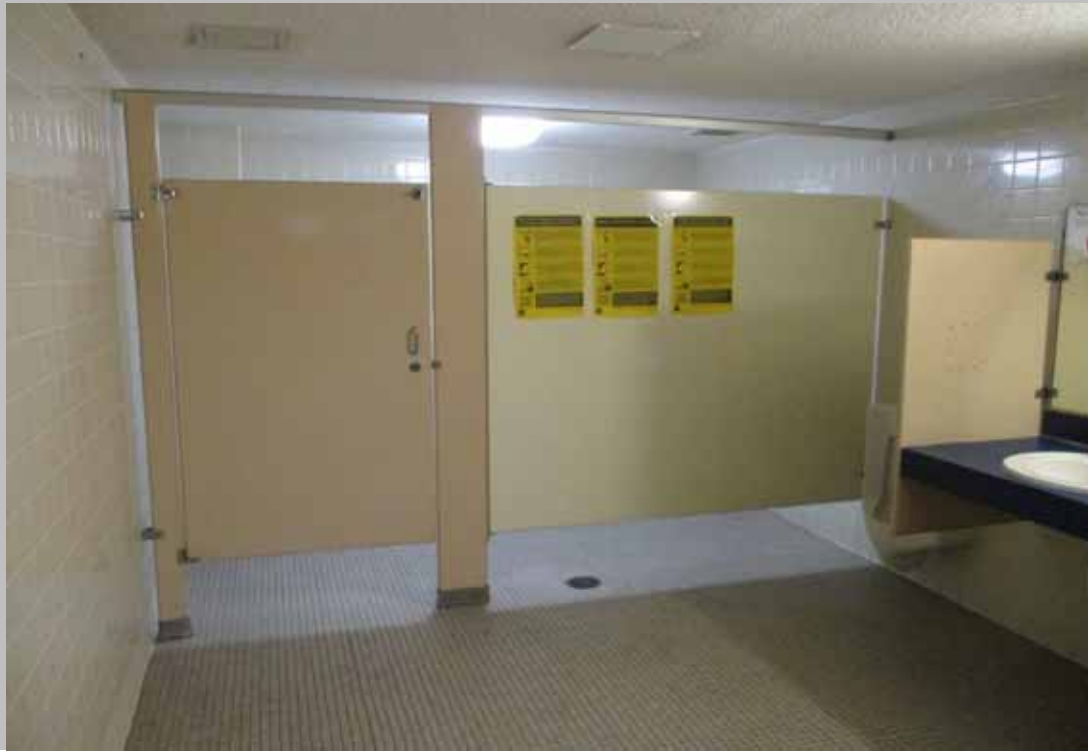
PHOTO #94

Accessible public Men's bathroom.

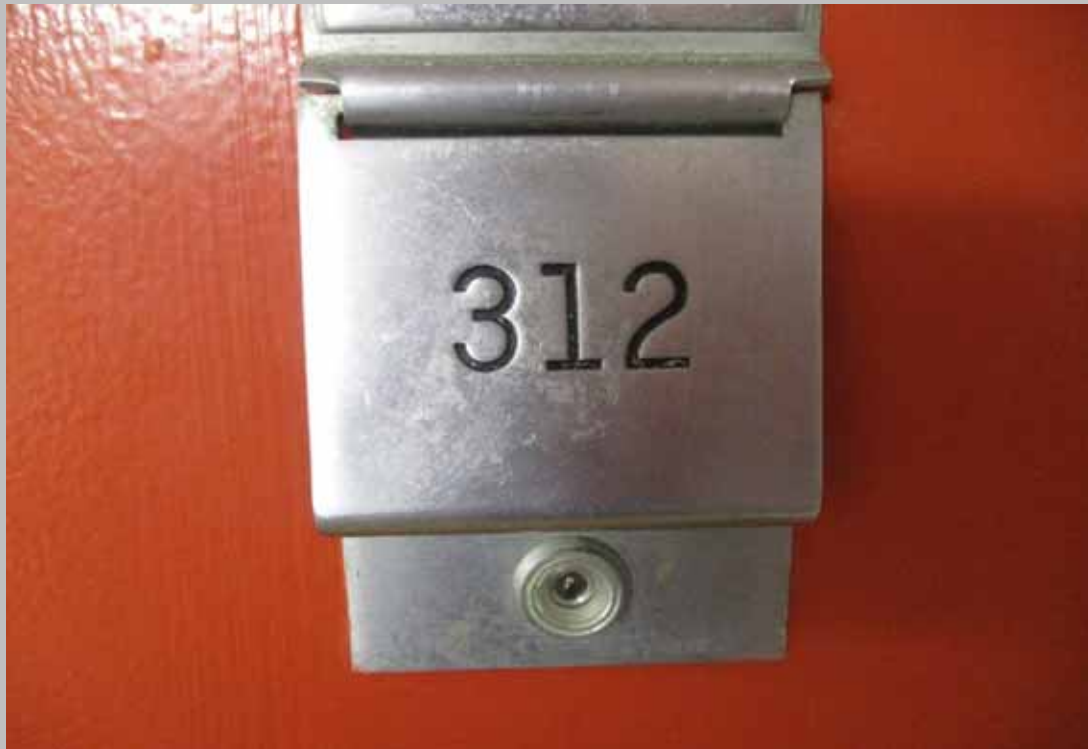
PHOTO #95

Unit 312, a one-bedroom, one-bath unit.

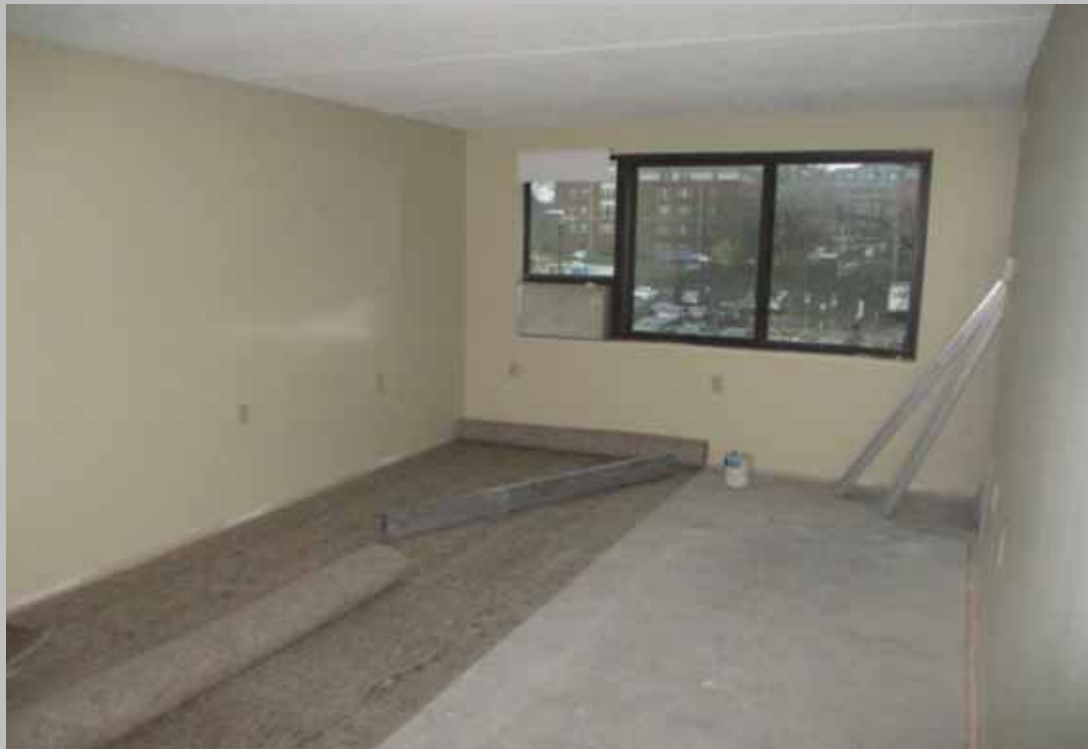
PHOTO #117

Livingroom.

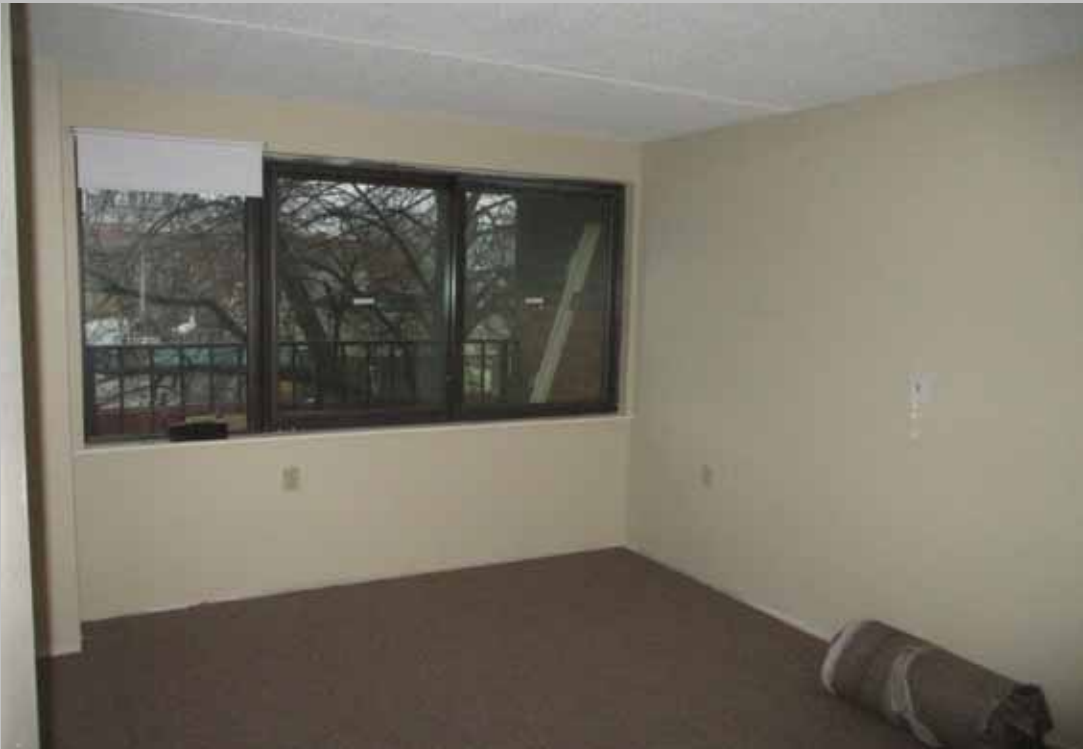
PHOTO #118

Bedroom.

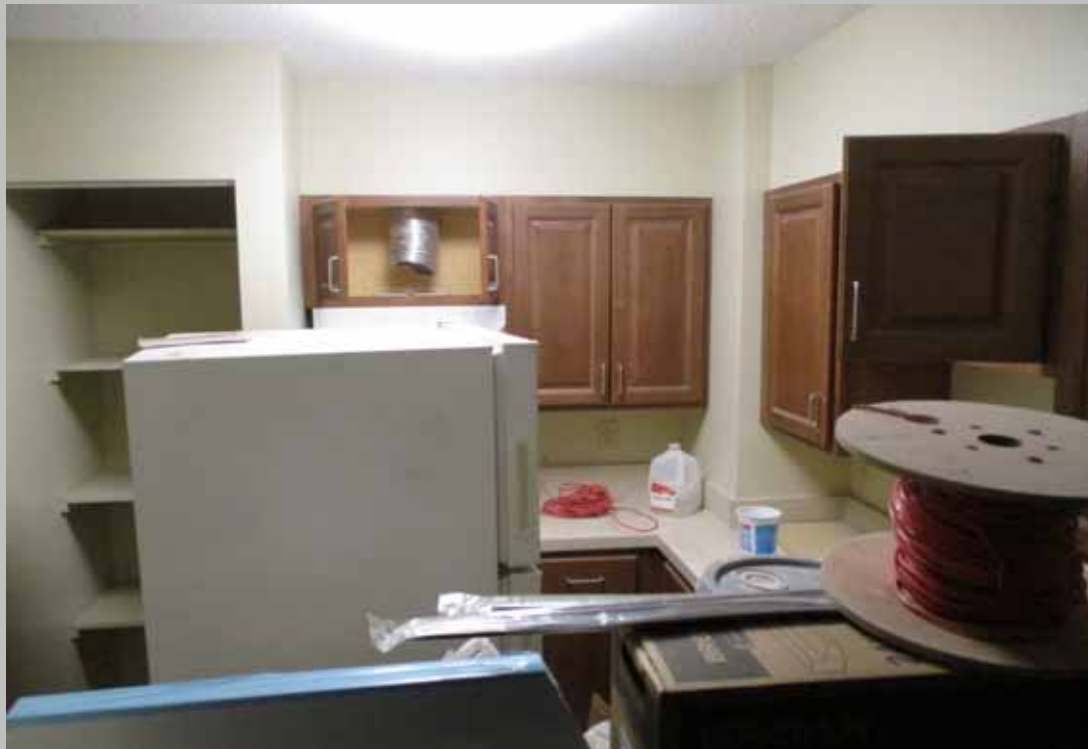
PHOTO #119

Kitchen.

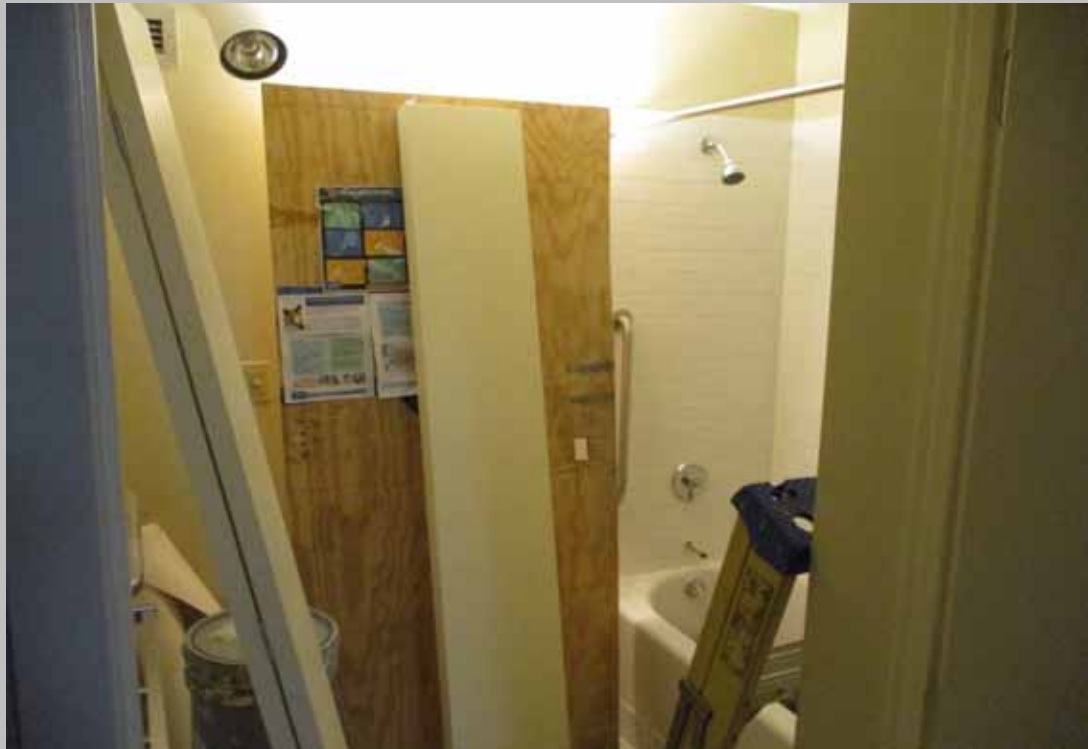
PHOTO #120

Bathroom.

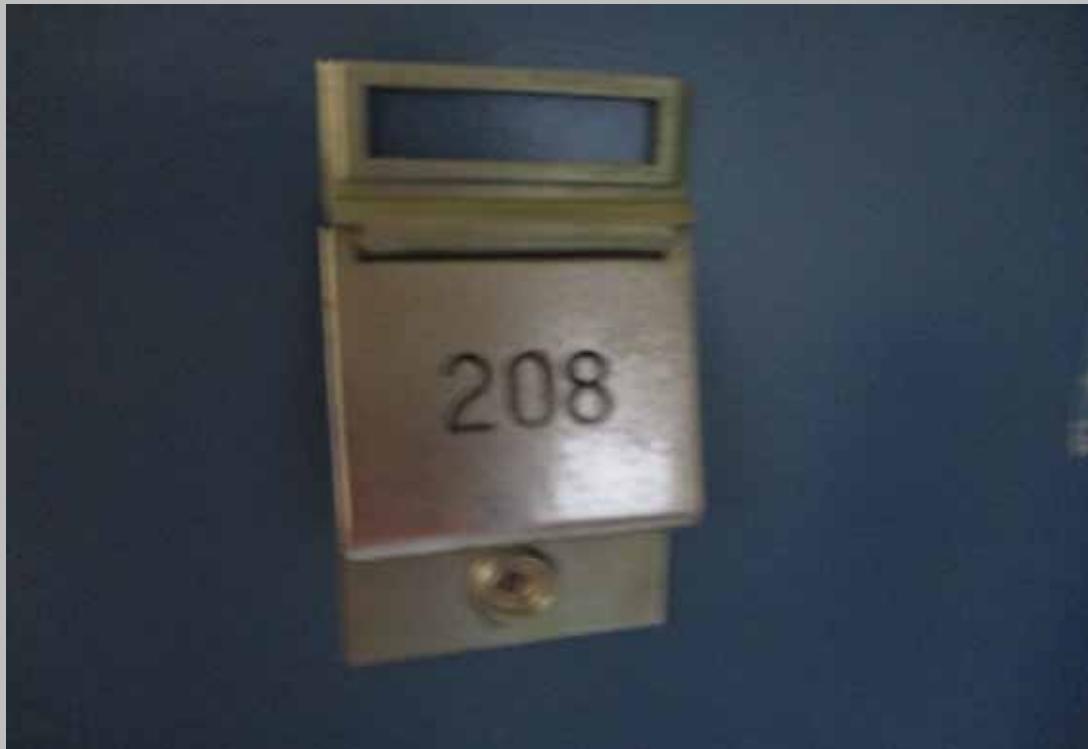
PHOTO #121

Vacant UFAS unit 208.

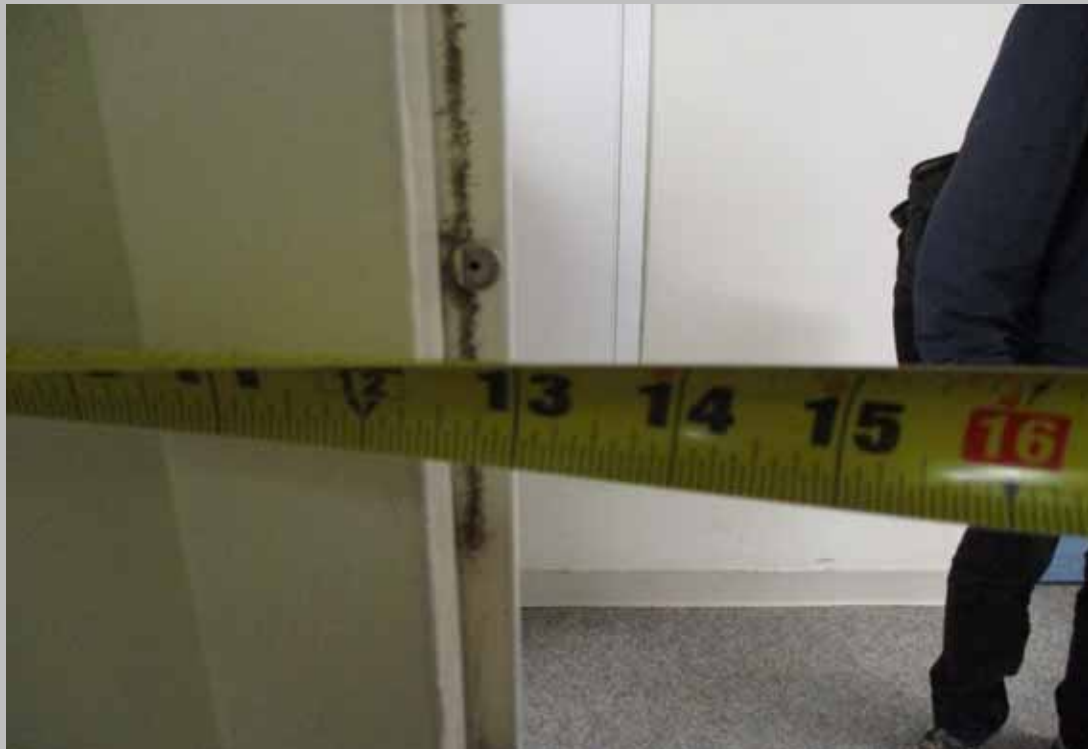
PHOTO #131

Only 12" at latch side of door.

- Select unit entry doors do not feature at least 18-inches clear floor space at the latch side/pull side (Critical Repair).
- Select kitchen and bathroom sinks do not feature scald and abrasion protection (Critical Repair).
- Select toilets feature non-compliant rear or side grab bars (Critical Repair).

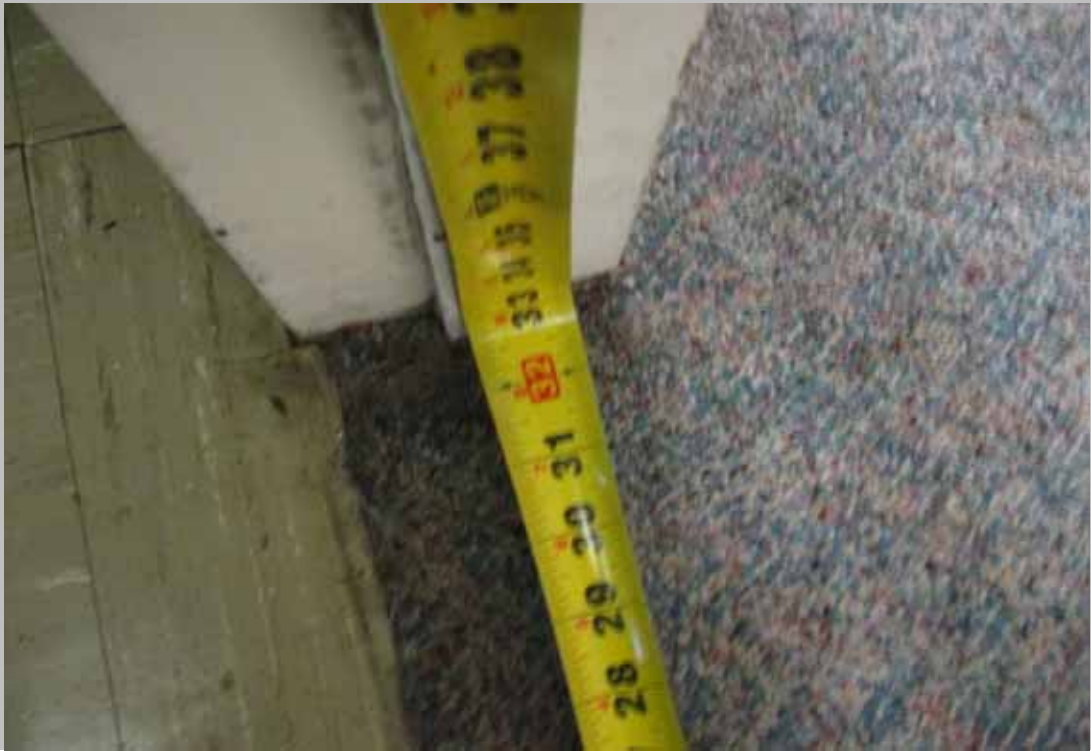
PHOTO #132

Correct entry door width.

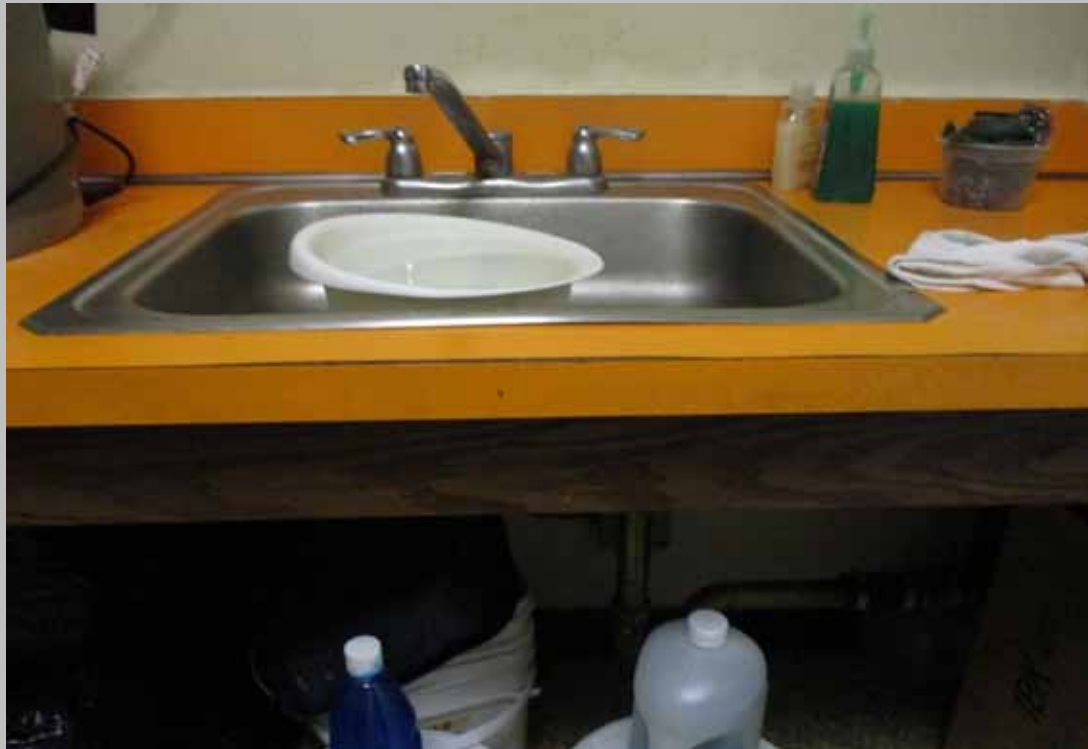
PHOTO #136

Roll under sink with levered hardware.

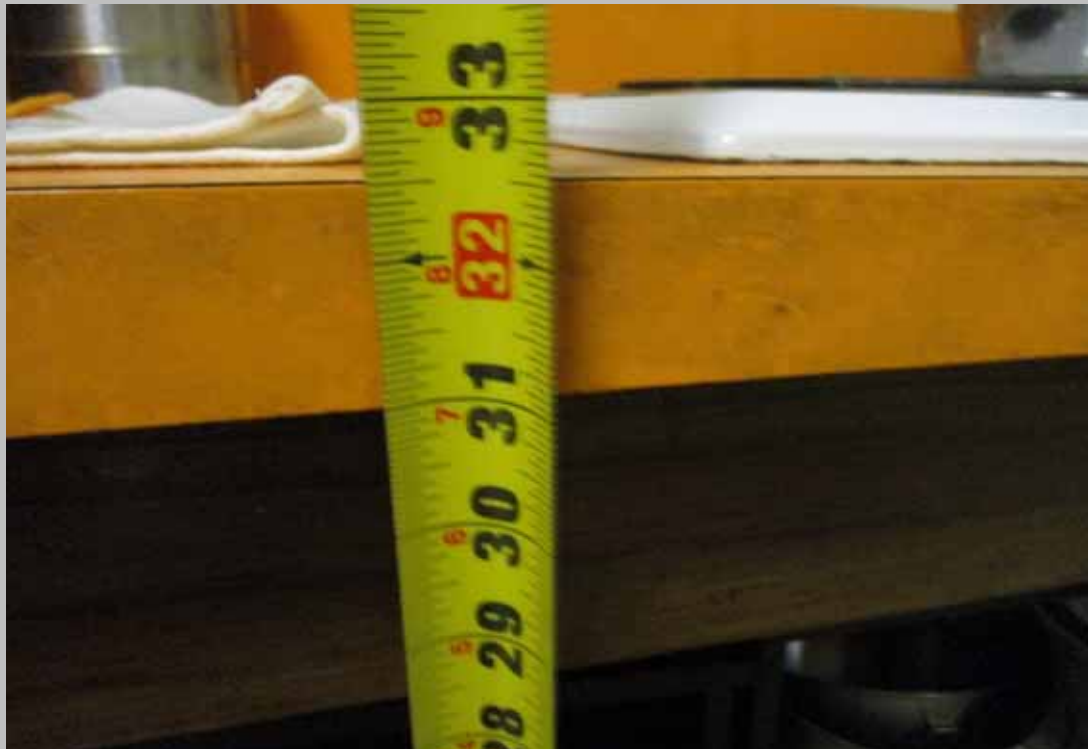
PHOTO #137

Correct counter height.

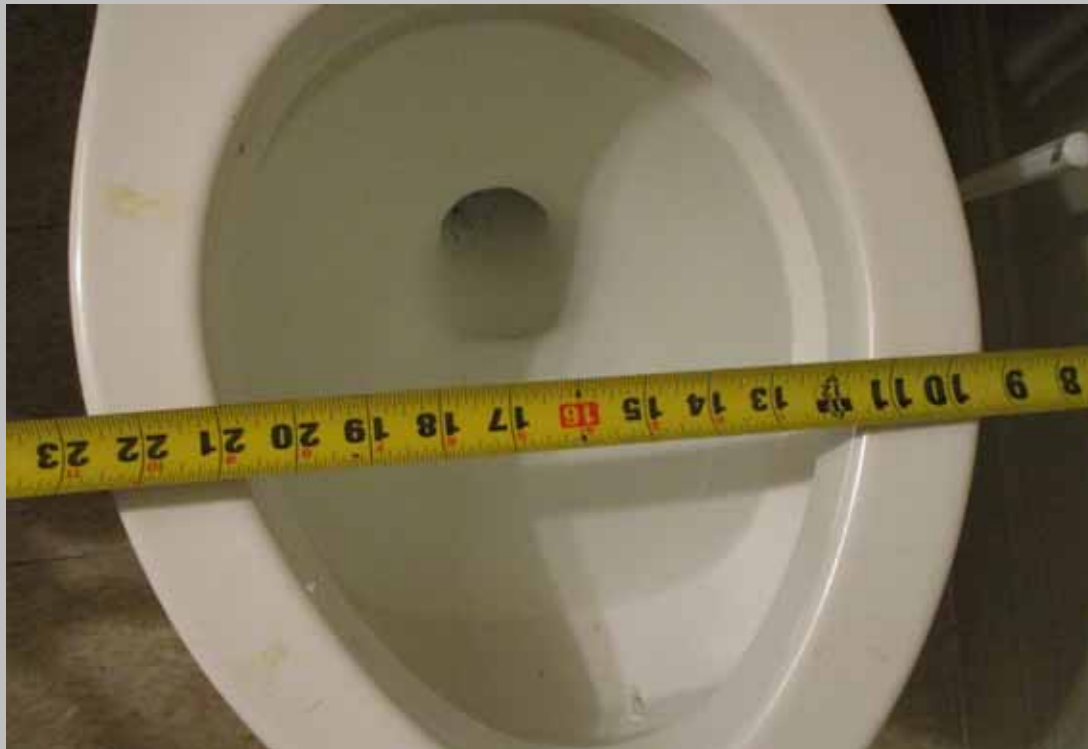
PHOTO #145

Typical toilet centering in UFAS units.

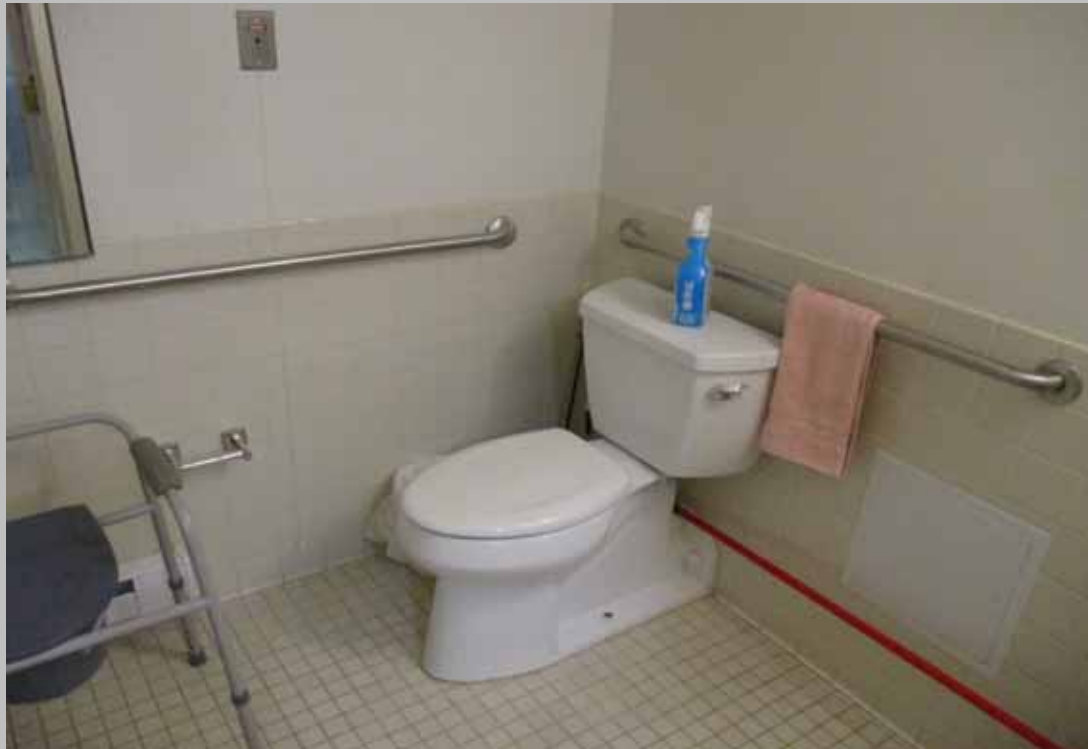
PHOTO #150

Correct grab bars in Unit 227

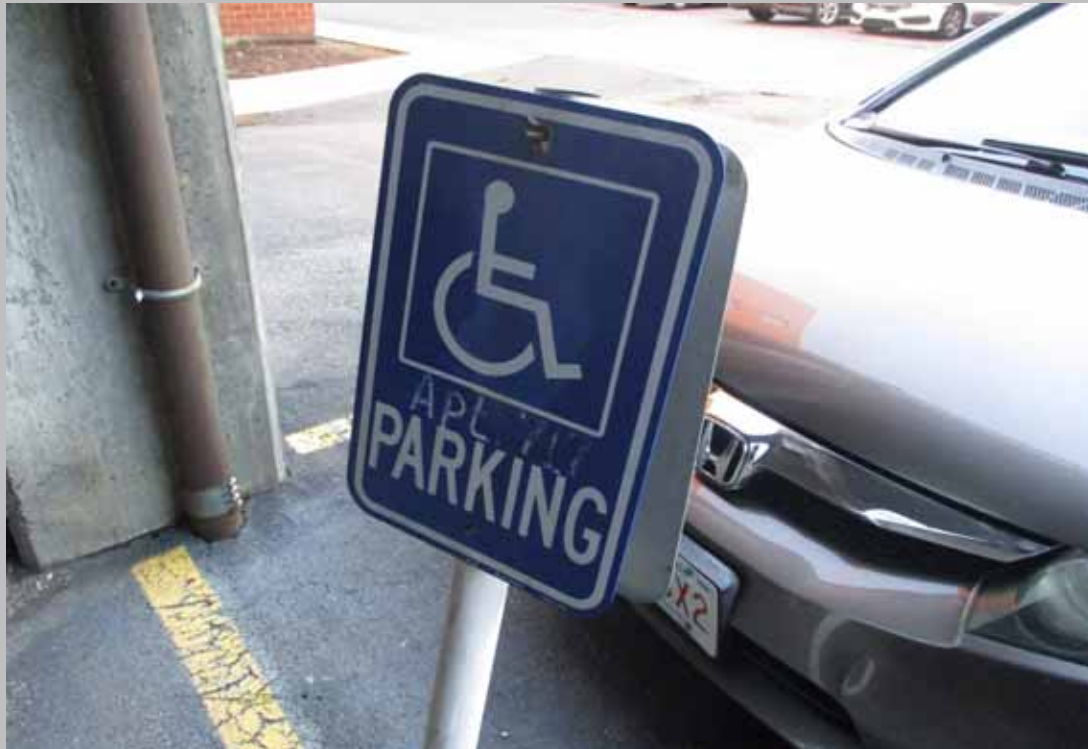
PHOTO #162

How all vertical signage is labeled.

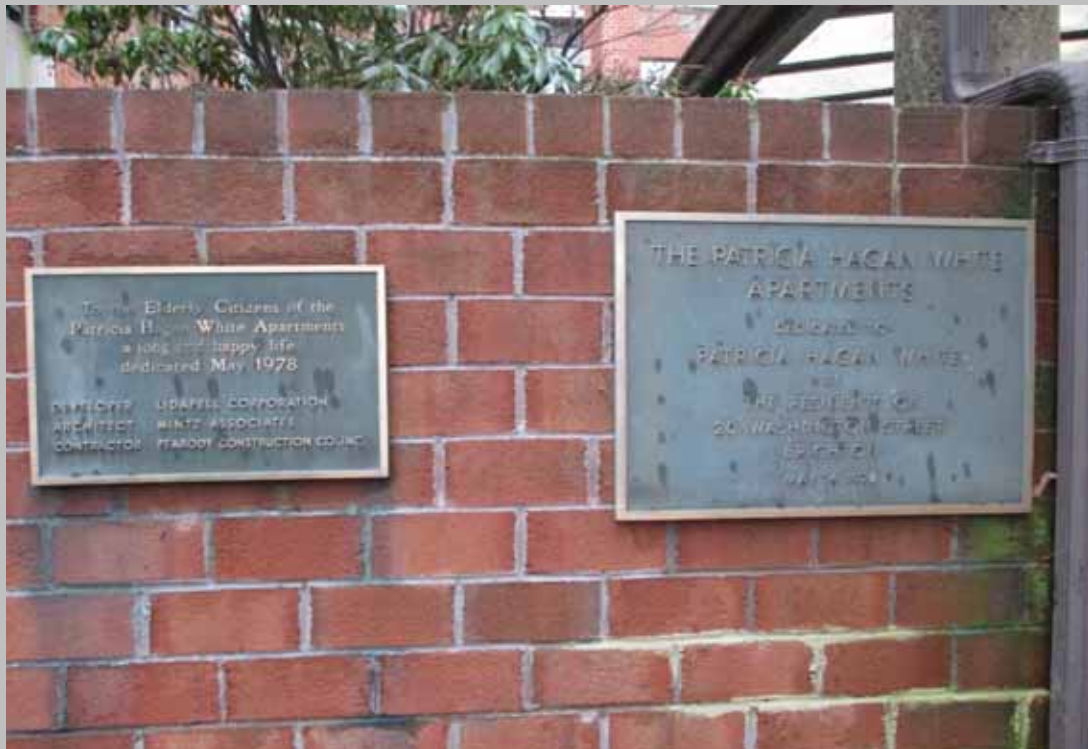
PHOTO #169

Property identifying placards.
