**CAPITAL NEEDS ASSESSMENT (CNA)
ROCKLAND TOWERS (2-50)
5300 WASHINGTON STREET
WEST ROXBURY, MASSACHUSETTS 02132**

**D3G PROJECT NUMBER:
2021-0378**

**FINAL REPORT ISSUE DATE:
OCTOBER 14, 2021**

**INSPECTION DATES:
APRIL 19 & 22, 2021**

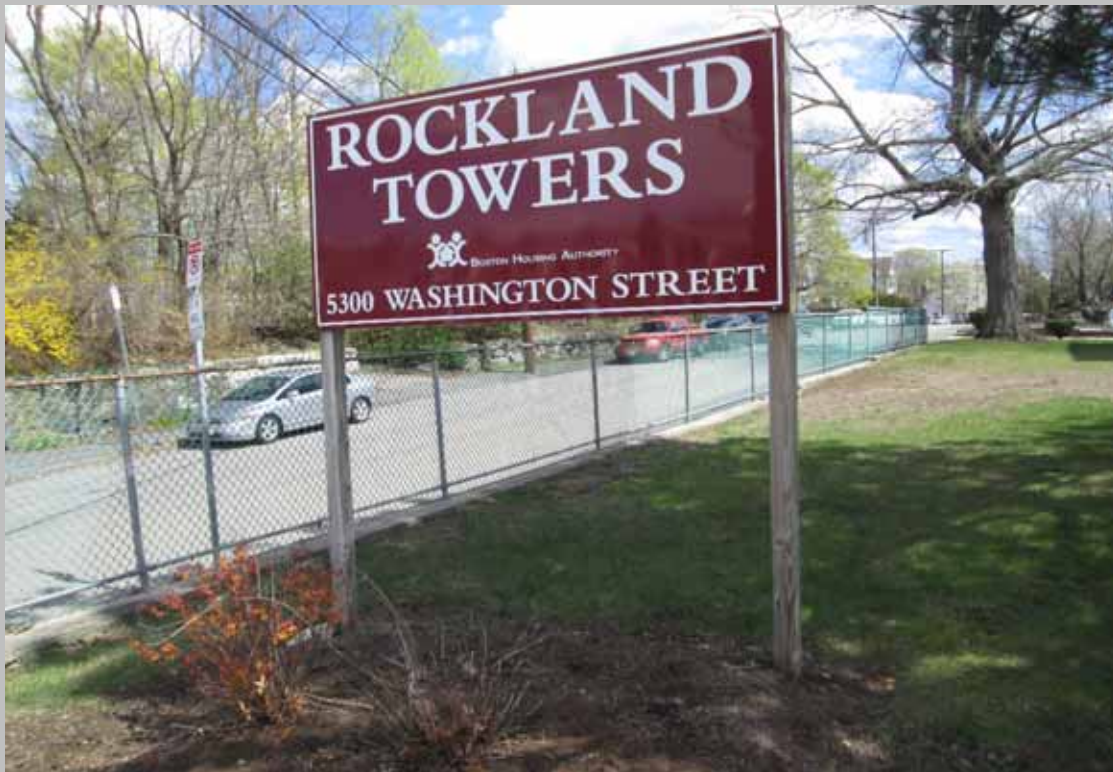
PHOTO #1

View of property identification sign

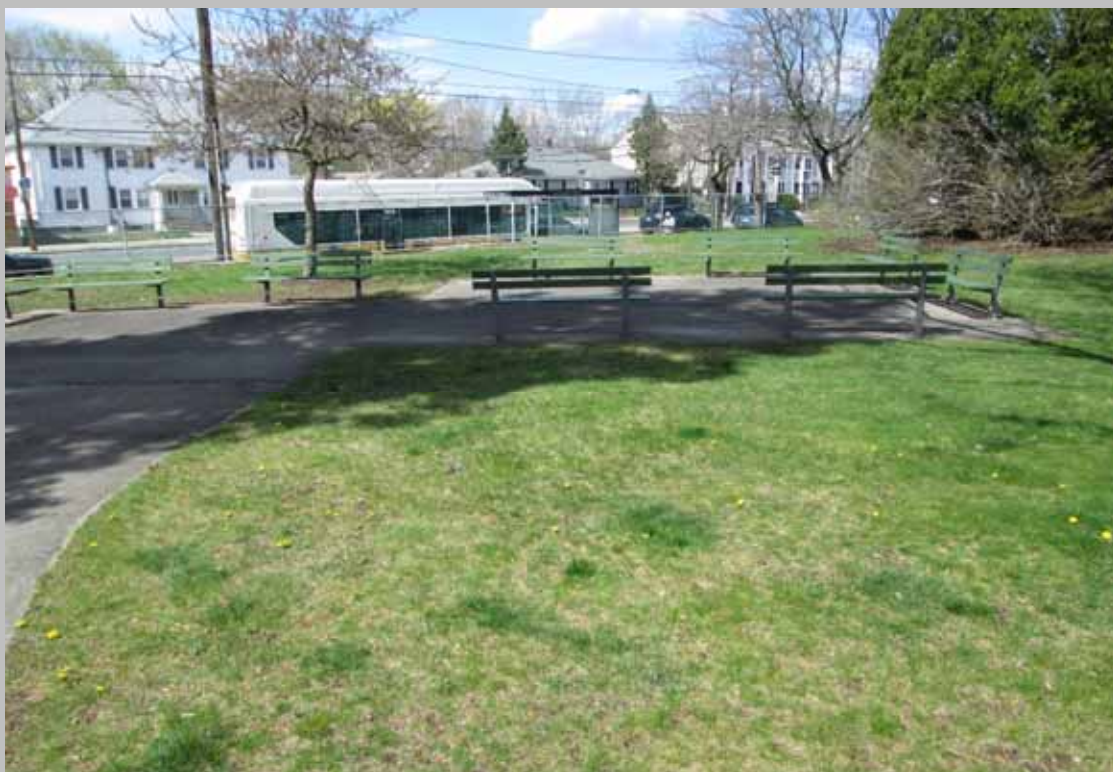
PHOTO #2

View of an outdoor seating area

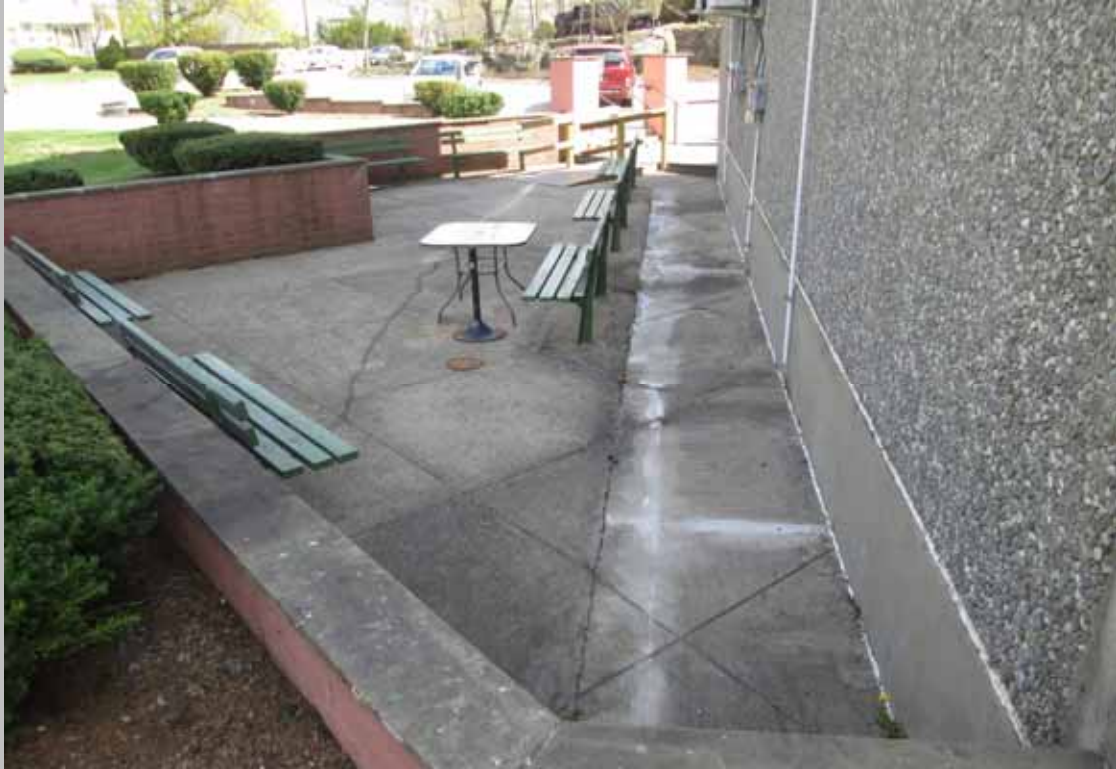
PHOTO #3

View of an outdoor seating area

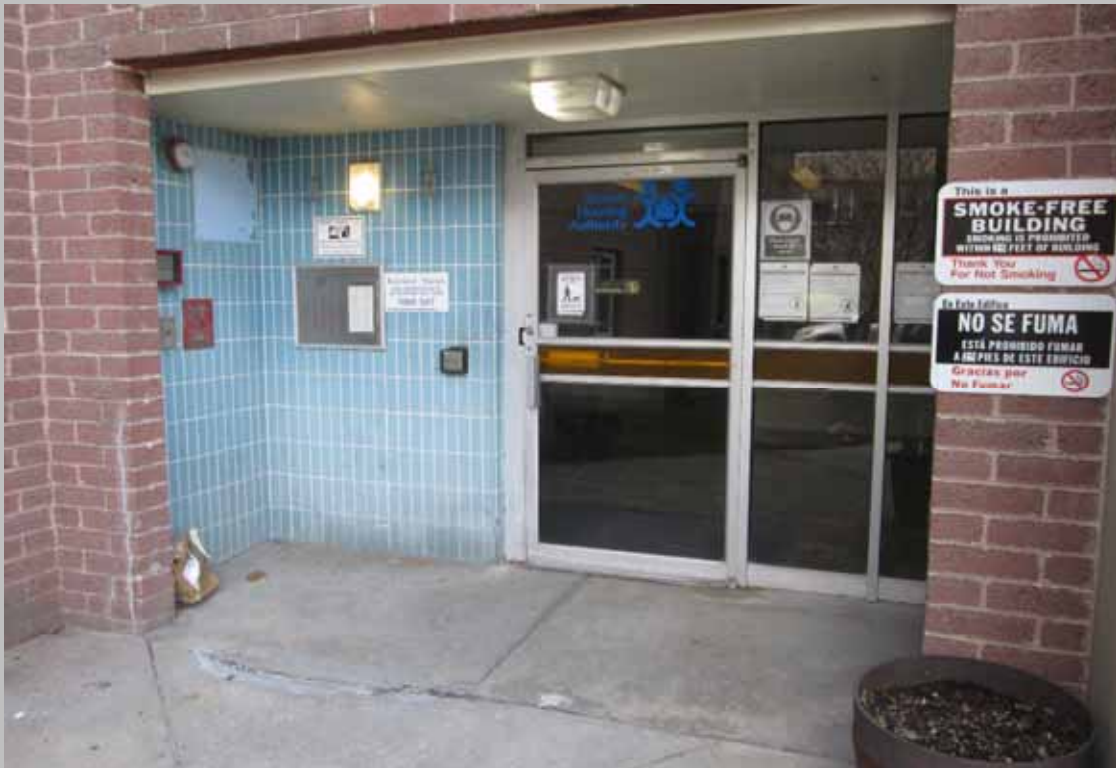
PHOTO #4

View of building main entrance

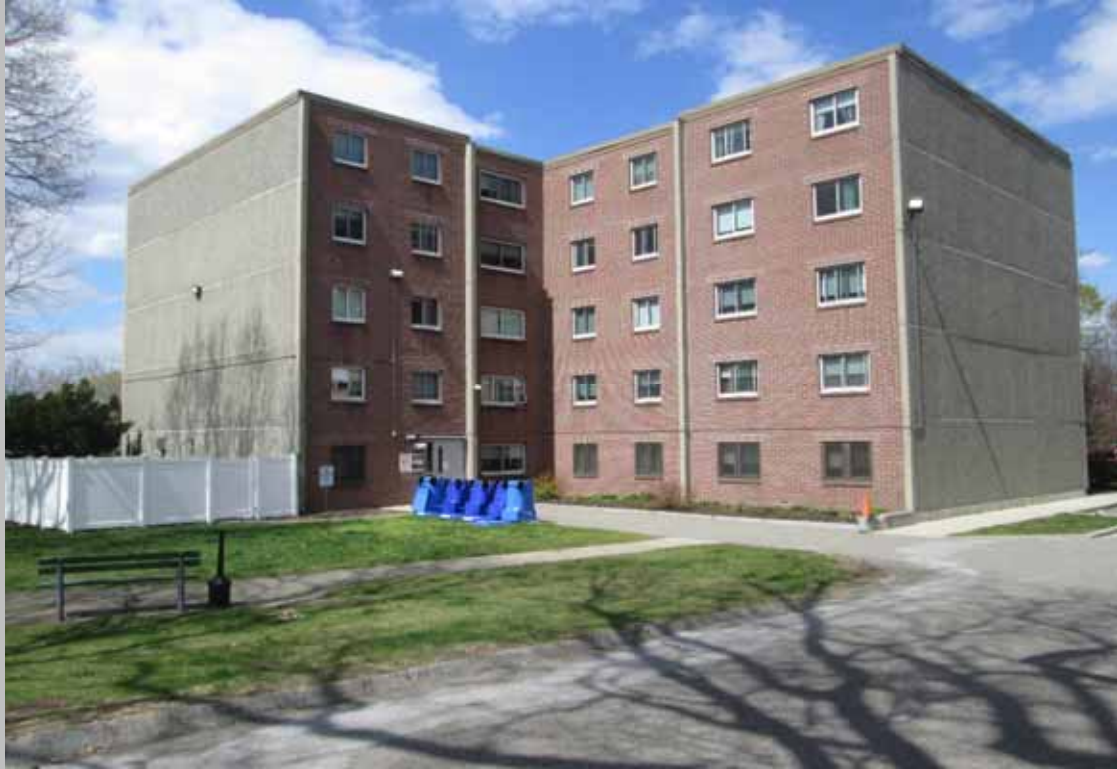
PHOTO #5

View of building exterior

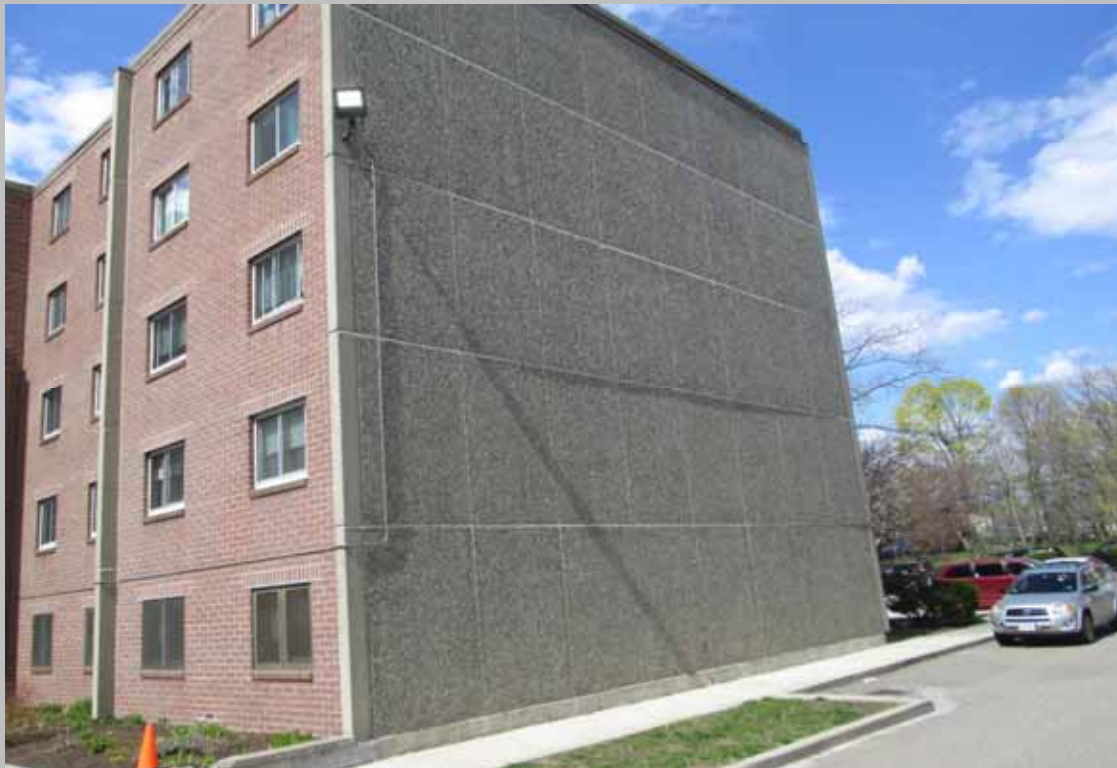
PHOTO #6

View of building exterior

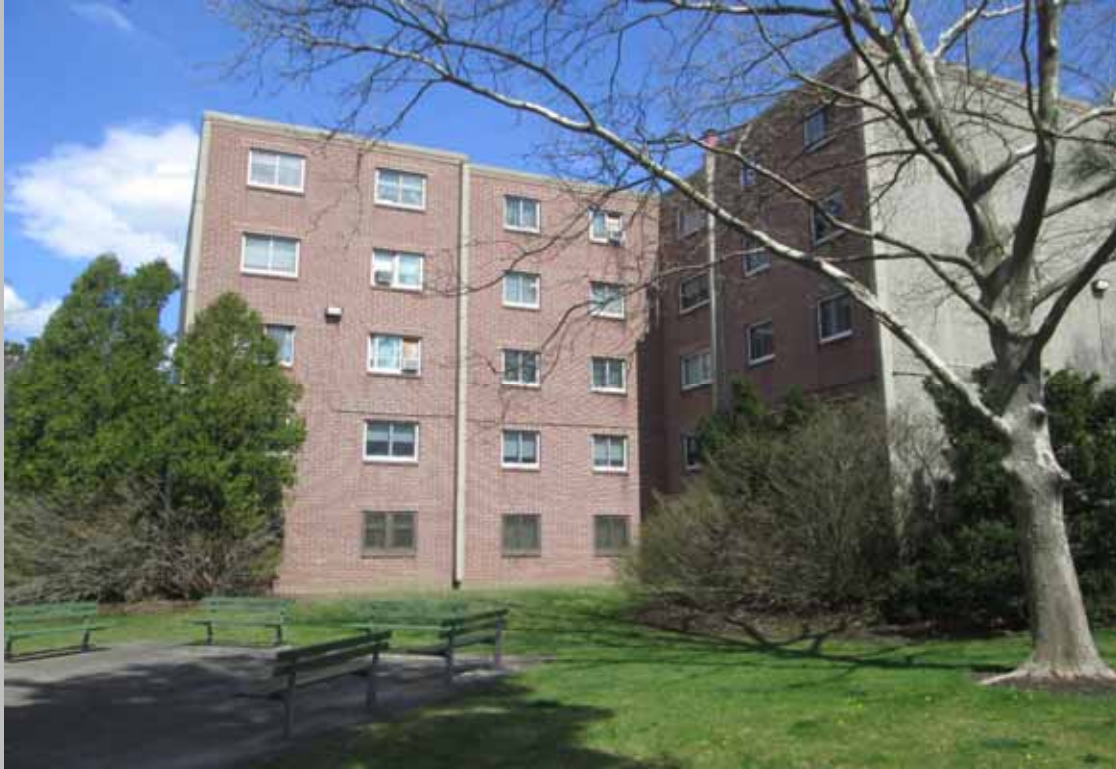
PHOTO #7

View of building exterior

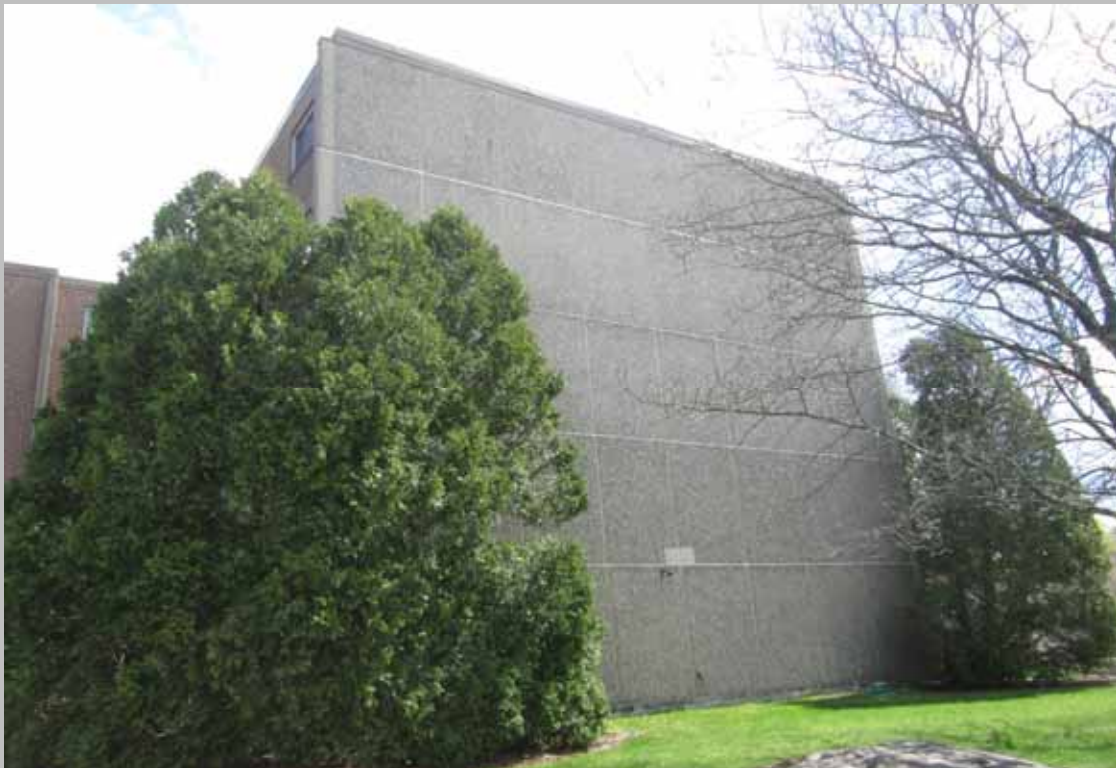
PHOTO #8

View of building exterior

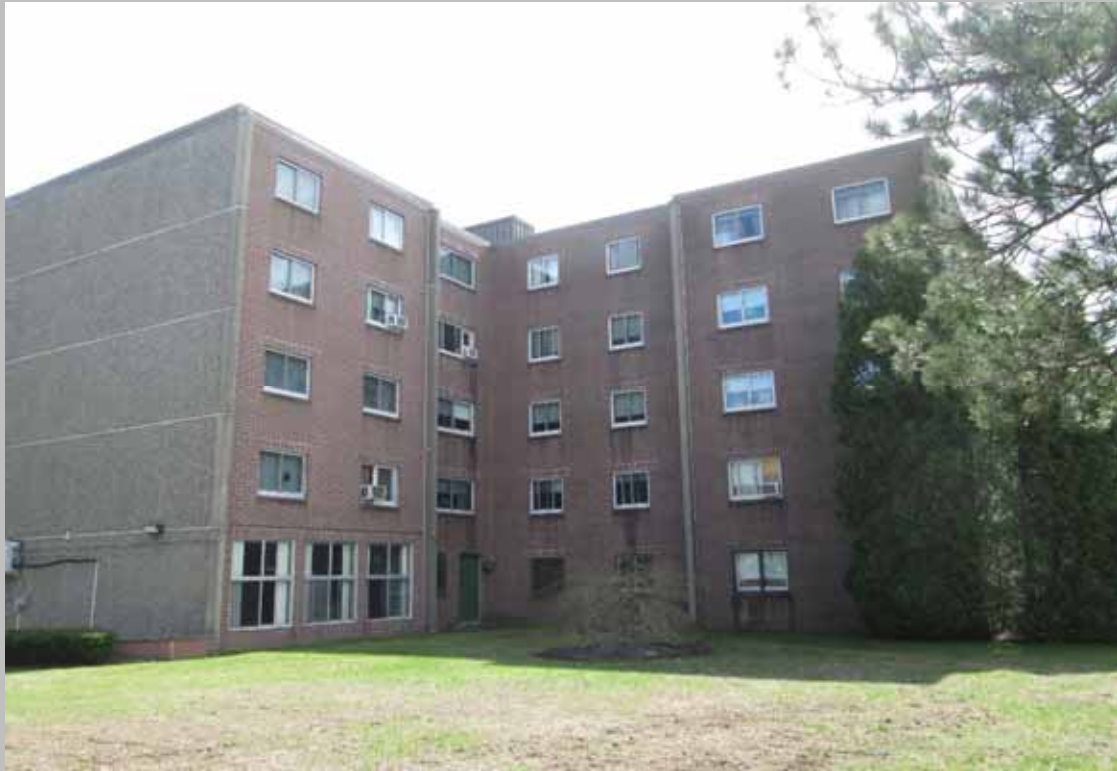
PHOTO #9

View of building exterior

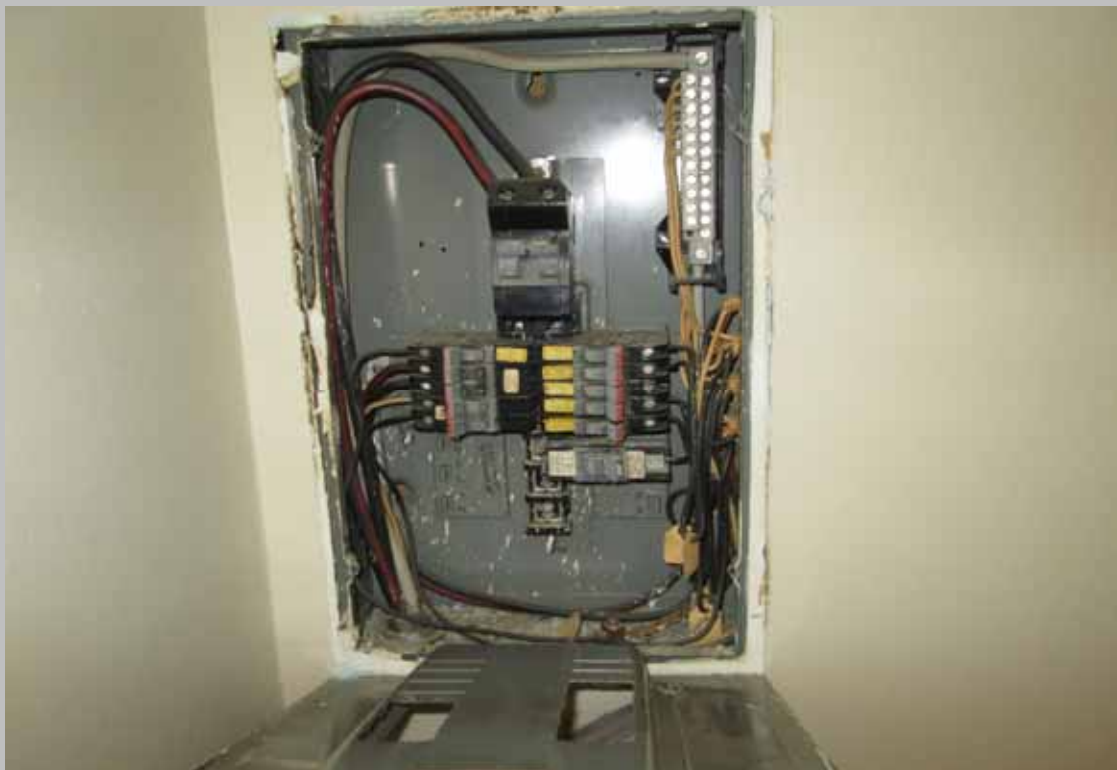
PHOTO #28

View of copper wire detail at electric breaker panel – dwelling unit

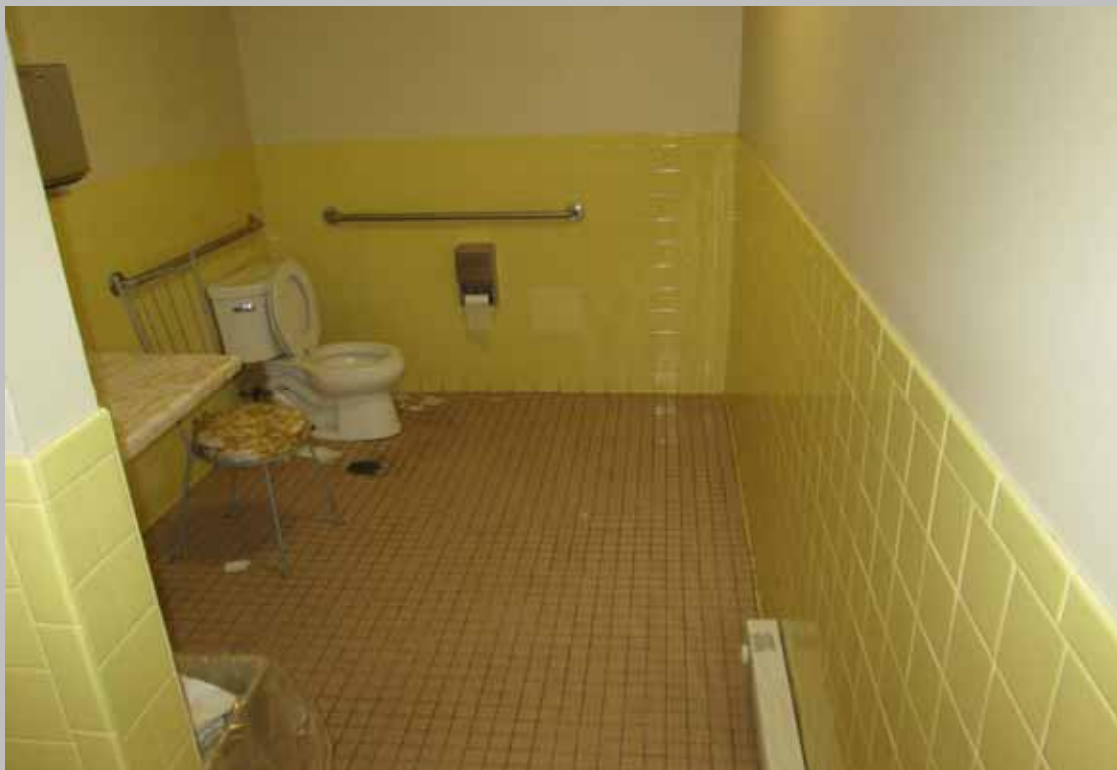
PHOTO #30

View of a common area restroom

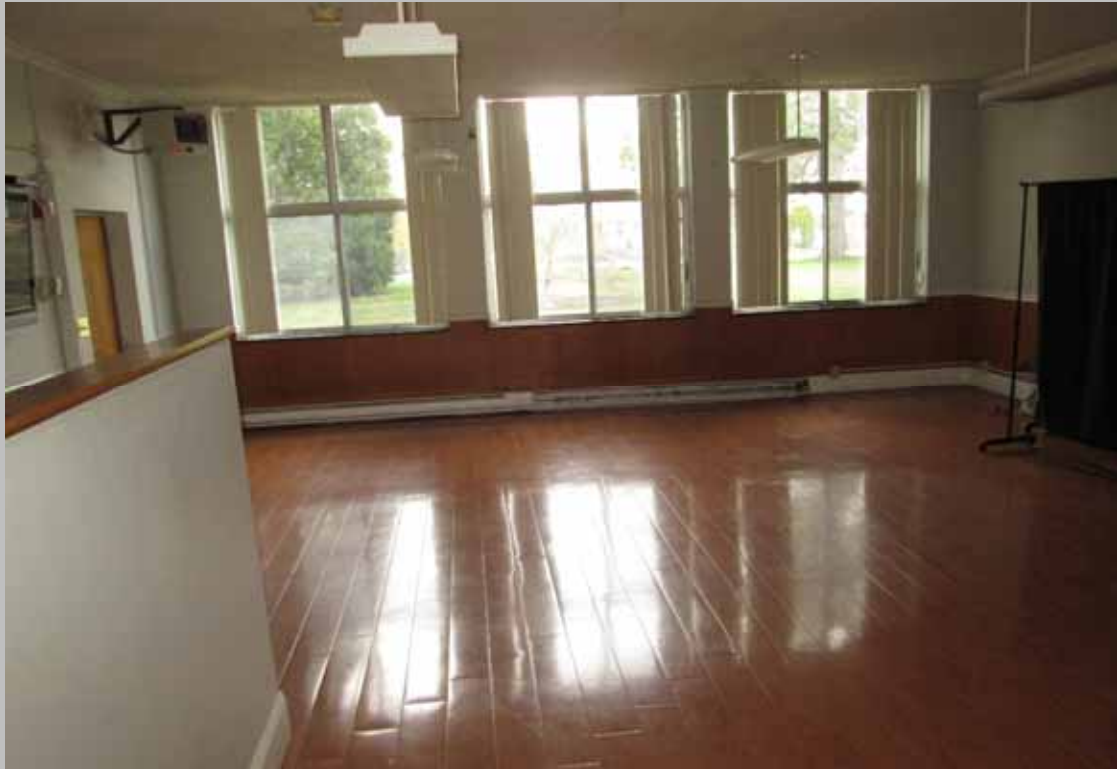
PHOTO #31

View of the main lobby

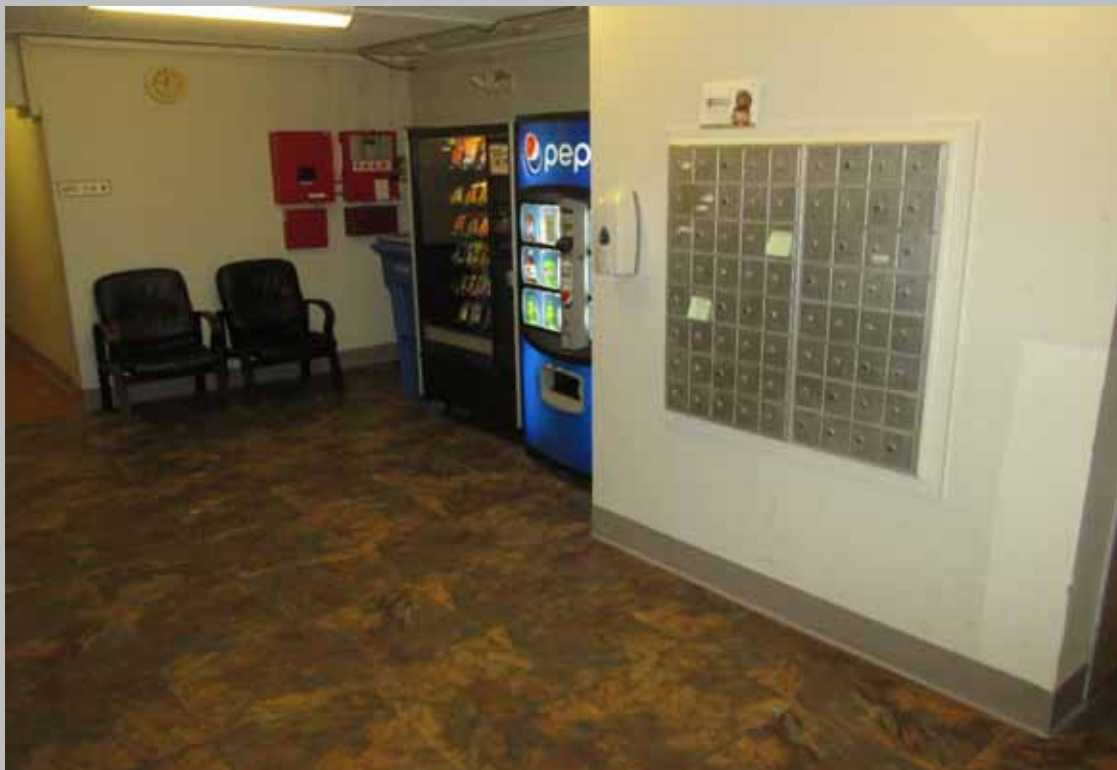
PHOTO #32

View of the mail kiosk

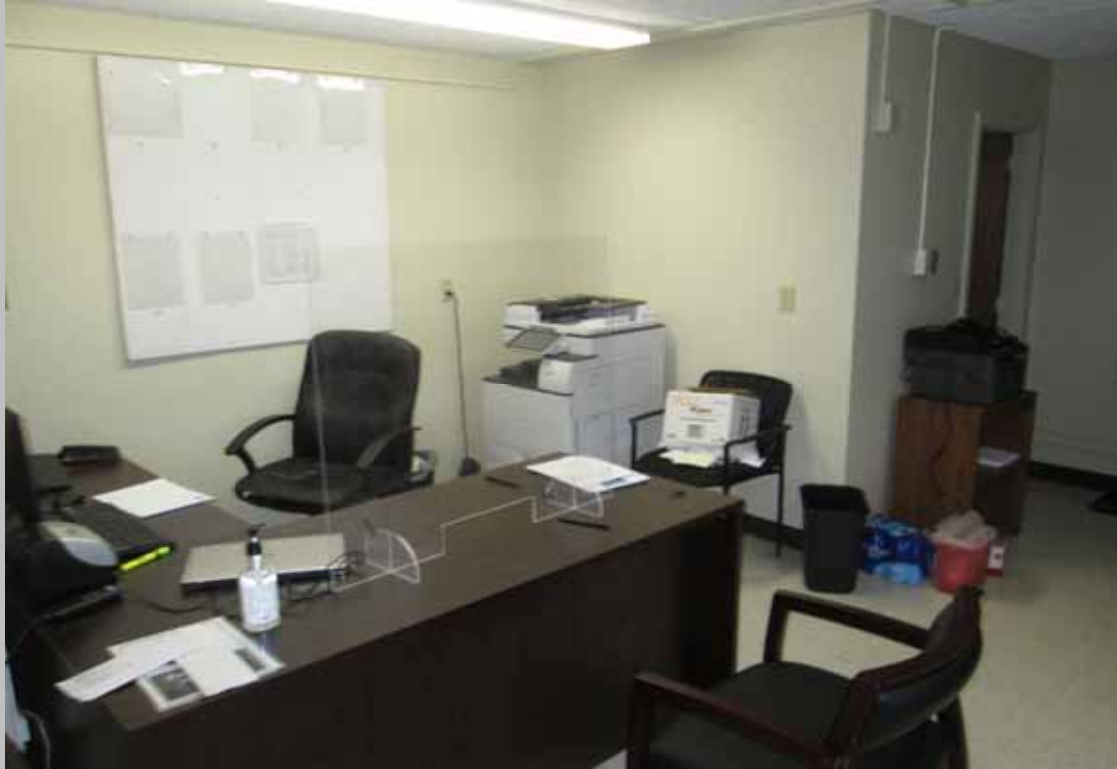
PHOTO #35

View of management office (leasing office)

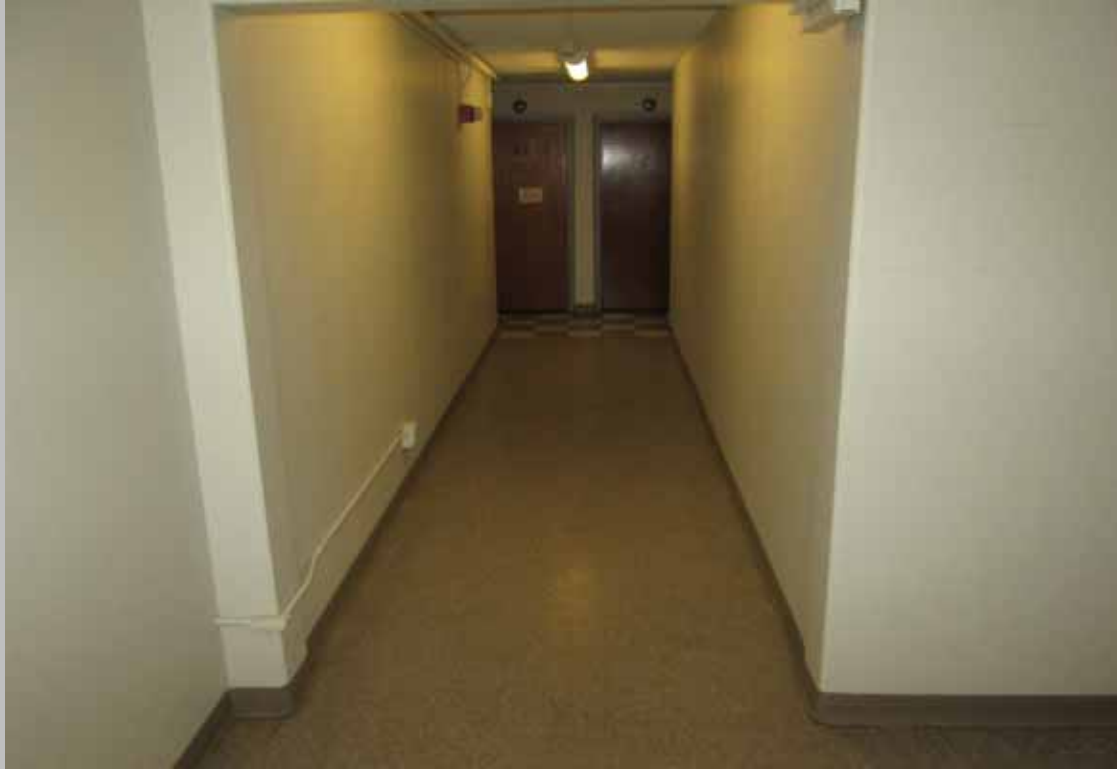
PHOTO #37

View of common interior hallway

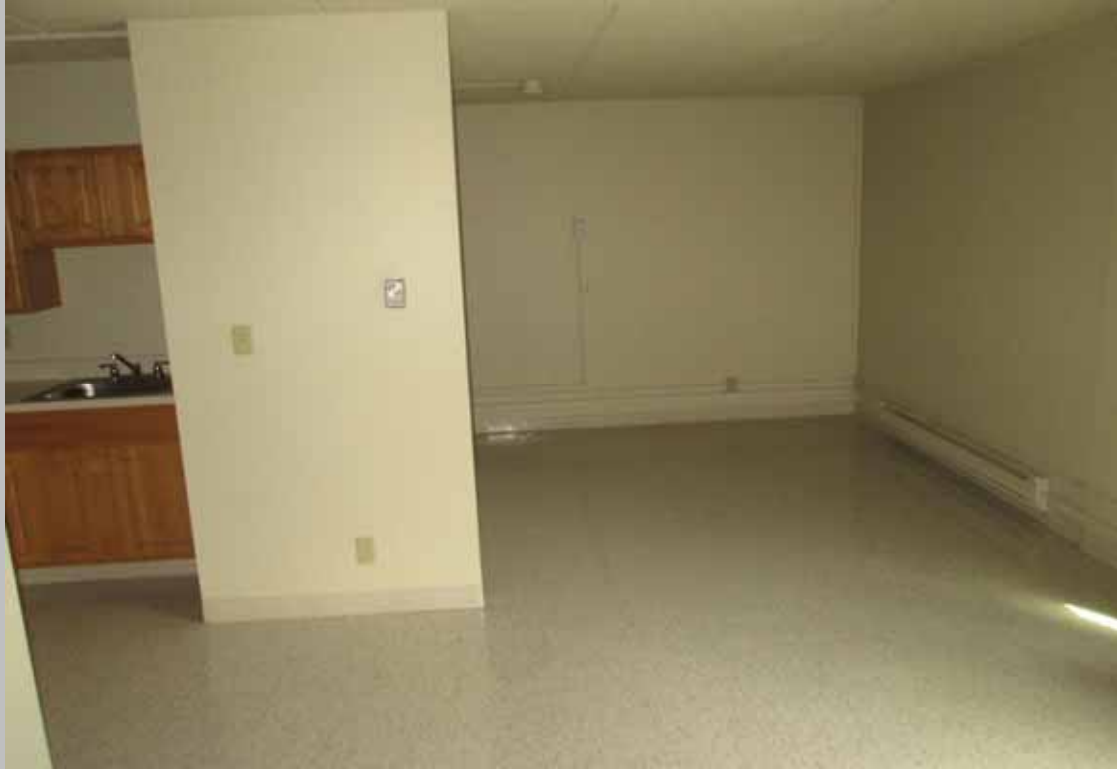
PHOTO #39

View of the living area within Unit 45

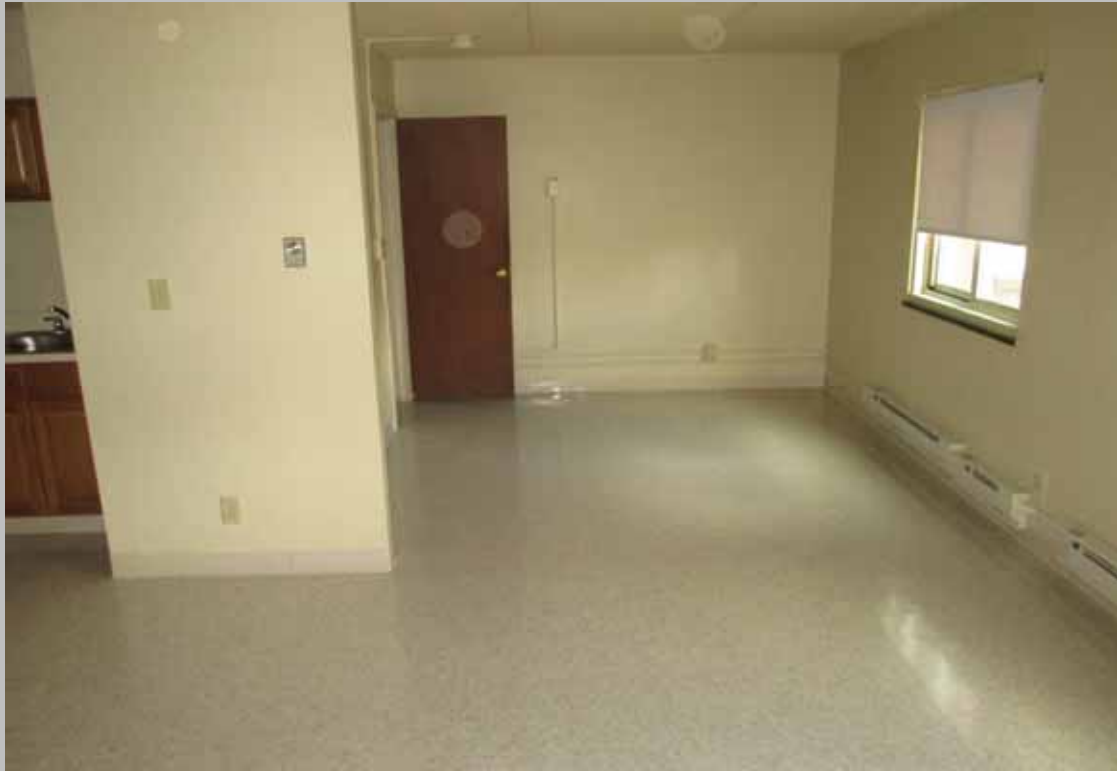
PHOTO #43

View of the living area within Unit 25

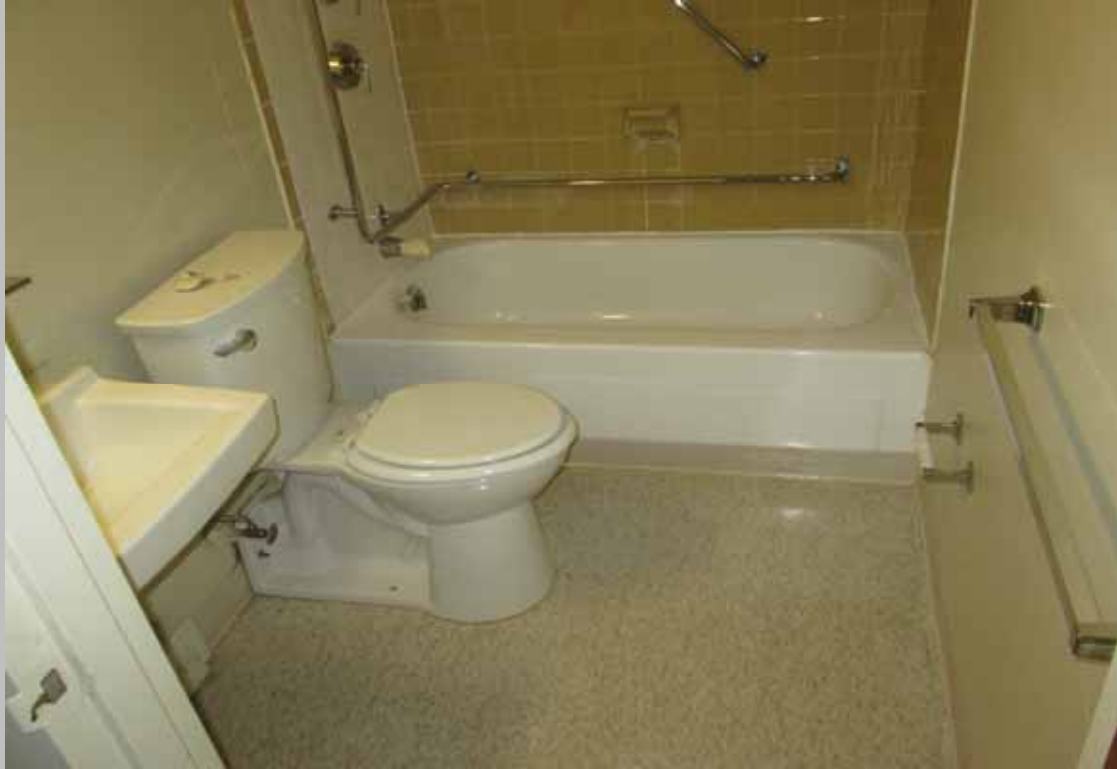
PHOTO #45

View of the bathroom at Unit 25

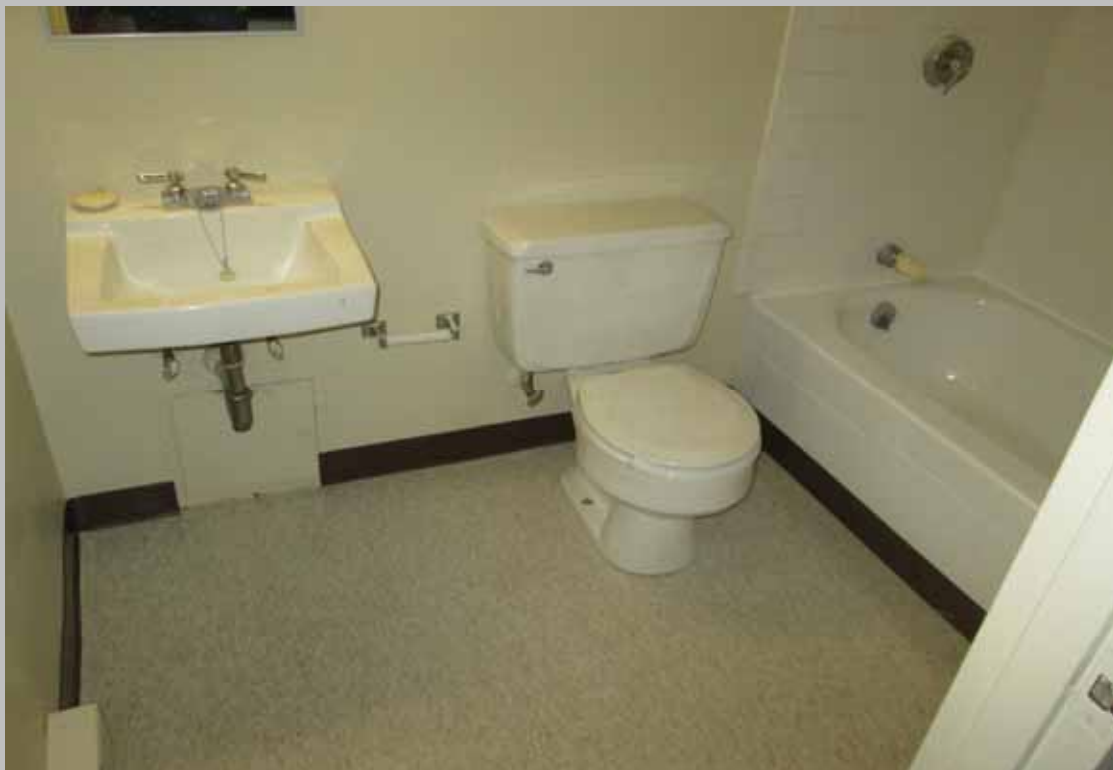
PHOTO #48

View of the bathroom at Unit 7

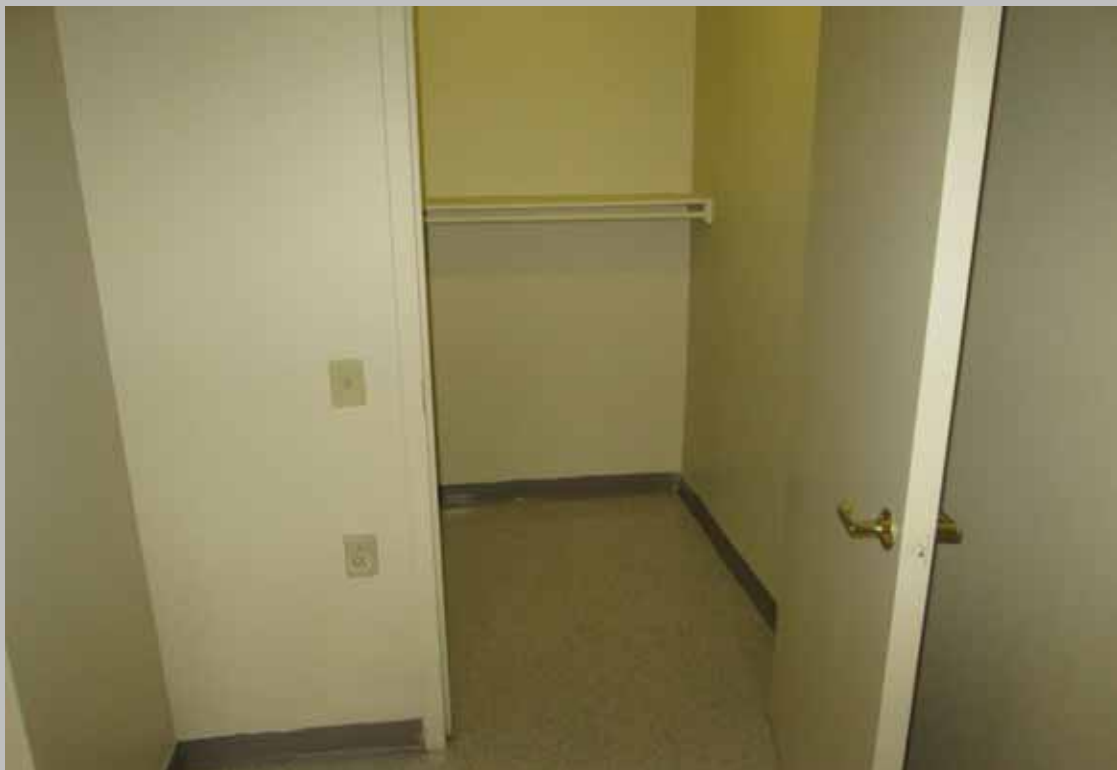
PHOTO #56

View of a closet within designated handicapped Unit 17
